Fire Inspection Report SFM Kayla Riggs

Name: Mississippi State Fairgrounds, Jackson, Hinds County **Location Street Number:** 1207 **Location Street Prefix:**
Location Street Name: Mississippi **Location Street Type:** Street **Location County:** Hinds
Phone Number: (601) 961-4000 **Zone:** 5
Code: CID

Name: Mississippi Trademart **Building Class Code:** All other assembly occupancies
Property Use: Convention center, exhibition hall
Occupant City: Jackson **Occupant Postal Code:** 39202 **Occupant State:** MS **Occupant County:** Hinds

Inspection Number: SFM20260008

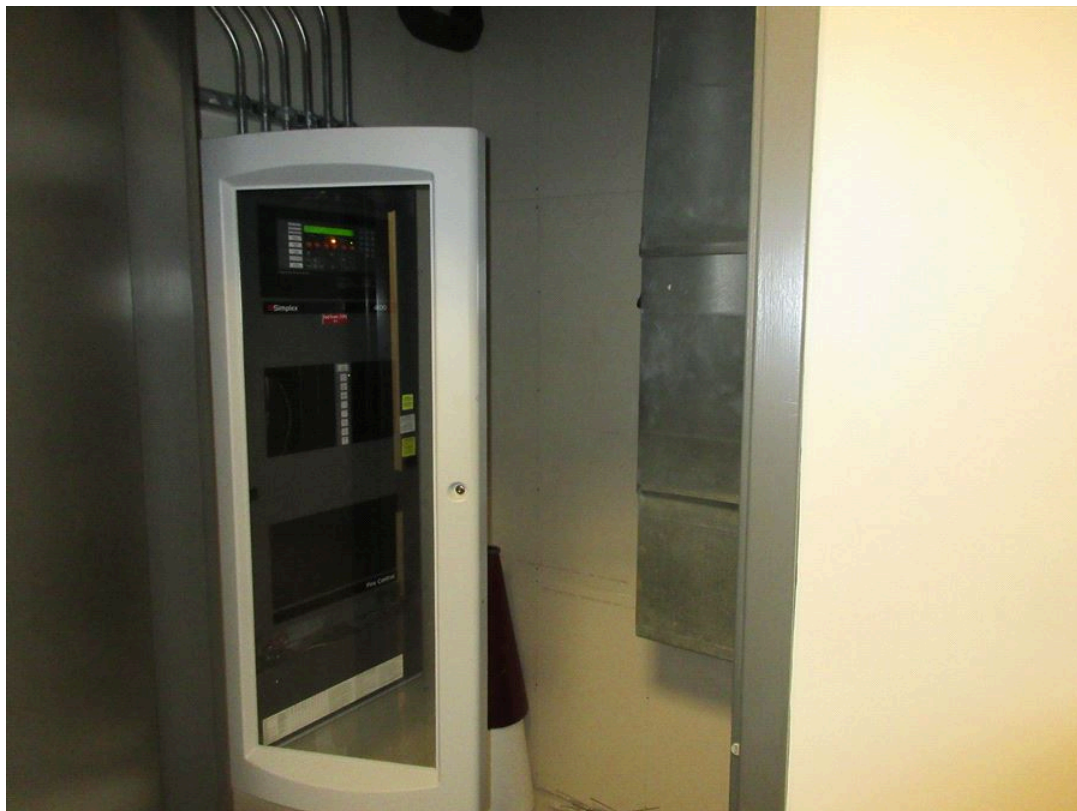
File Name: photo showing the entire fire alarm panel
Violation Code: 907.8
Inspected Date: 2026-03-26 17:41:41

Violation Code	Description	Comments
907.8	<p>Inspection, testing and maintenance. The maintenance and testing schedules and procedures for fire alarm and fire detection systems shall be in accordance with Sections 907.8.1 through 907.8.4 and NFPA 72. Records of inspection, testing and maintenance shall be maintained.</p>	<p>There are troubles on the fire alarm panels that need to be corrected. Please note that at the time of the inspection there was clean-up work being conducted to remove soot and to clear the ducts.</p>

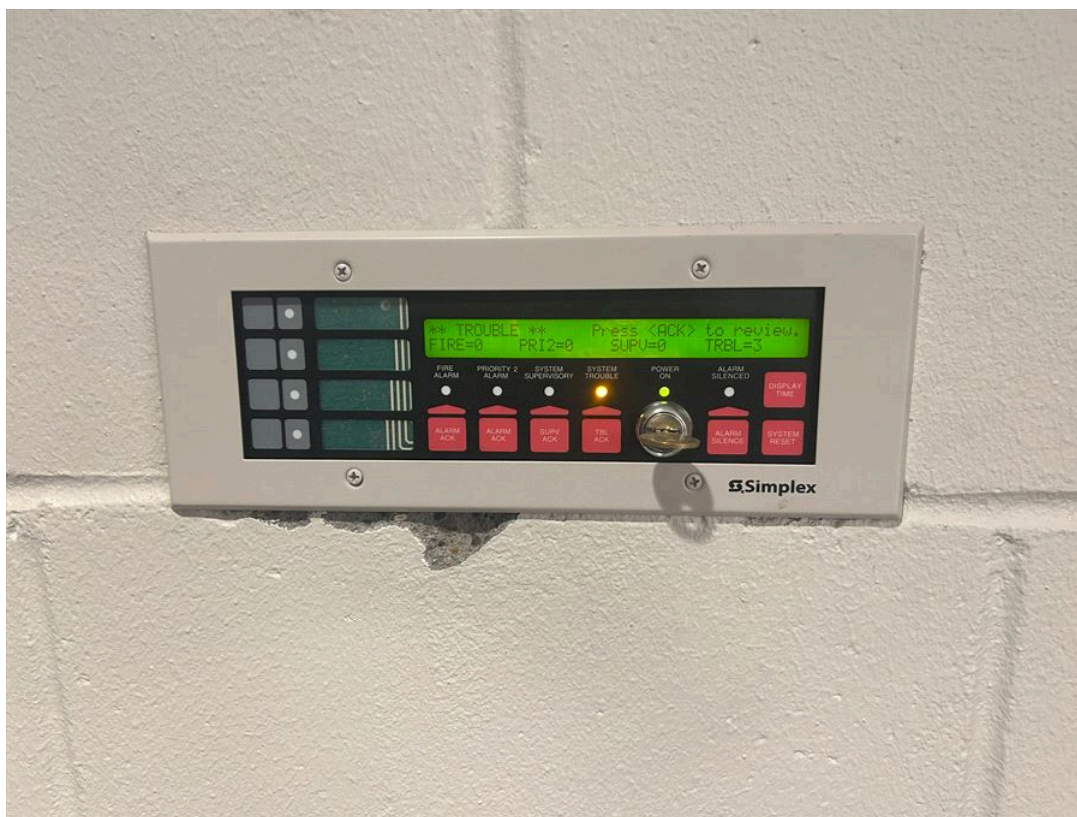
File Name: photo showing the annunciator panel with 3 troubles on it
Violation Code: 907.8
Inspected Date: 2026-03-26 17:41:41

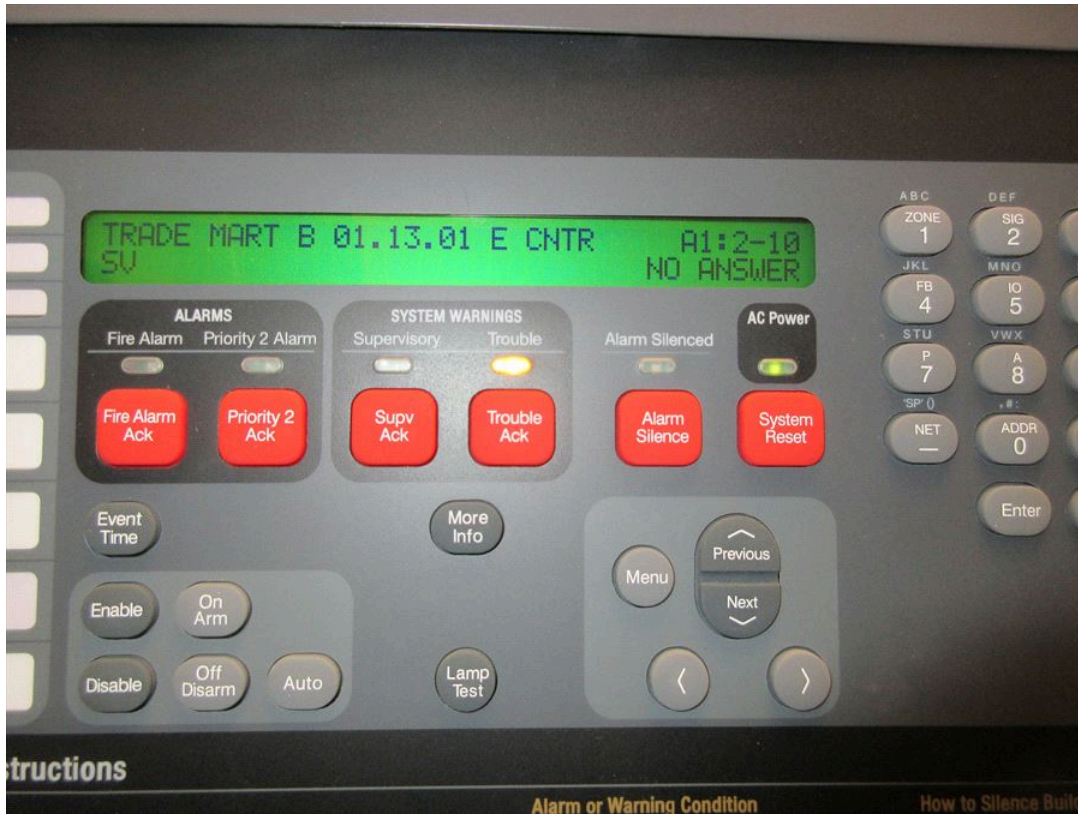
File Name: photo showing no answer trouble on the fire alarm
Violation Code: 907.8
Inspected Date: 2026-03-26 17:41:41

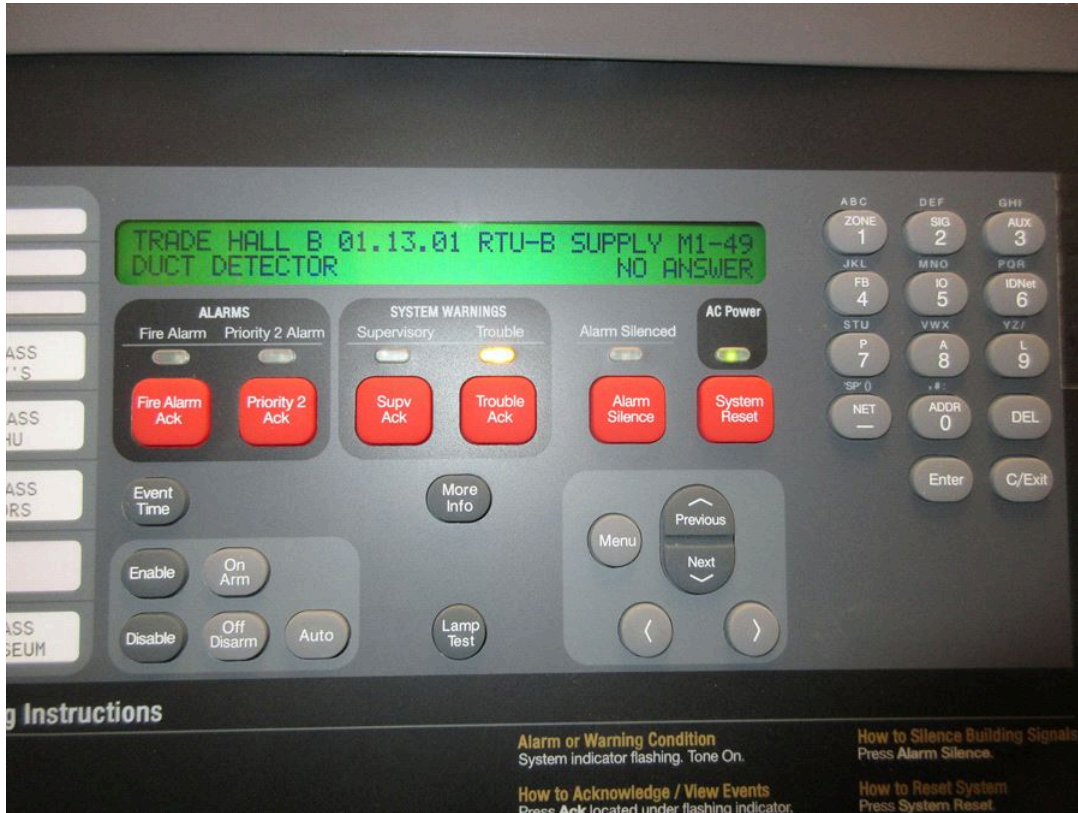
File Name: photo showing duct detector trouble
Violation Code: 907.8
Inspected Date: 2026-03-26 17:41:41

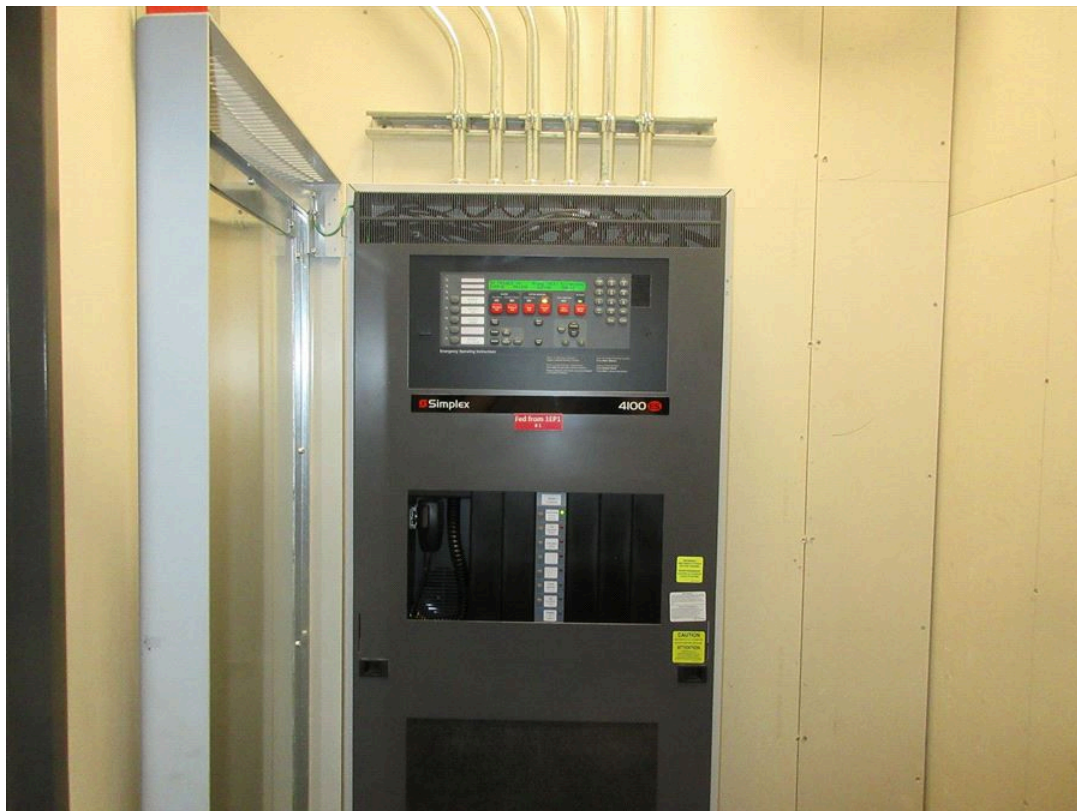
File Name: photo of the fire alarm panel
Violation Code: 907.8
Inspected Date: 2026-03-26 17:41:41

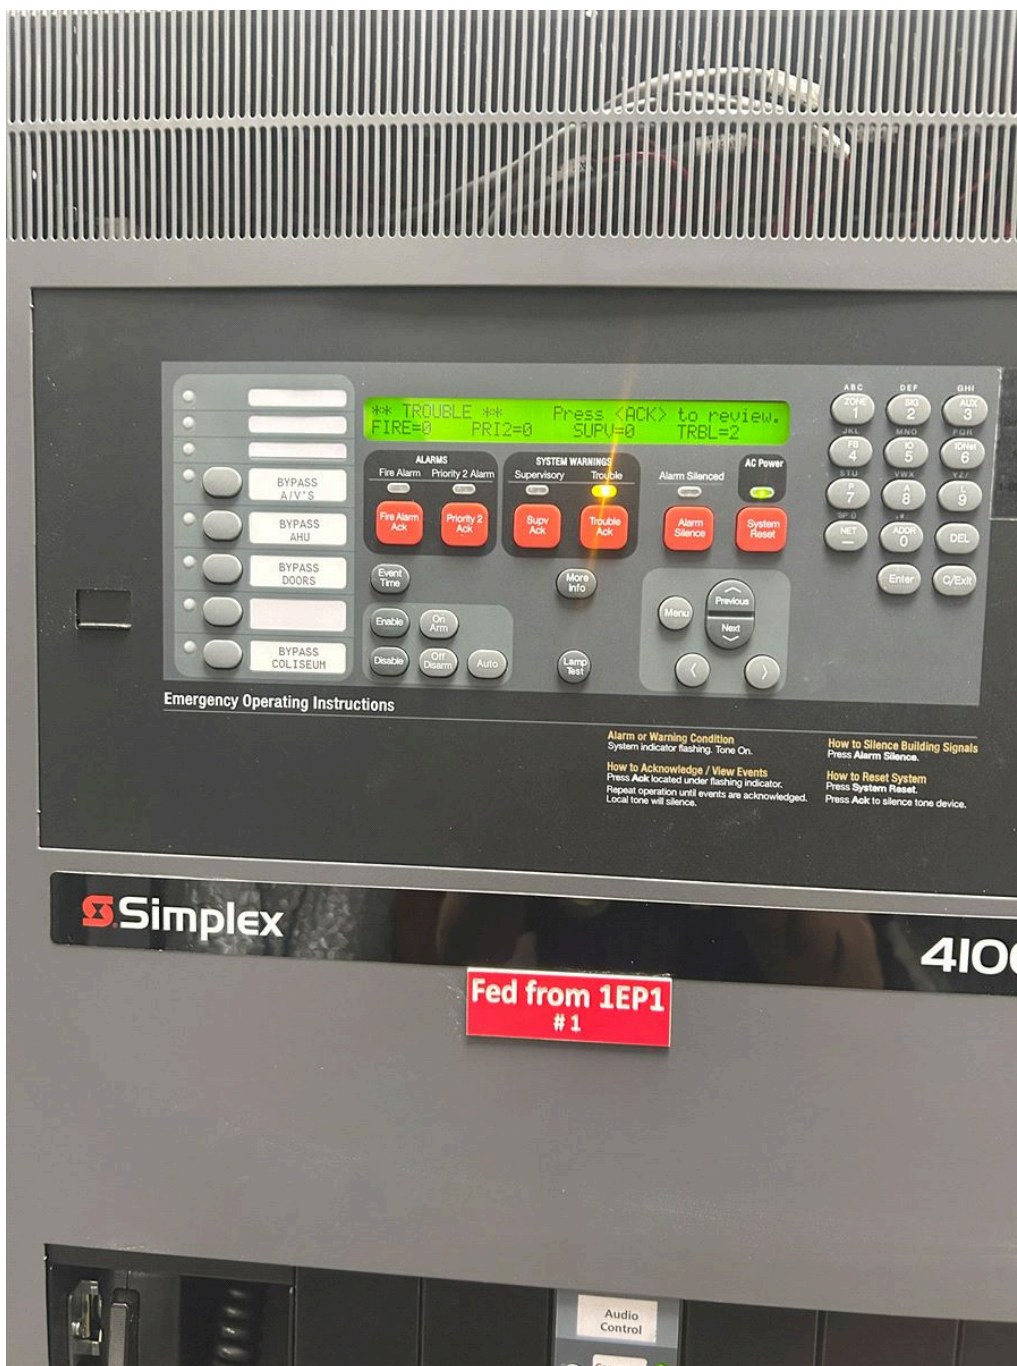
File Name: photo of close up of the troubles on the fire alarm panel

Violation Code: 907.8

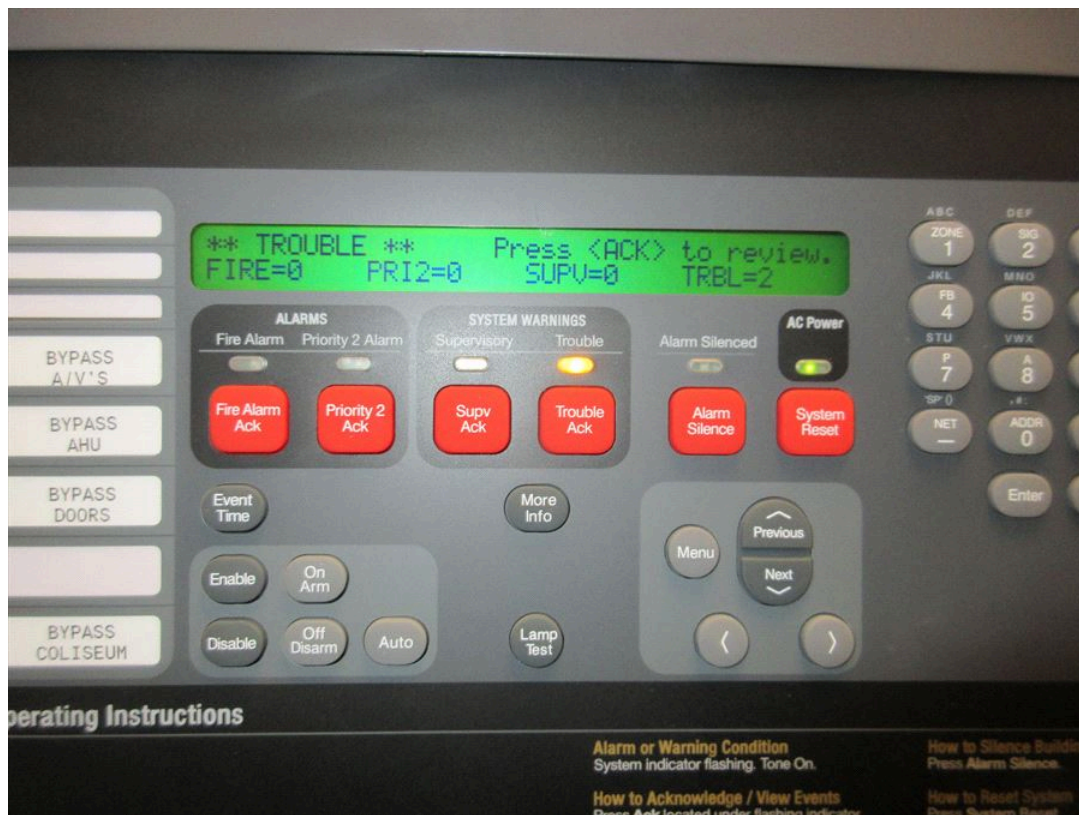
File Name: photo of close up of fire alarm panel troubles
Violation Code: 907.8
Inspected Date: 2026-03-26 17:41:41

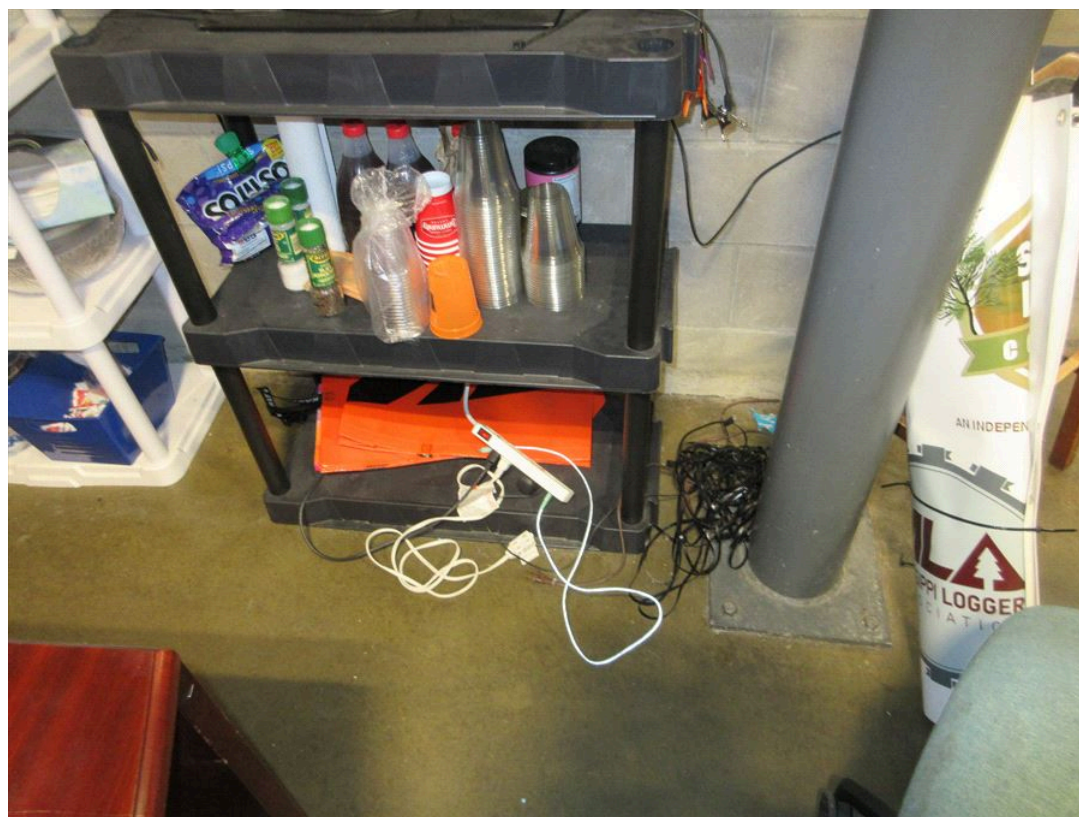
File Name: photo of power strip 2
Violation Code: 603.5.1
Inspected Date: 2026-03-27 17:49:53

603.5.1	<p>Listing. Relocatable power taps shall be listed and labeled in accordance with UL 1363. Current taps shall be listed and labeled in accordance with UL 498A.</p>	<p>There is improper use of power strips.</p>
1104.3	<p>Exit sign illumination. Exit signs shall be internally or externally illuminated. The face of an exit sign illuminated from an external source shall have an intensity of not less than 5 footcandles (54 lux). Internally illuminated signs shall provide equivalent luminance and be listed for the purpose.</p> <p>Exception: Approved self-luminous signs that provide evenly illuminated letters shall have a minimum luminance of 0.06 foot-lamberts (0.21 cd/m²).</p>	<p>There are exit signs that are not illuminated.</p>
1013.1	<p>Where required. Exits and exit access doors shall be marked by an approved exit sign readily visible from any direction of egress travel. The path of egress travel to exits and within exits shall be marked by readily visible exit signs to clearly indicate the direction of egress travel in cases where the exit or the path of egress travel is not immediately visible to the occupants. Intervening means of egress doors within exits shall be marked by exit signs. Exit sign placement shall be such that any point in an exit access corridor or exit passageway is within 100 feet (30 480 mm) or the listed viewing distance of the sign, whichever is less, from the nearest visible exit sign.</p> <p>Exceptions:</p> <ol style="list-style-type: none"> 1. Exit signs are not required in rooms or areas that require only one exit or exit access. 2. Main exterior exit doors or gates that are obviously and clearly identifiable as exits need not have exit signs where approved by the fire code official. 3. Exit signs are not required in occupancies in Group U and individual sleeping units or dwelling units in Group R-1, R-2 or R-3. 4. Exit signs are not required in dayrooms, sleeping rooms or dormitories in occupancies in Group I-3. 5. In occupancies in Groups A-4 and A-5, exit signs are not required on the seating side of vomitories or openings into seating areas where exit signs are provided in the concourse that are readily apparent from the vomitories. Egress lighting is provided to identify each vomitory or opening within the seating area in an emergency. 	<p>The exit signs in the north lobby are not readily visible from any direction of egress travel.</p>

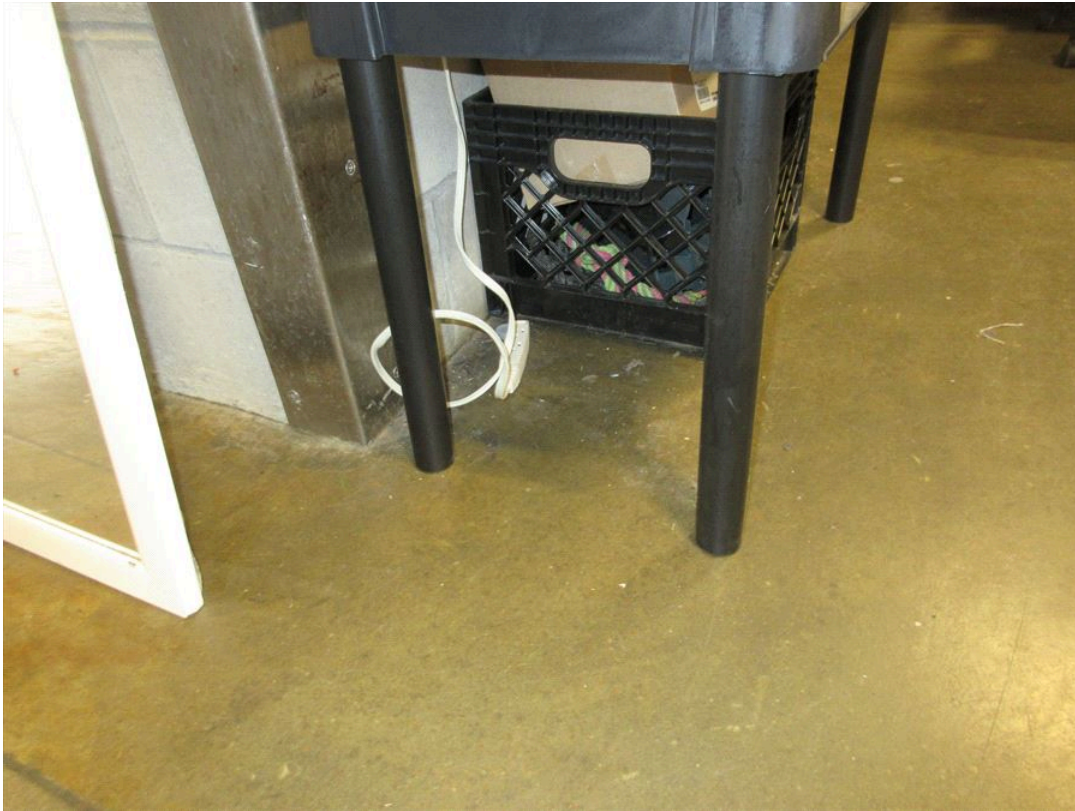
File Name: photo of power strip 3
Violation Code: 603.5.1
Inspected Date: 2026-03-27 17:49:53

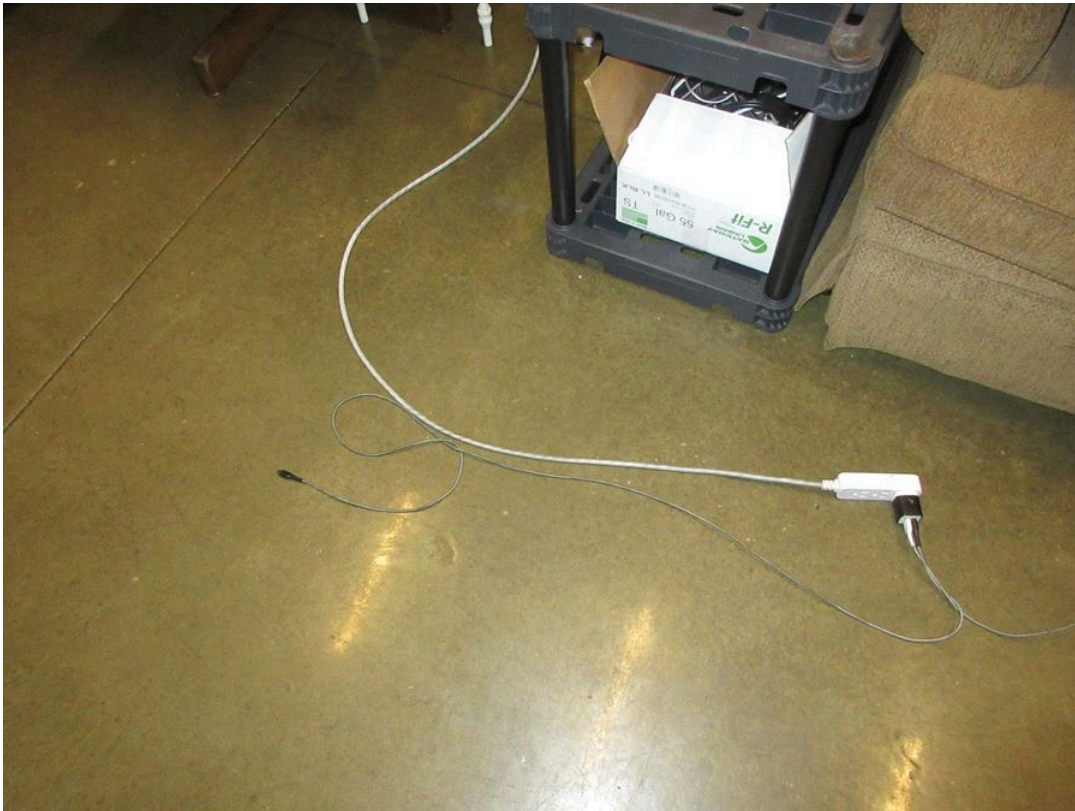
File Name: photo of power strip 4
Violation Code: 603.5.1
Inspected Date: 2026-03-27 17:49:53

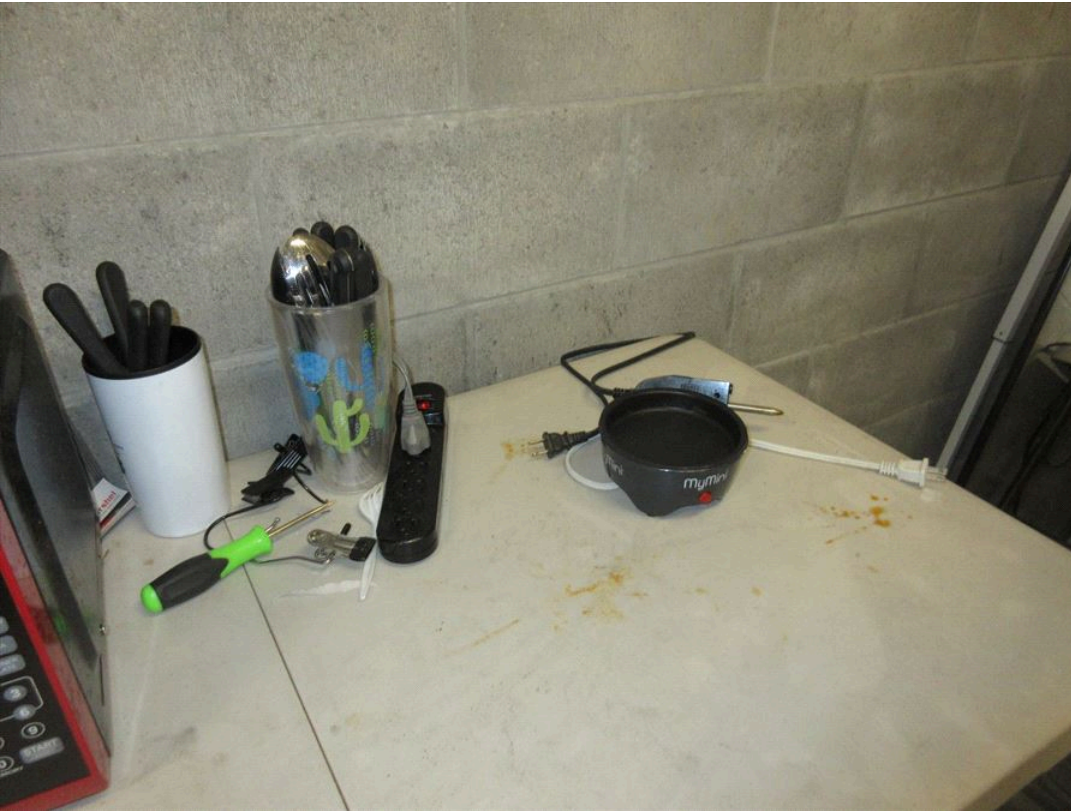
File Name: photo of power strip
Violation Code: 603.5.1
Inspected Date: 2026-03-27 17:49:53

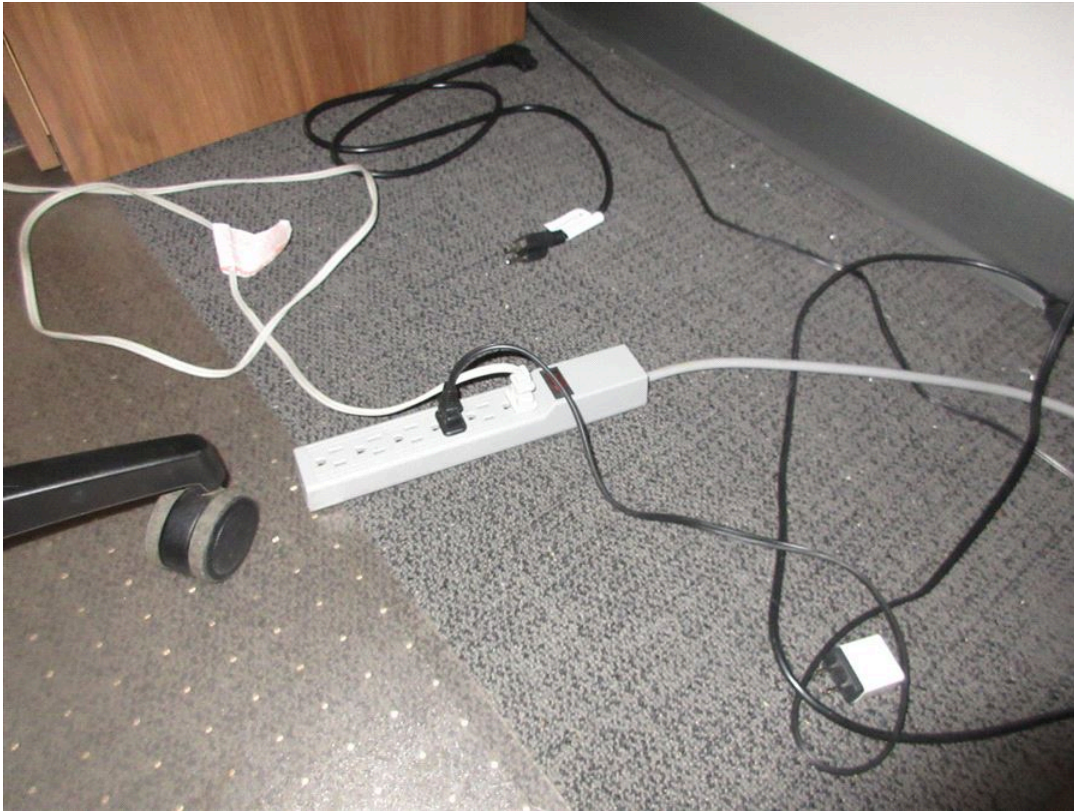
File Name: photo of close up of power strip under desk
Violation Code: 603.5.1
Inspected Date: 2026-03-27 17:49:53

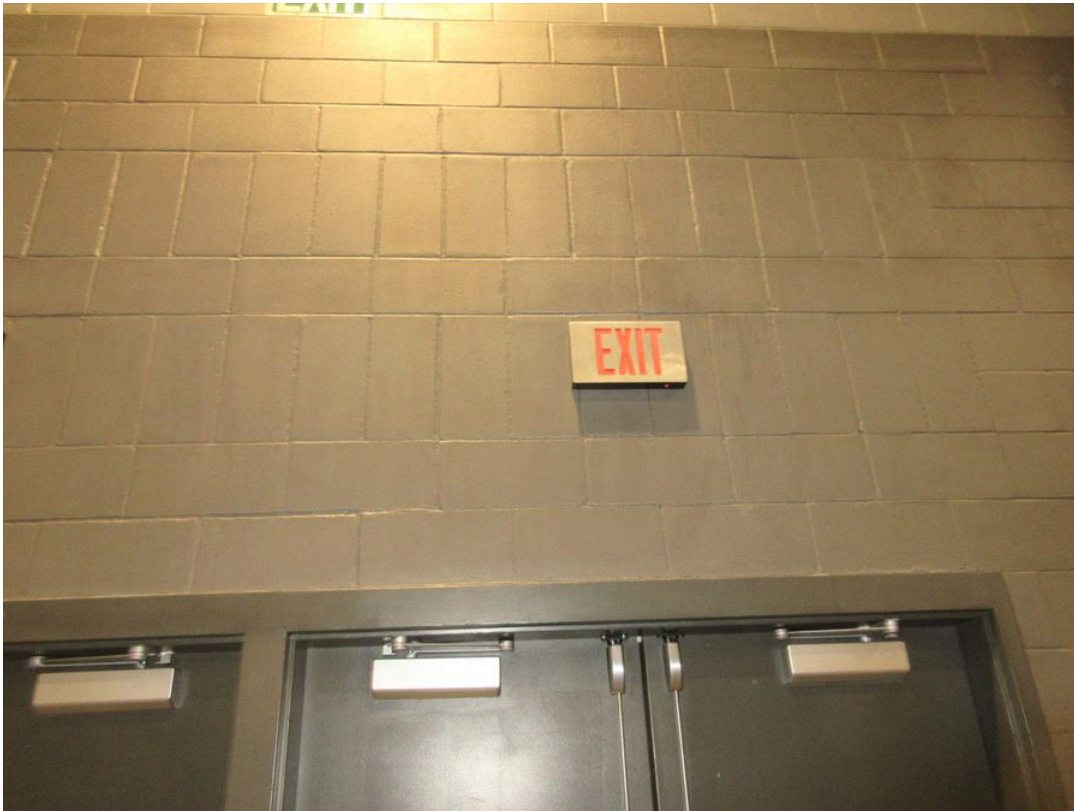
File Name: photo of an exit light that is not illuminated
Violation Code: 1104.3
Inspected Date: 2026-03-27 17:54:12

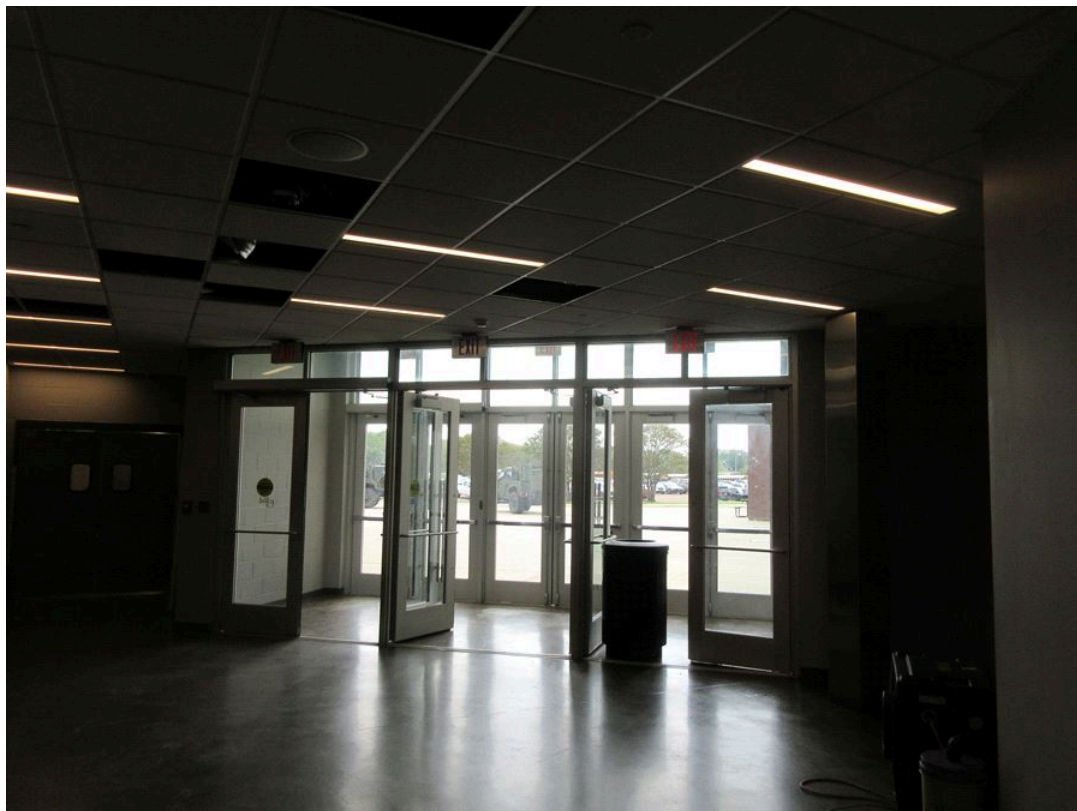
File Name: photo of non illuminated exit light
Violation Code: 1104.3
Inspected Date: 2026-03-27 17:54:12

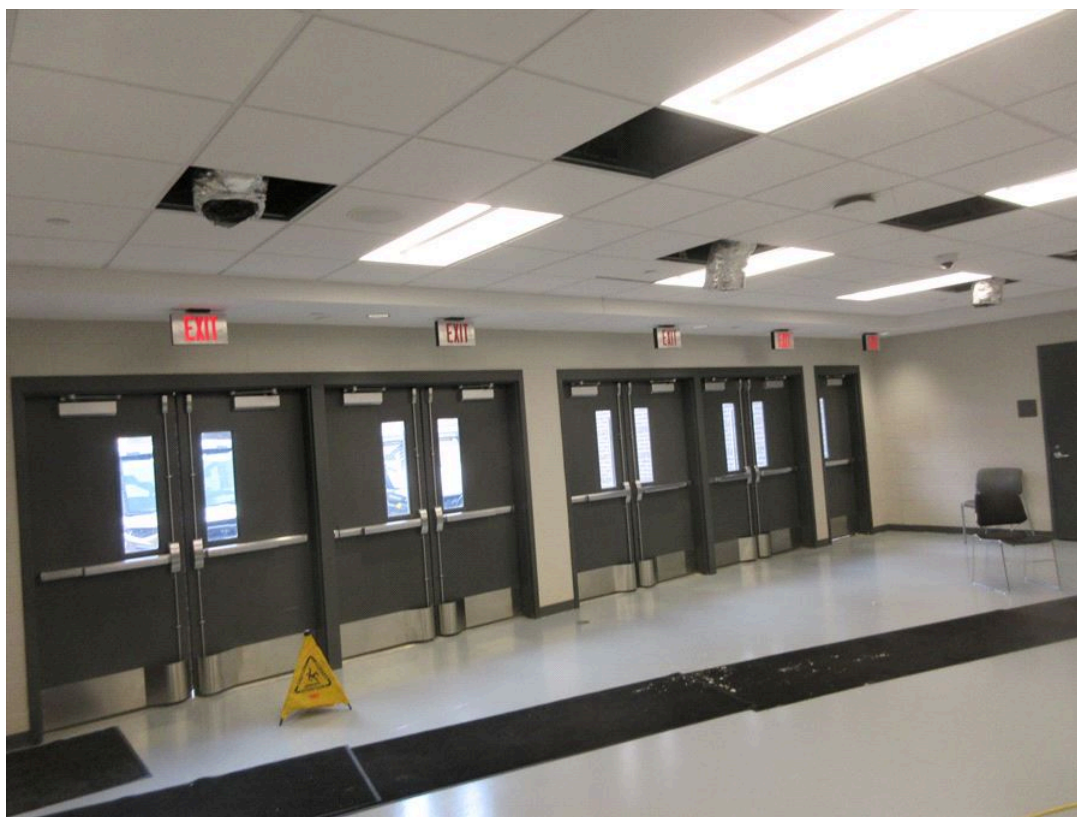
File Name: photo of non illuminated exit lights in lobby
Violation Code: 1104.3
Inspected Date: 2026-03-27 17:54:12

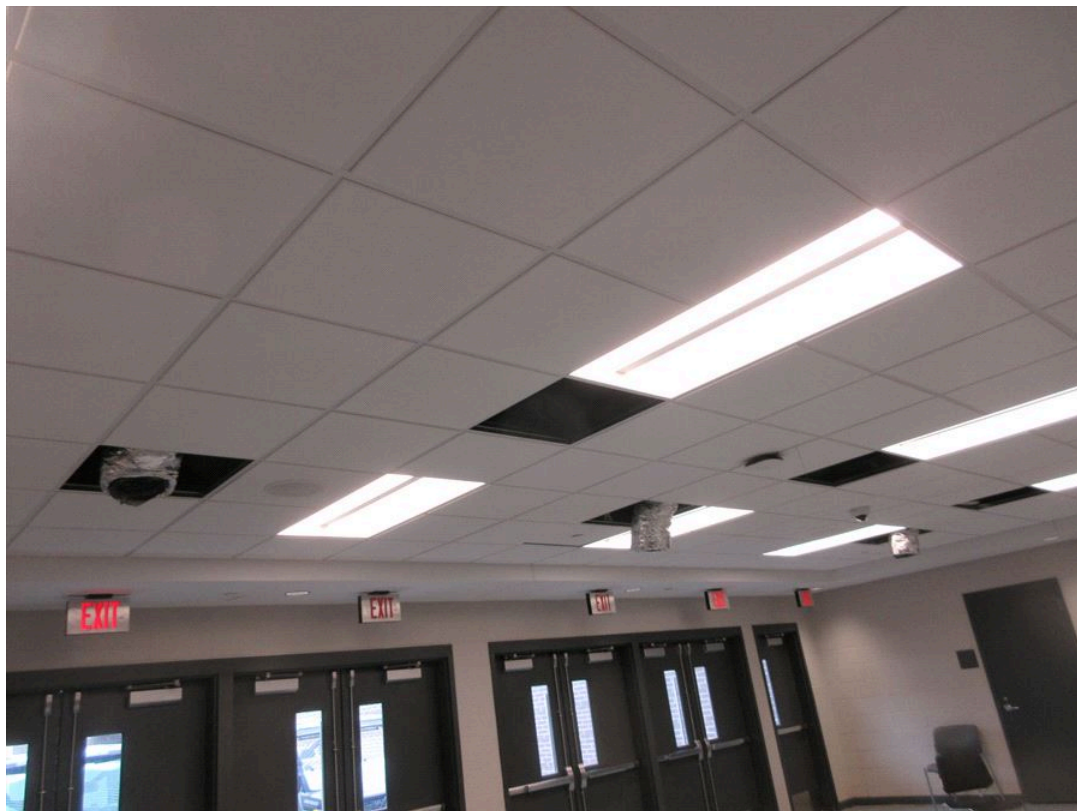
File Name: photo of non illuminated exit lights in lobby 2
Violation Code: 1104.3
Inspected Date: 2026-03-27 17:54:12

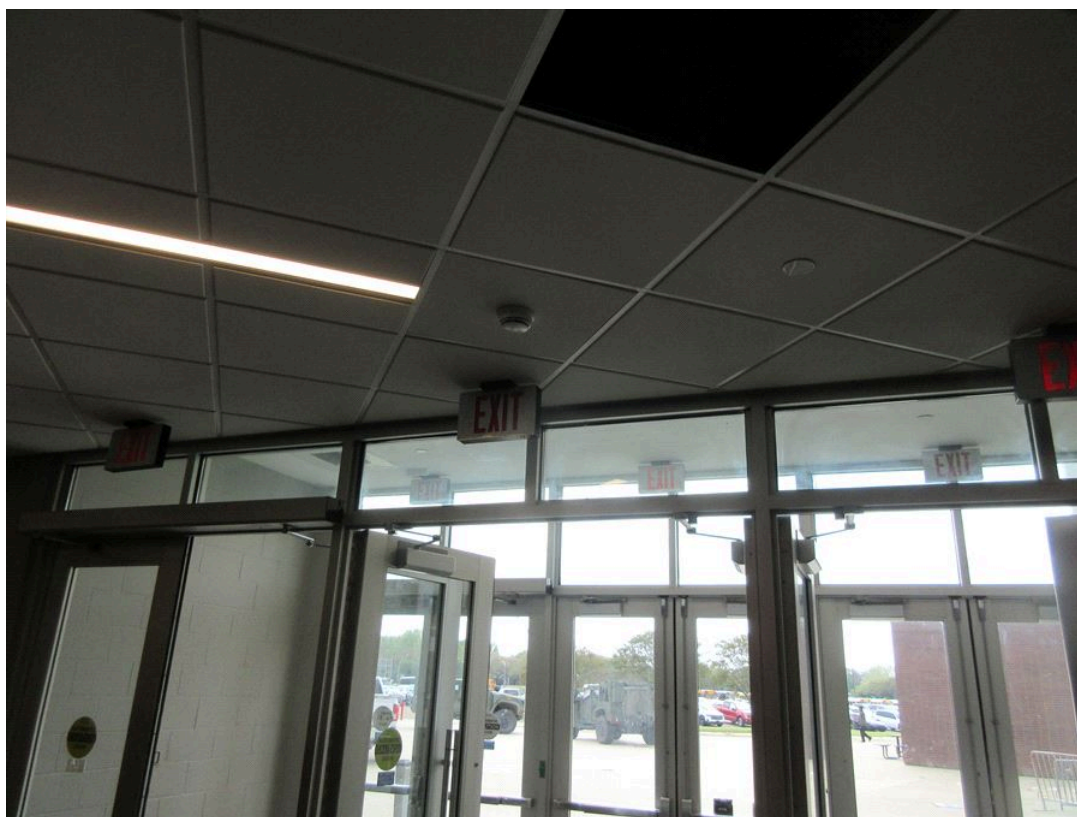
File Name: photo of non illuminated exit sign
Violation Code: 1104.3
Inspected Date: 2026-03-27 17:54:12

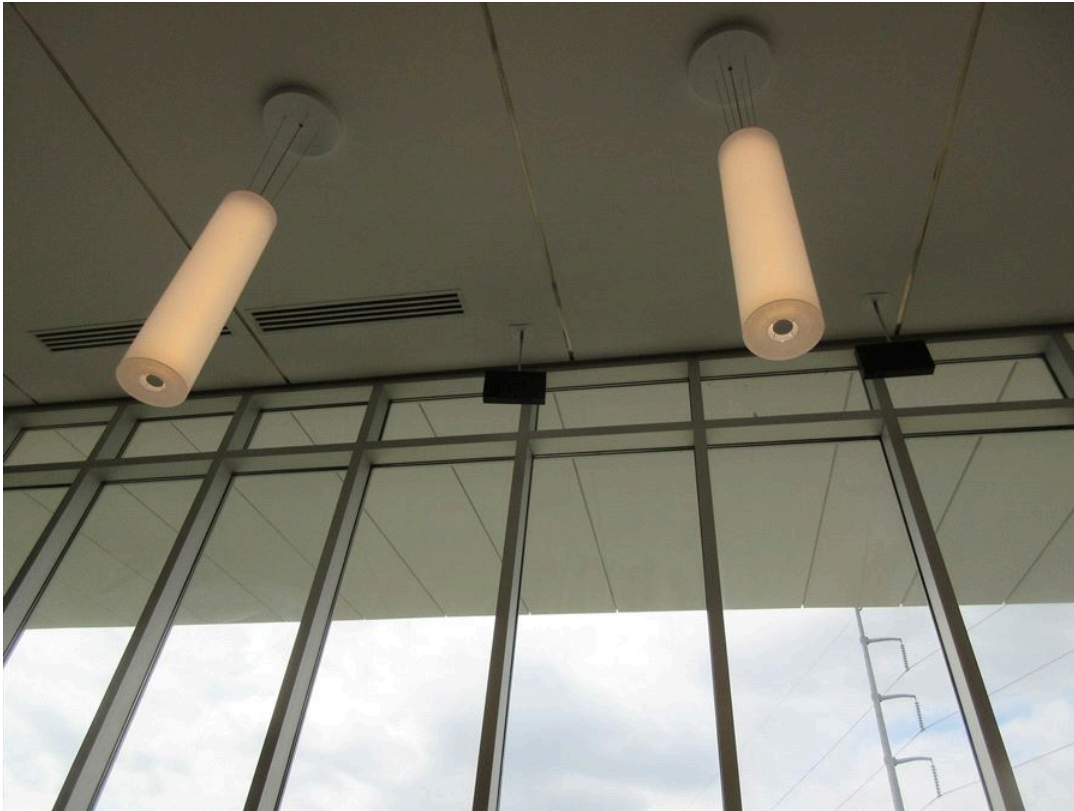
File Name: photo of exit signs turned in the wrong direction 2
Violation Code: 1013.1
Inspected Date: 2026-03-27 17:56:29

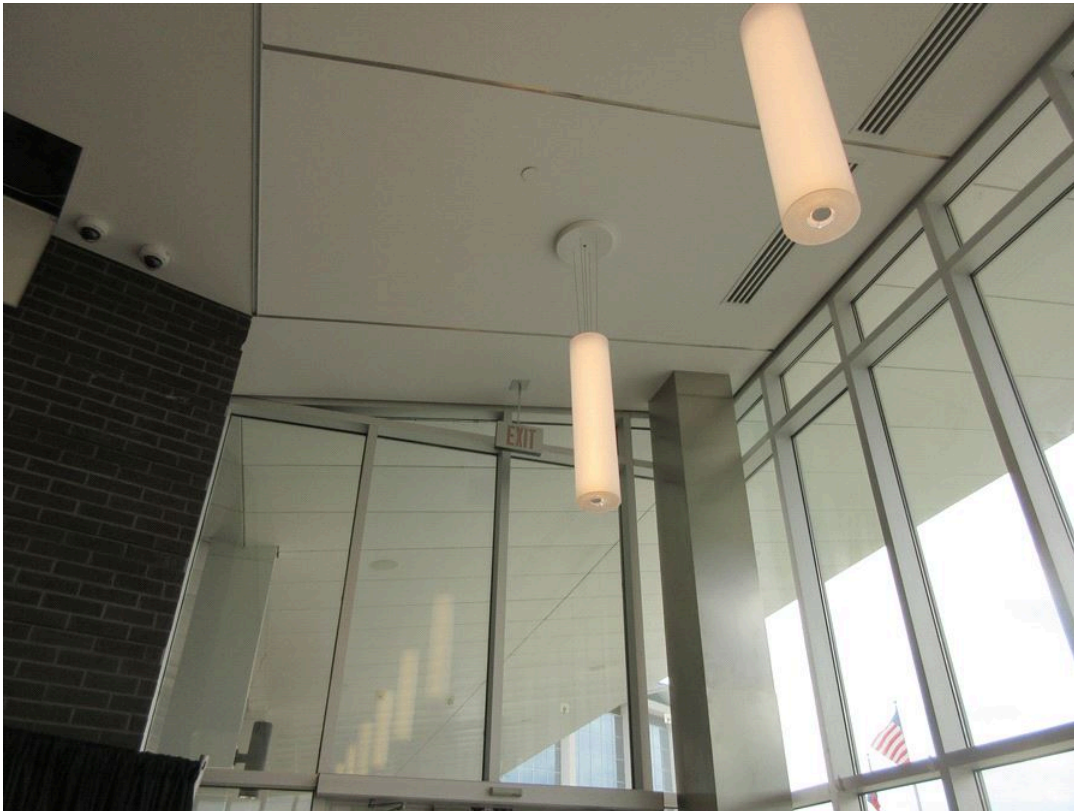
File Name: photo of exit signs turned in the wrong direction 3
Violation Code: 1013.1
Inspected Date: 2026-03-27 17:56:29

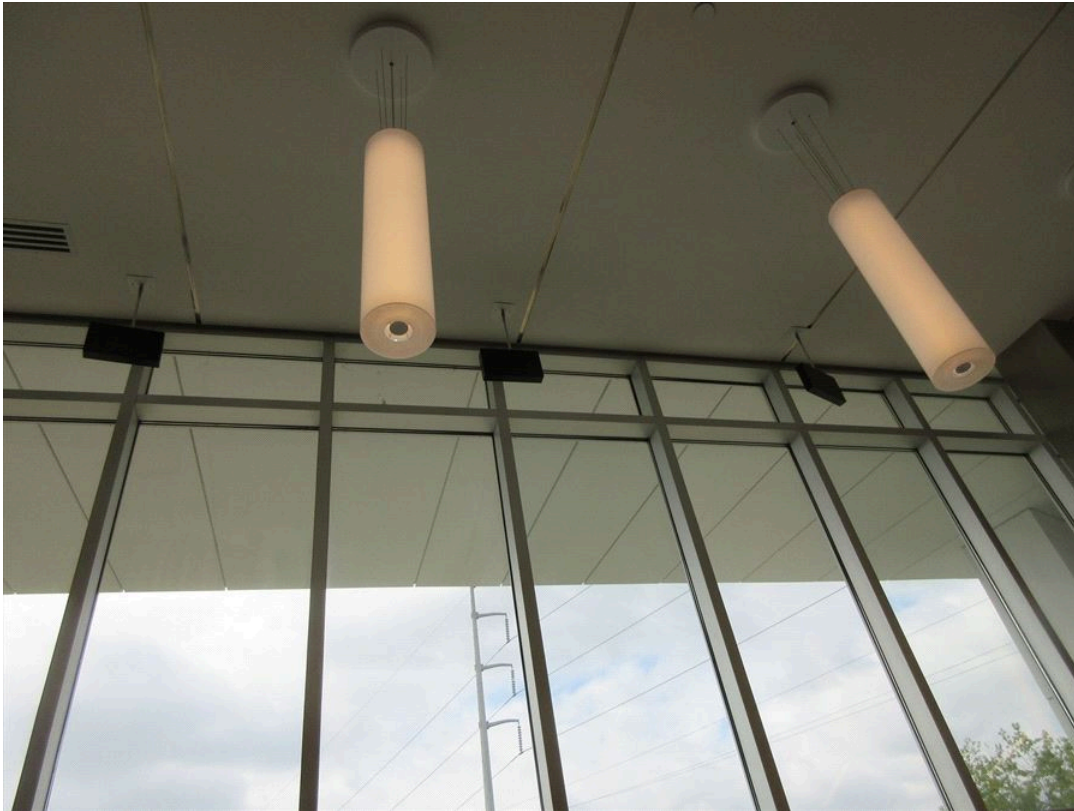
File Name: photo of exit signs turned in the wrong direction
Violation Code: 1013.1
Inspected Date: 2026-03-27 17:56:29

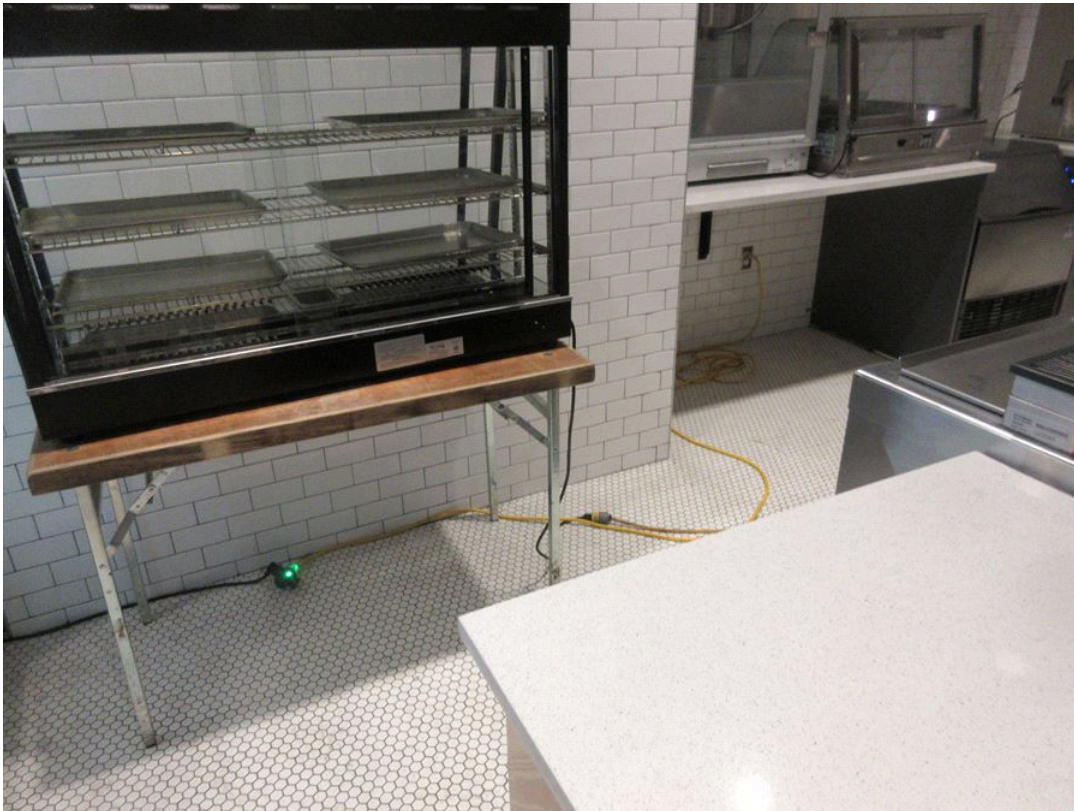
File Name: photo of improperly used extension cord
Violation Code: 603.6
Inspected Date: 2026-03-27 17:58:11

Violation Code	Description	Comments
603.6	<p>Extension cords shall not be a substitute for permanent wiring and shall be listed and labeled in accordance with UL 817. Extension cords shall not be affixed to structures, extended through walls, ceilings or floors, or under doors or floor coverings, nor shall such cords be subject to environmental damage or physical impact. Extension cords shall be used only with portable appliances. Extension cords marked for indoor use shall not be used outdoors.</p>	Extension cords are being used as permanent wiring.

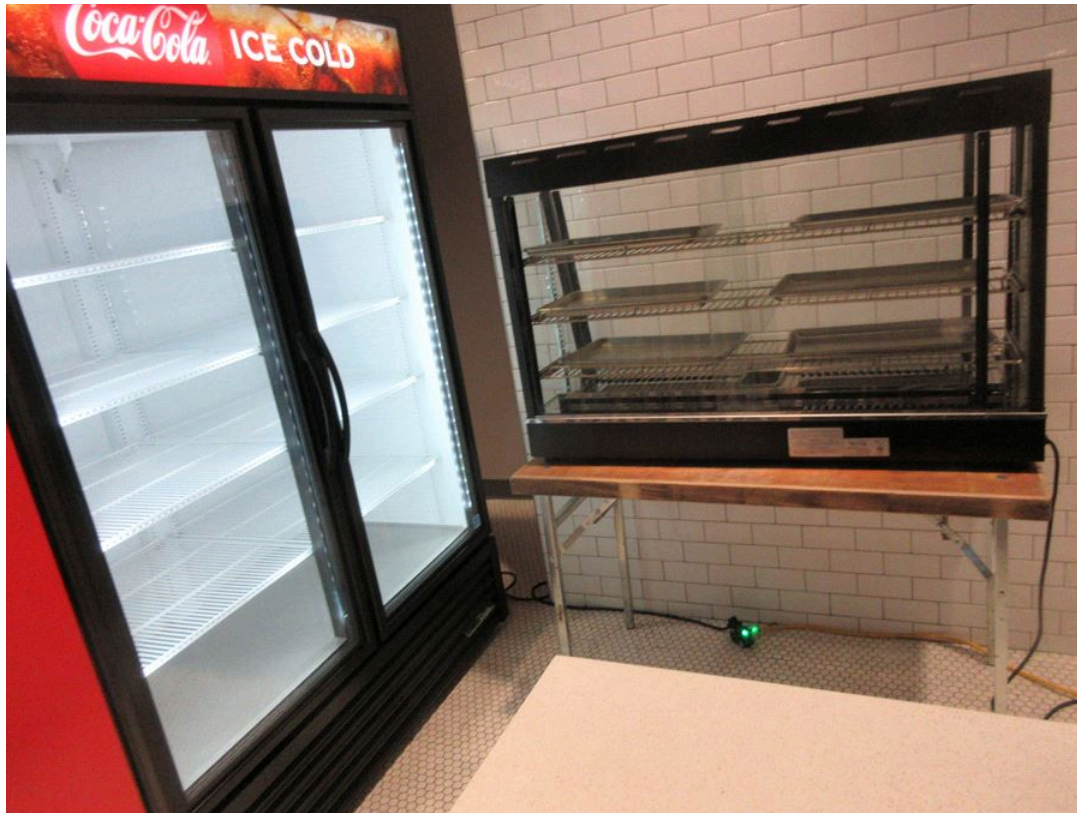
File Name: photo showing improperly used extension cord 2

Violation Code: 603.6

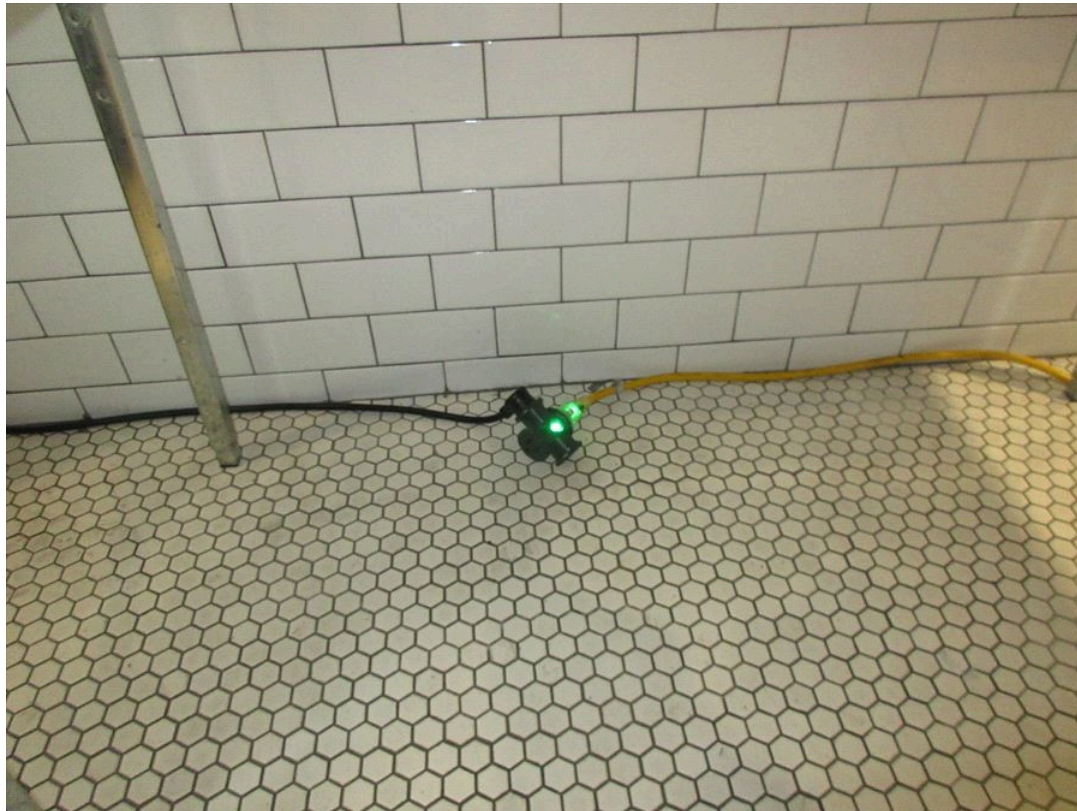
File Name: photo of impropoerly used multiplug

Violation Code: 603.6.1

603.6.1	<p>Application and use. Extension cords shall be plugged directly into an approved receptacle, relocatable power tap or current tap and, except for approved multiplug extension cords, shall serve only one portable appliance.</p>	There is an improper use of a multiplug.
