Fire Inspection Report SFM Kayla Riggs

Name: Mississippi State Fairgrounds, Jackson, Hinds County **Location Street Number:** 1207 **Location Street Prefix:**
Location Street Name: Mississippi **Location Street Type:** Street **Location County:** Hinds
Phone Number: (601) 961-4000 **Zone:** 5
Code: CID

Name: Mississippi Trademart **Building Class Code:** All other assembly occupancies
Property Use: Convention center, exhibition hall
Occupant City: Jackson **Occupant Postal Code:** 39202 **Occupant State:** MS **Occupant County:** Hinds

Inspection Number: SFM20260008

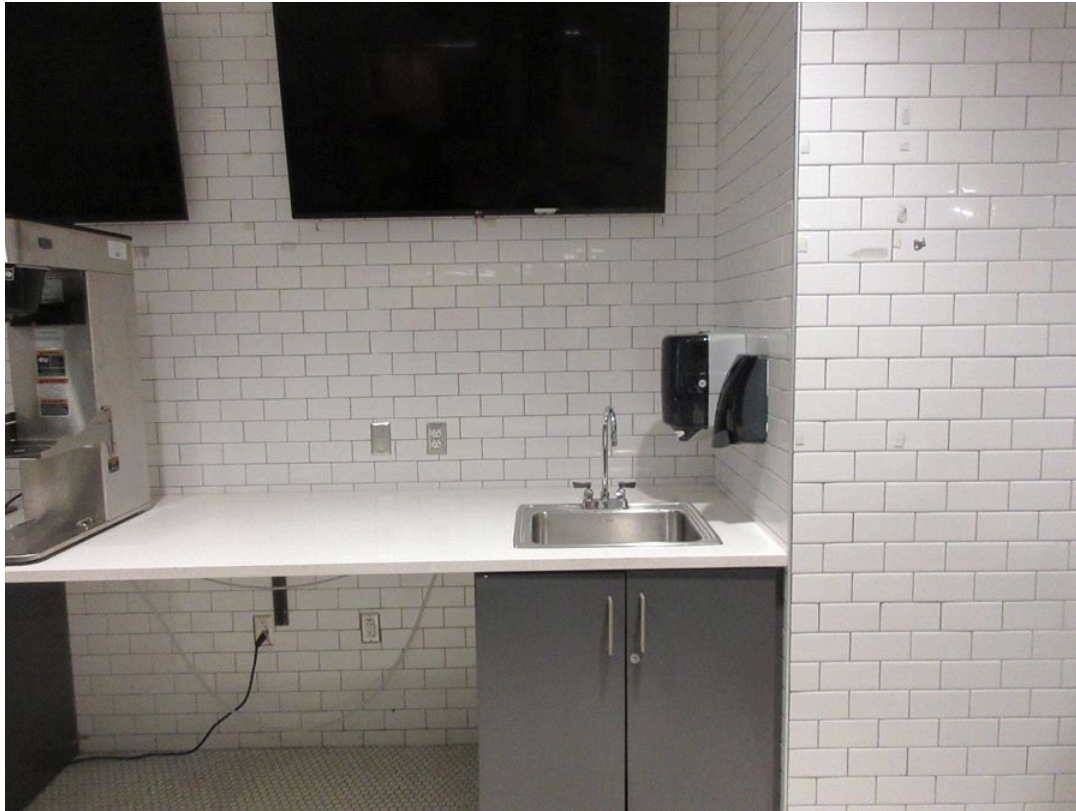
File Name: photo of an electrical outlet that needs to be a gcfi

Violation Code: 603.1.1

603.1.1	<p>Equipment and wiring. All electrical equipment, wiring, devices and appliances shall be tested; listed and labeled; and installed, used and maintained in accordance with NFPA 70 and all instructions included as part of such listing.</p>	There is an outlet that needs to be GCFI rated.

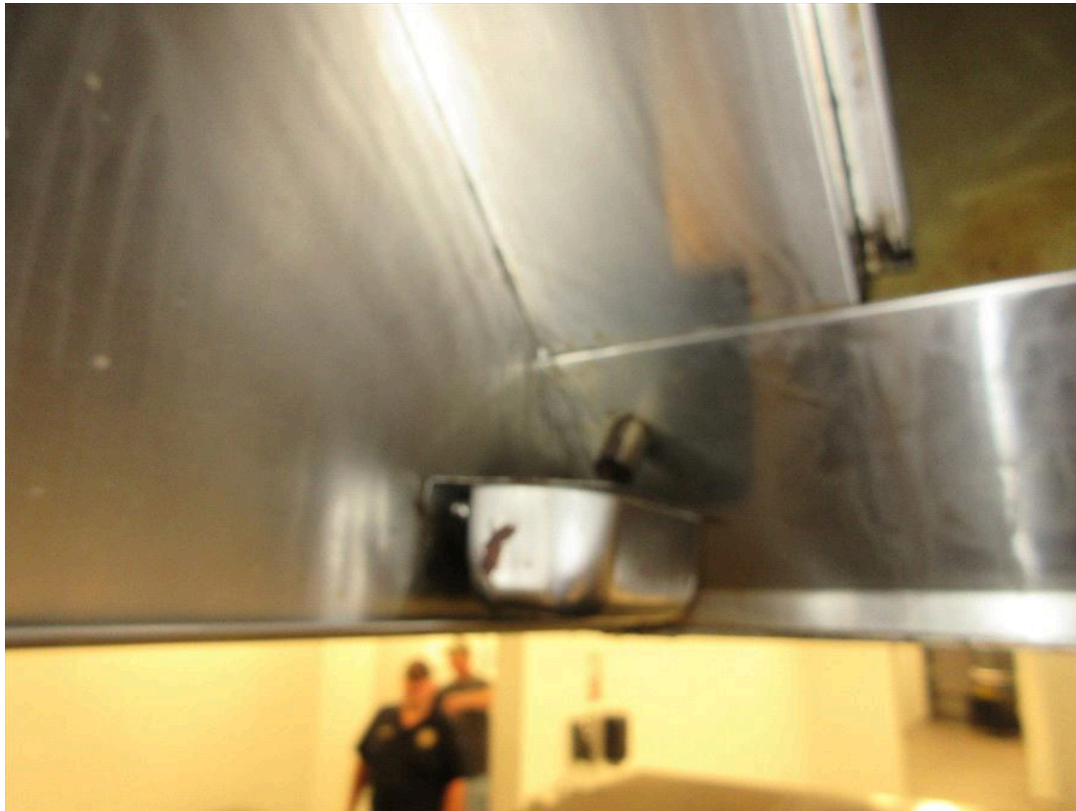
File Name: photo showing grease collection pan needs to be cleaned

Violation Code: 606.3.3.2

606.3.3.2	<p>Grease accumulation. If during the inspection it is found that hoods, grease-removal devices, fans, ducts or other appurtenances have an accumulation of grease, such components shall be cleaned in accordance with ANSI/IFCA C10.</p>	The vent hood in the kitchen has grease accumulation.

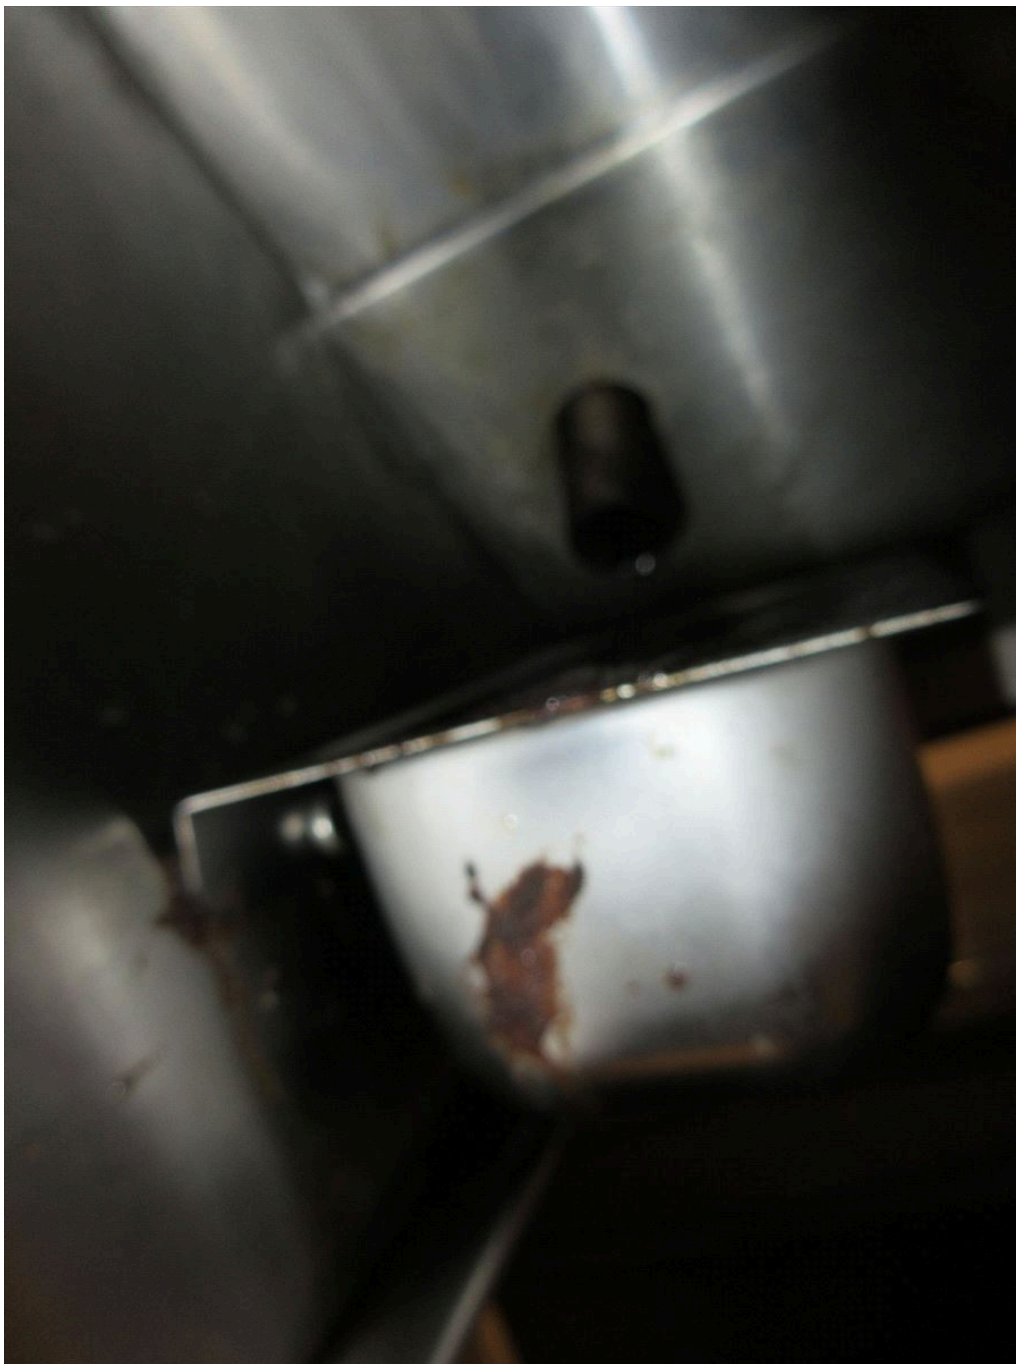
File Name: photo showing grease collection pan needs to be cleaned 3

Violation Code: 606.3.3.2

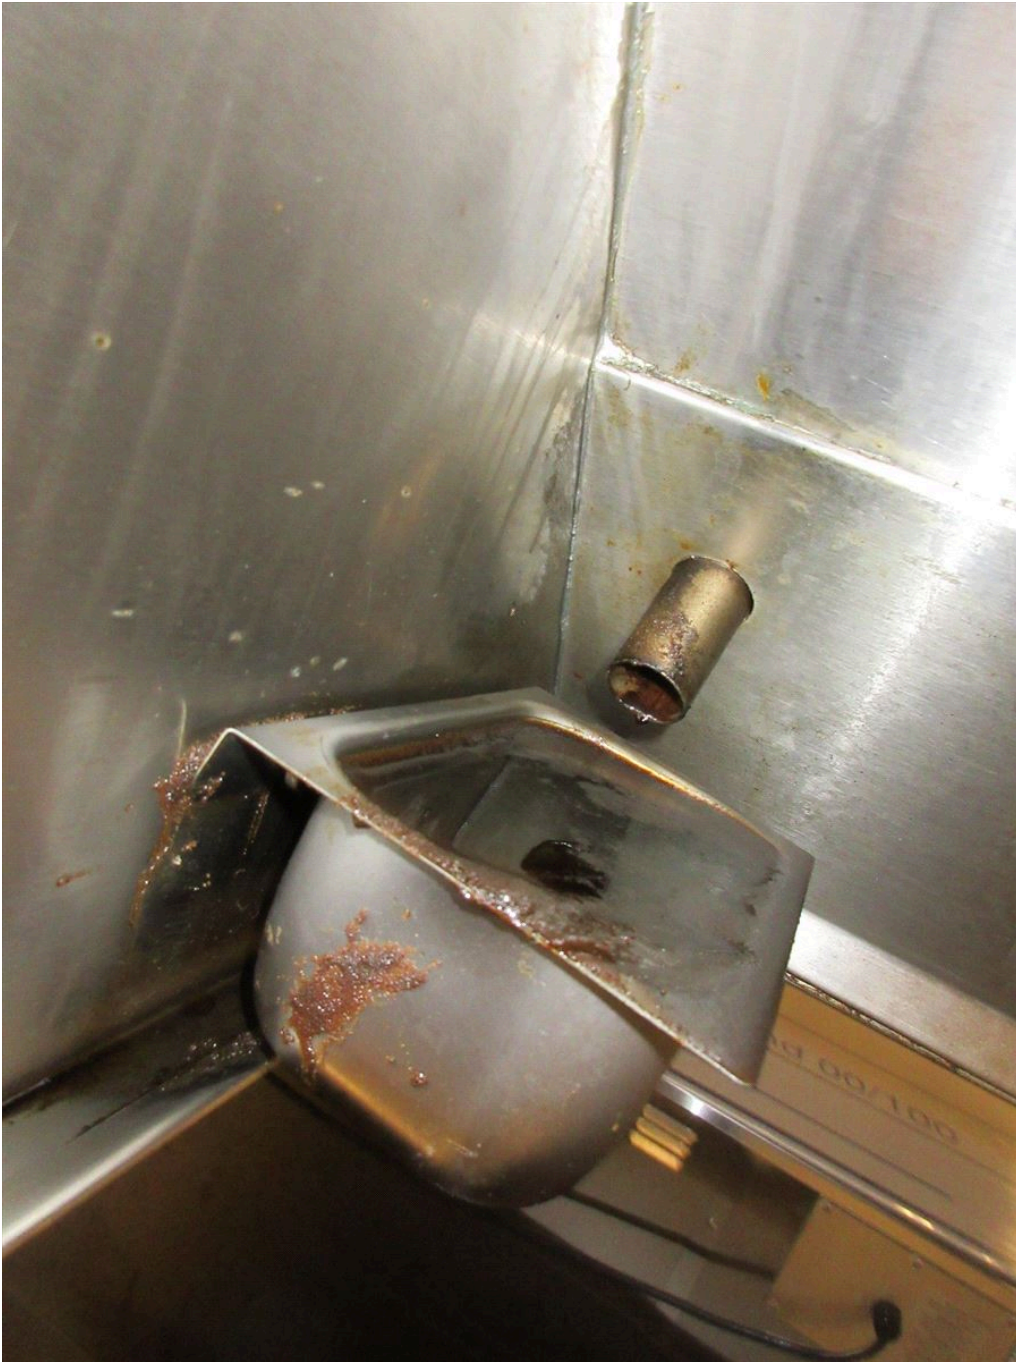
File Name: photo showing grease collection pan needs to be cleaned 2
Violation Code: 606.3.3.2
Inspected Date: 2026-03-27 18:05:03

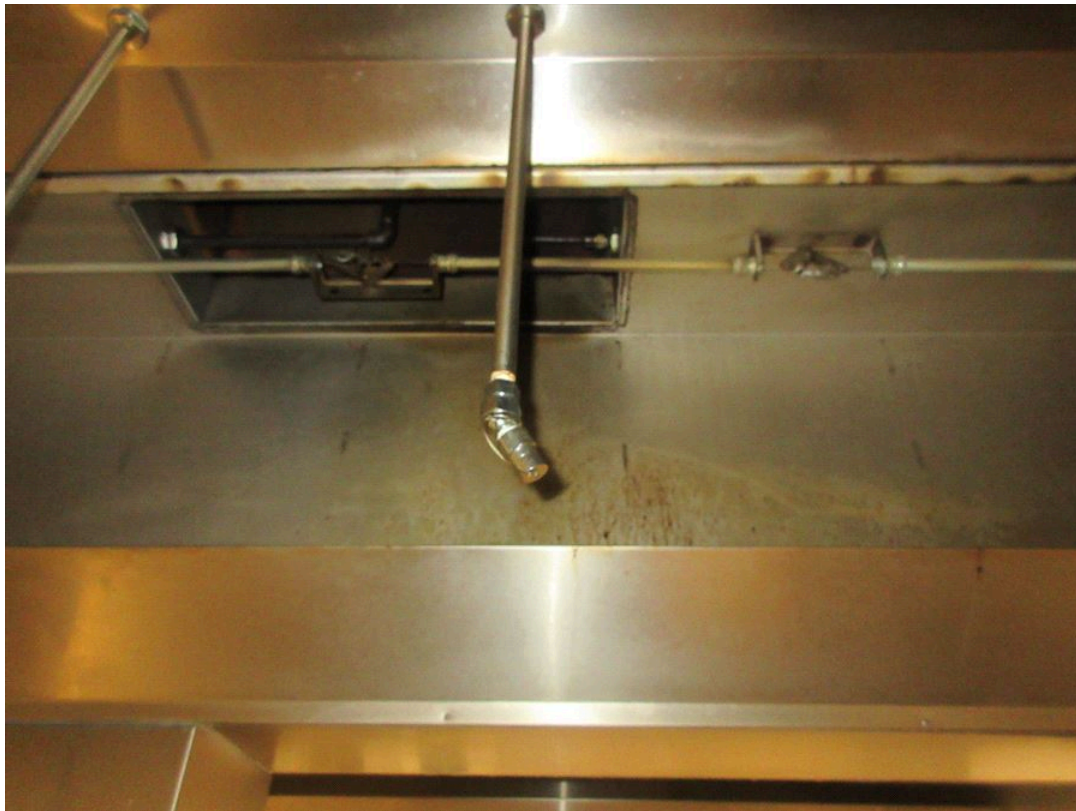
File Name: photo showing vent hood needs to be cleaned

Violation Code: 606.3.3.2

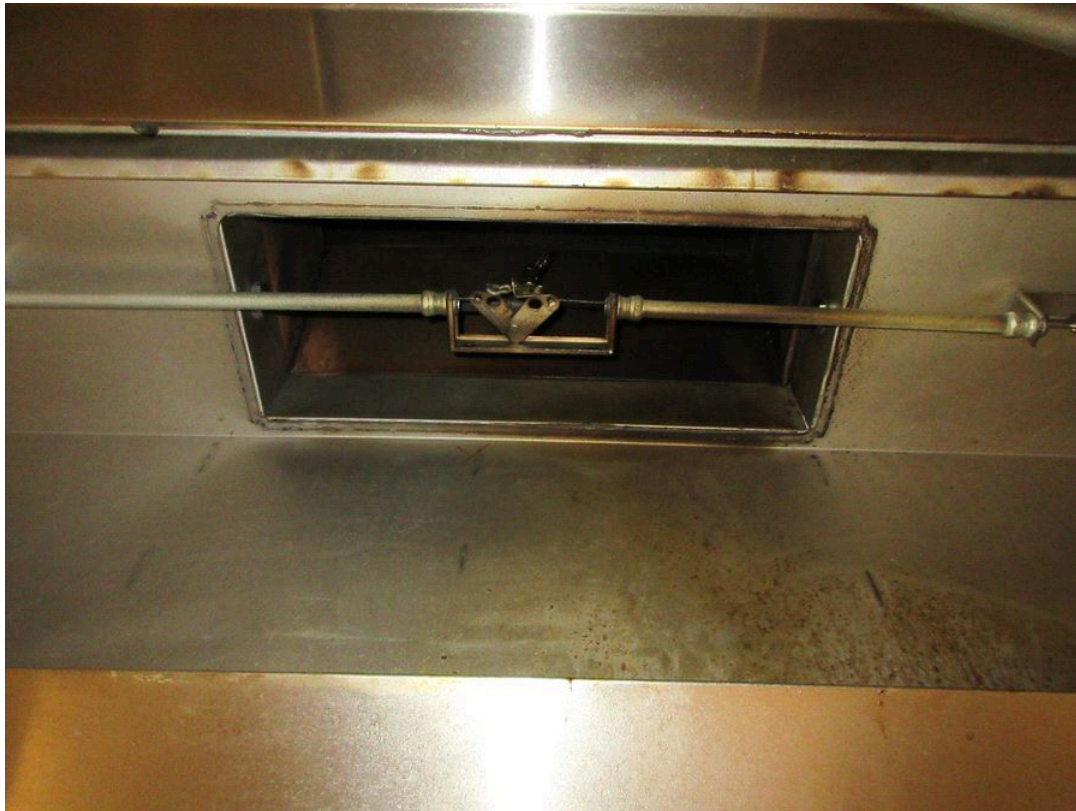
File Name: photo showing vent hood needs to be cleaned 2

Violation Code: 606.3.3.2

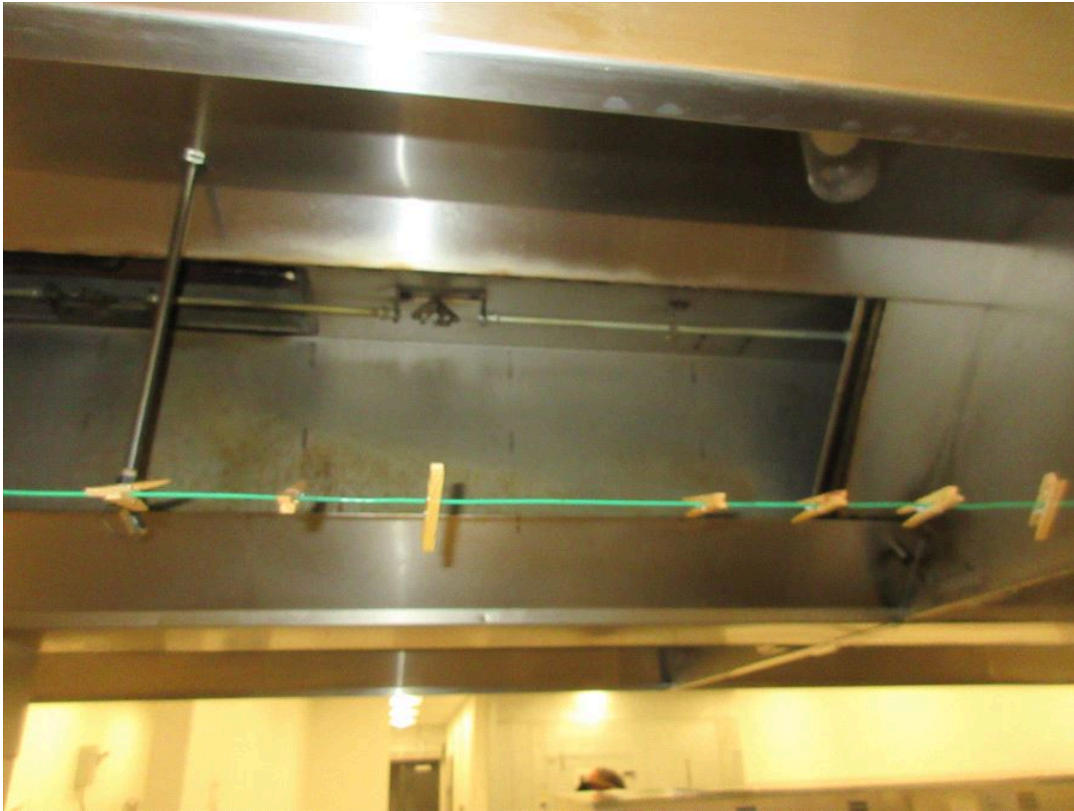
File Name: photo showing vent hood needs to be cleaned 3
Violation Code: 606.3.3.2
Inspected Date: 2026-03-27 18:05:03

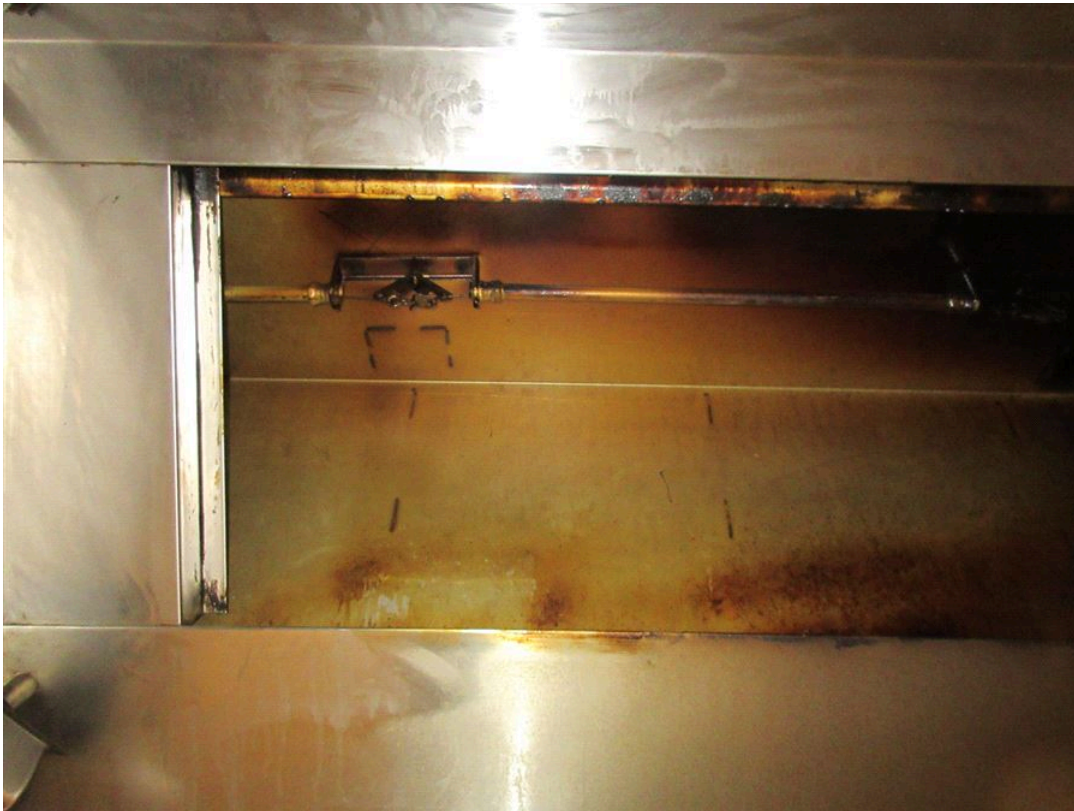
File Name: photo showing vent hood needs to be cleaned 4
Violation Code: 606.3.3.2
Inspected Date: 2026-03-27 18:05:03

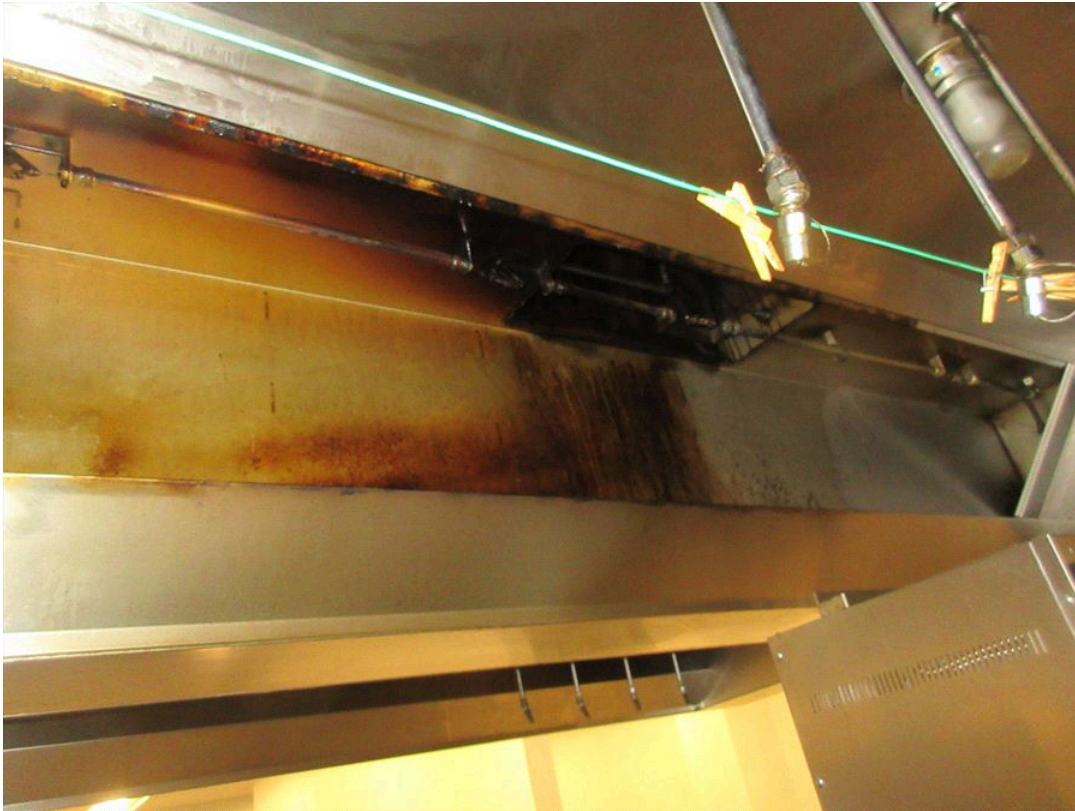
File Name: photo showing vent hood needs to be cleaned 5
Violation Code: 606.3.3.2
Inspected Date: 2026-03-27 18:05:03

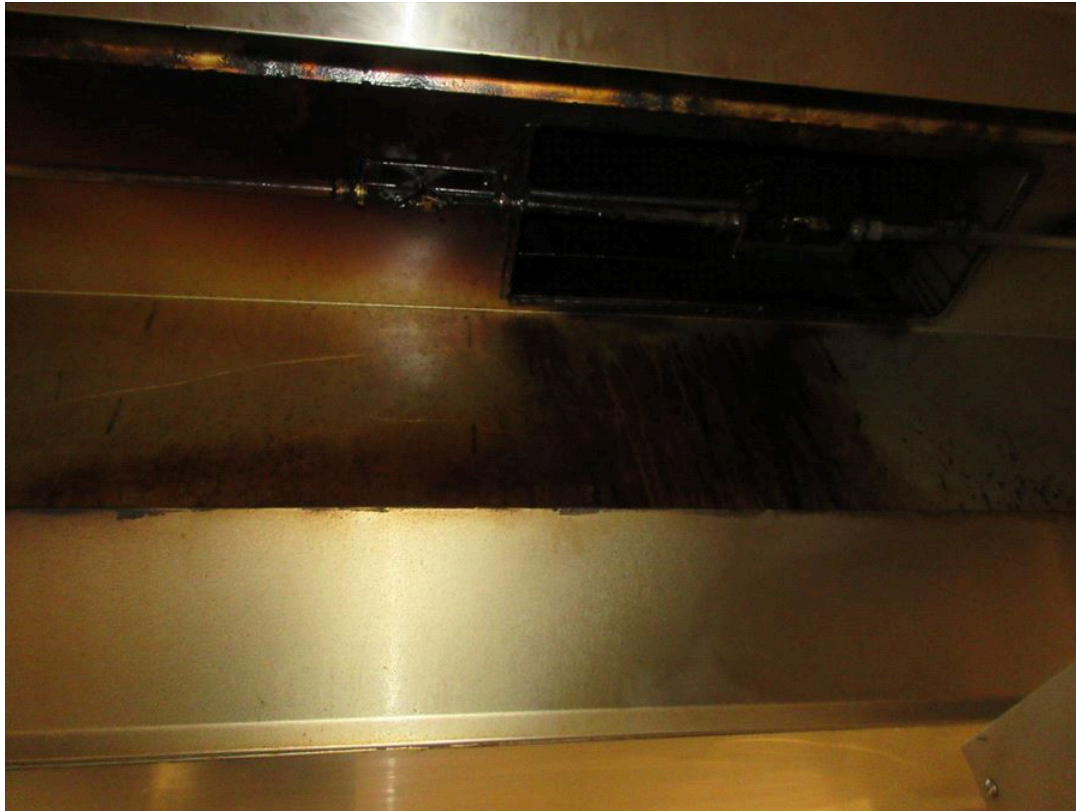
File Name: photo showing vent hood needs to be cleaned 7

Violation Code: 606.3.3.2

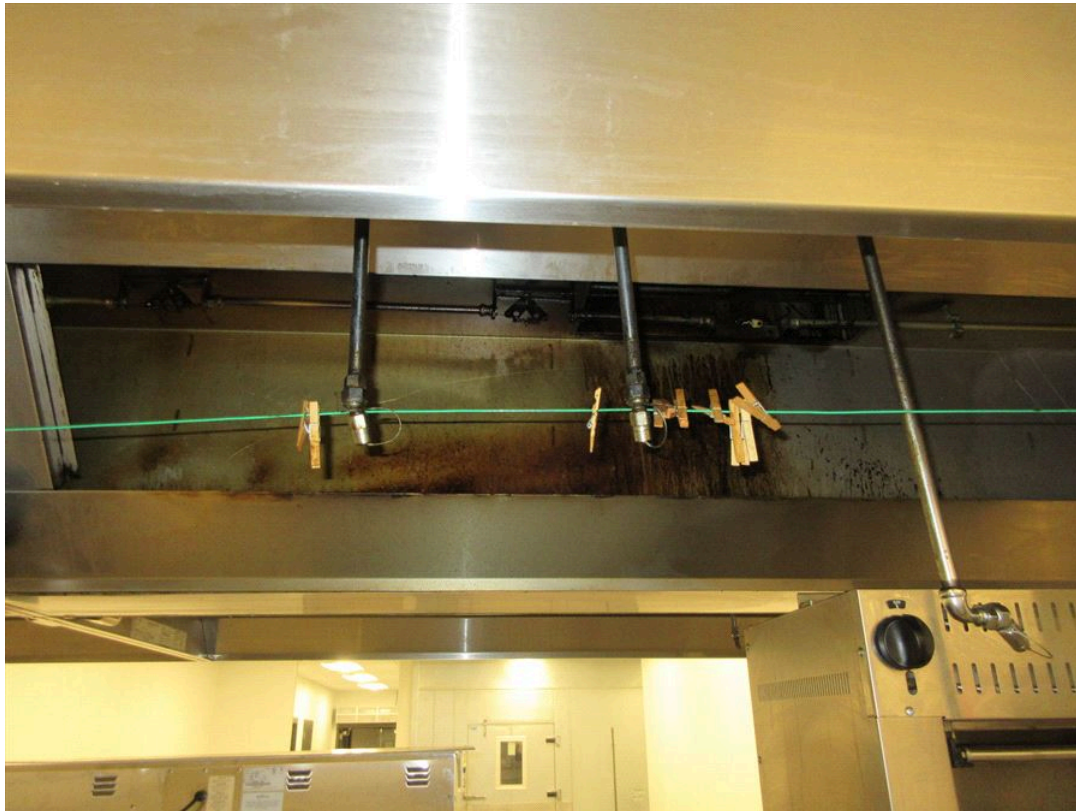
File Name: photo of string hanging on supression system

Violation Code: 901.8

901.8	<p>Removal of or tampering with equipment. It shall be unlawful for any person to remove, tamper with or otherwise disturb any fire protection or life safety system required by this code except for the purposes of extinguishing fire, training, recharging or making necessary repairs or where approved by the fire code official.</p>	There is a string tied onto the hood suppression system.

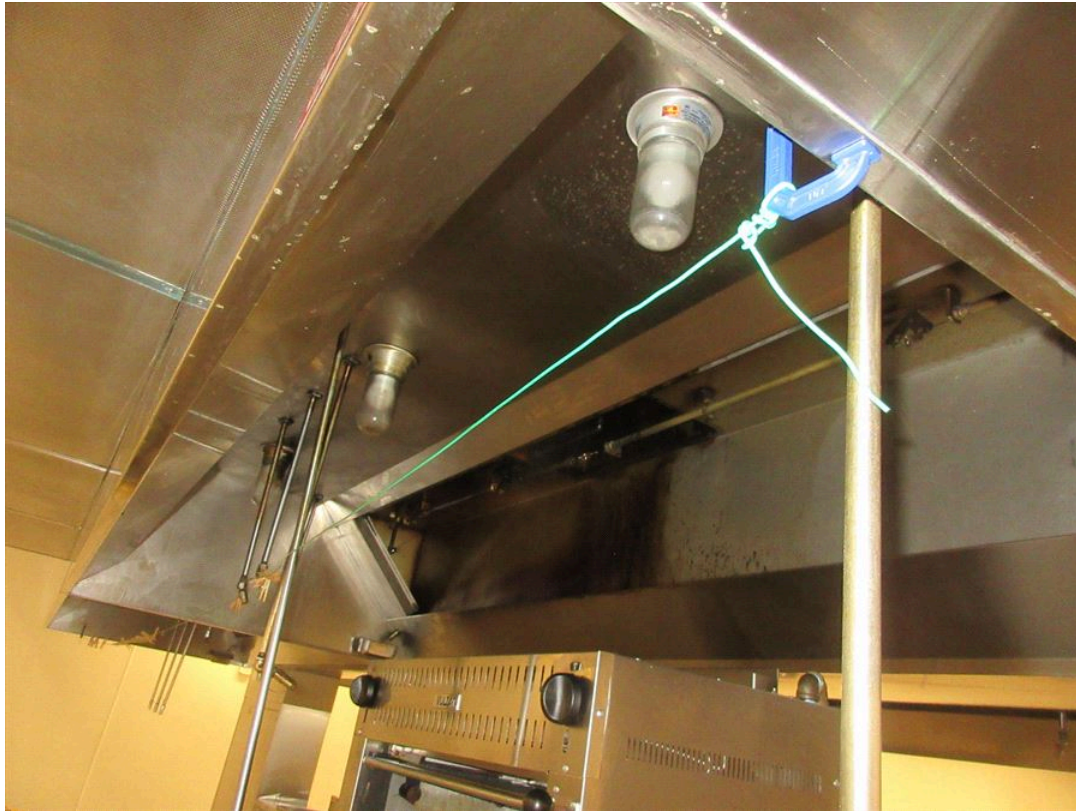
File Name: photo of string hanging on supression system 2
Violation Code: 901.8
Inspected Date: 2026-03-27 18:10:30

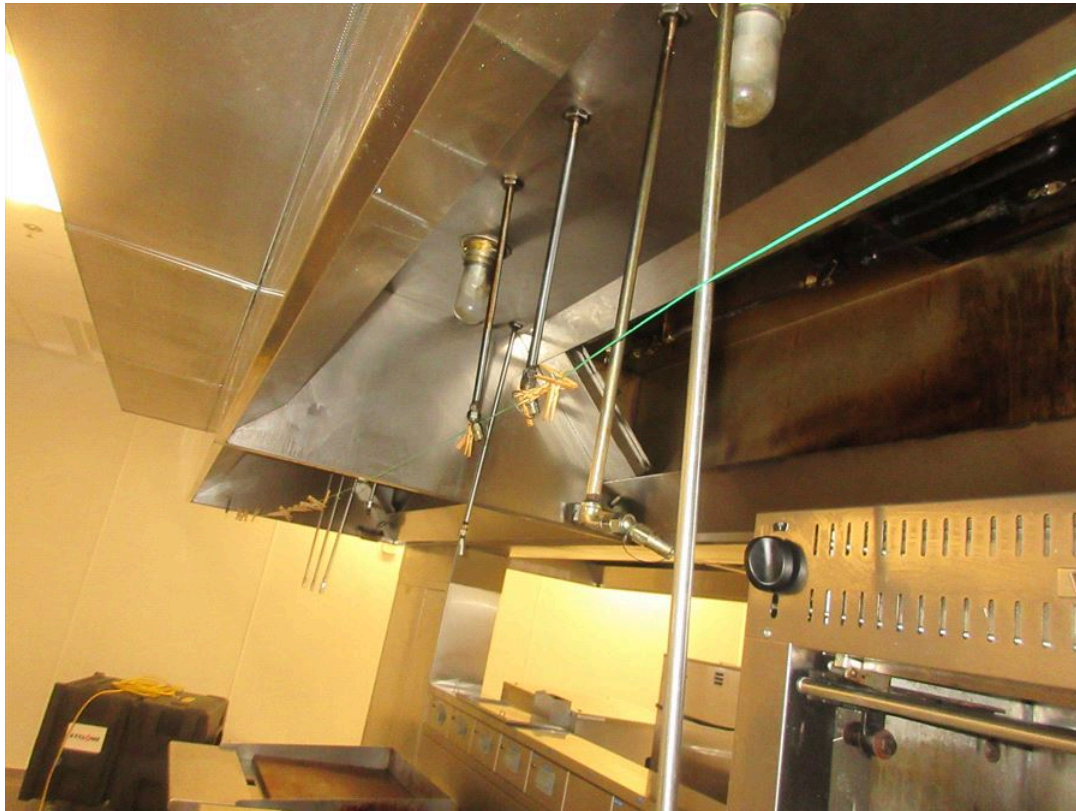
File Name: photo of string hanging on supression system 3
Violation Code: 901.8
Inspected Date: 2026-03-27 18:10:30

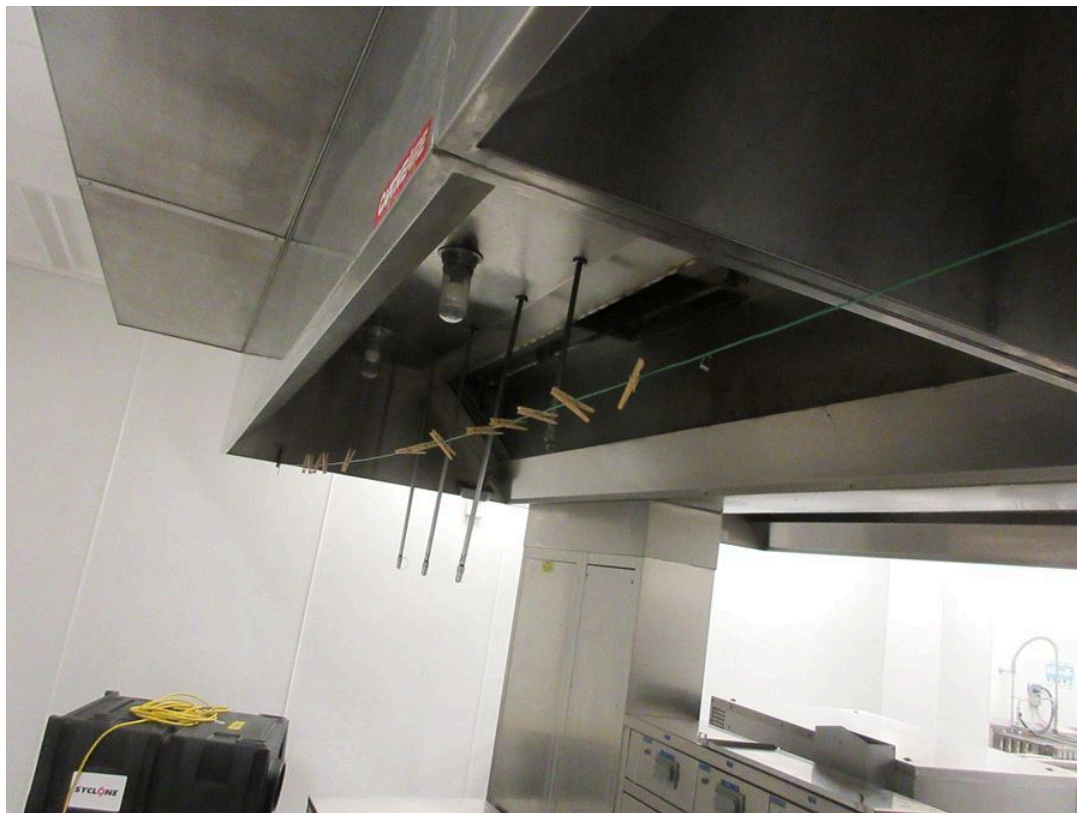
File Name: photo of string hanging on supression system 4
Violation Code: 901.8
Inspected Date: 2026-03-27 18:10:30

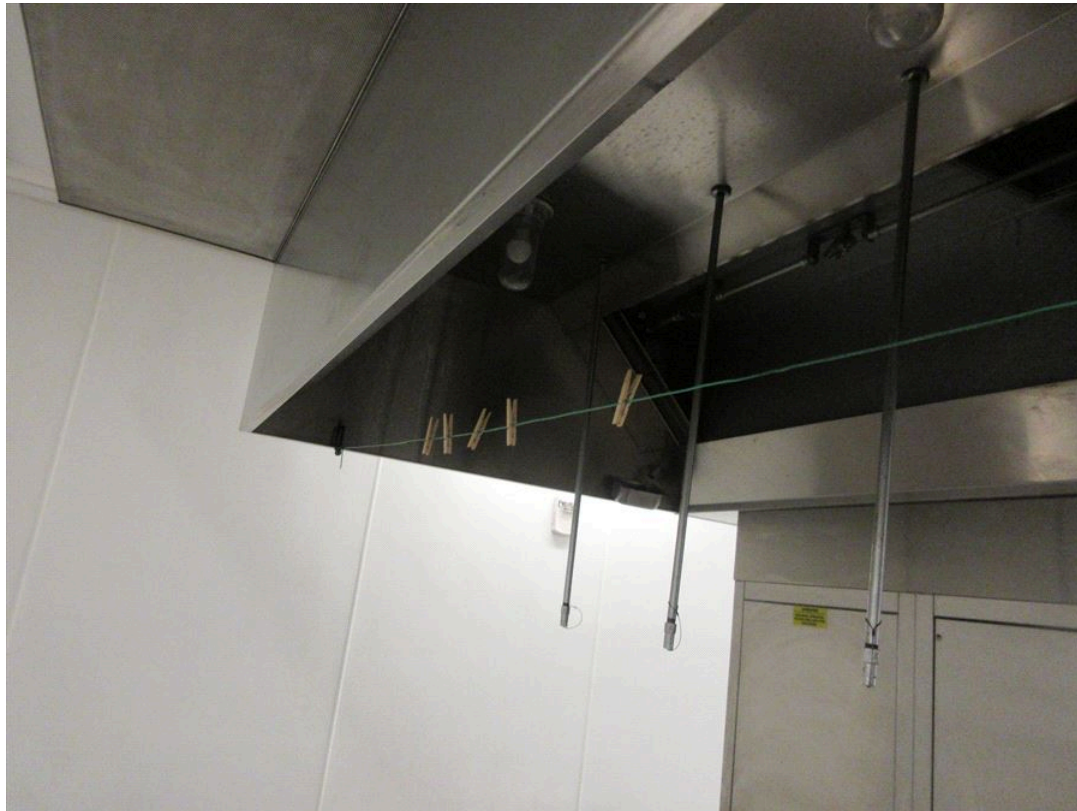
File Name: photo of string hanging on supression system 5
Violation Code: 901.8
Inspected Date: 2026-03-27 18:10:30

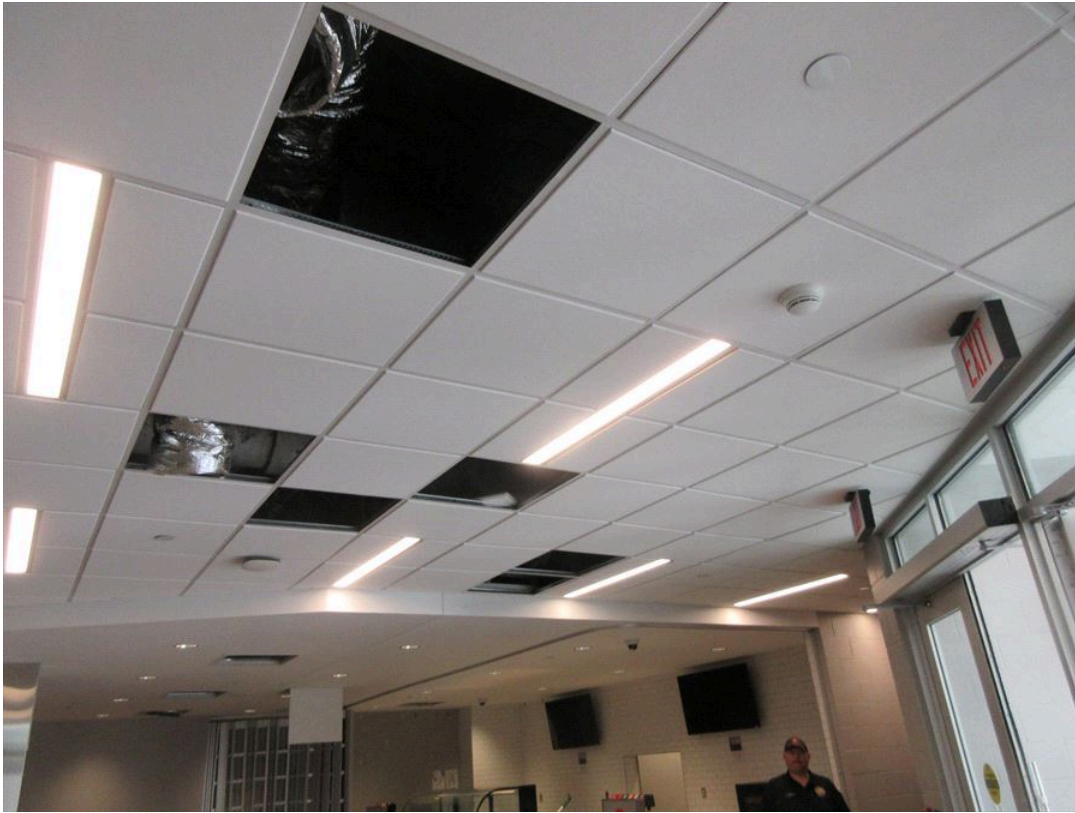
File Name: photo of missing ceiling tiles
Violation Code: 707.1
Inspected Date: 2026-03-27 18:13:59

707.1	<p>Fireblocking and draftstopping. Required fireblocking and draftstopping in combustible concealed spaces shall be maintained to provide continuity and integrity of the construction.</p>	There are missing ceiling tiles and there is a penetration in the wall.

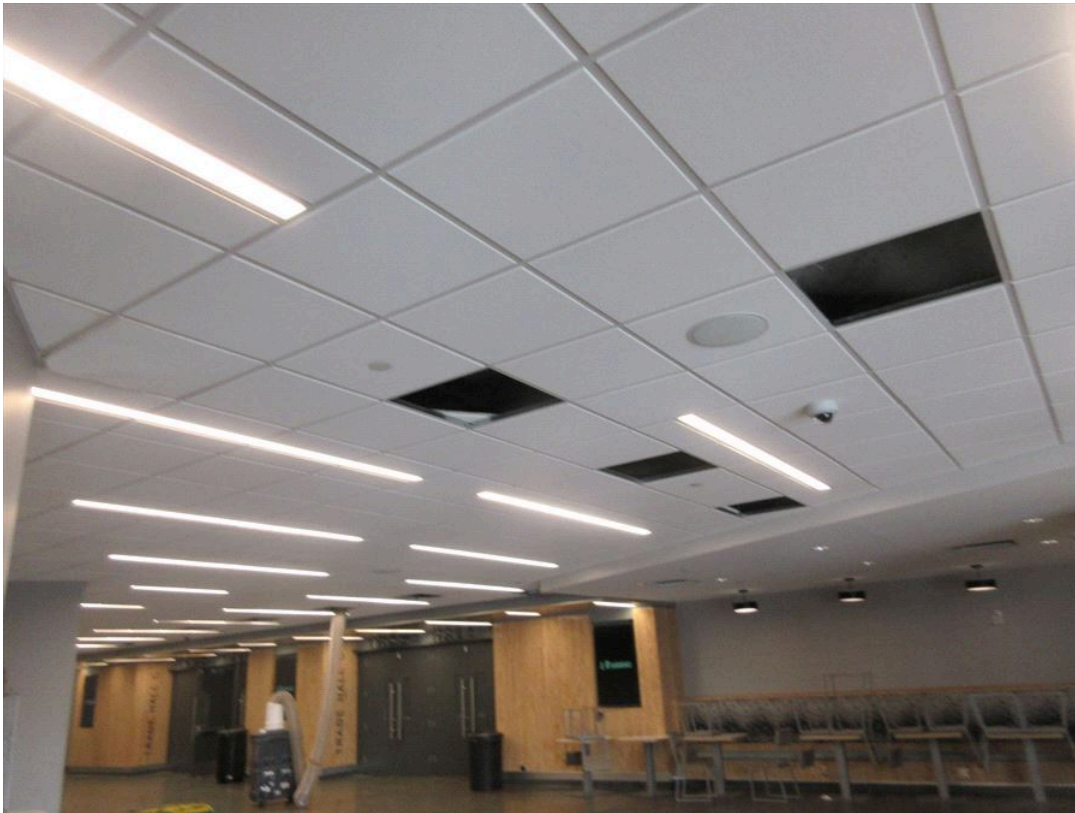
File Name: photo of missing ceiling tiles 2
Violation Code: 707.1
Inspected Date: 2026-03-27 18:13:59

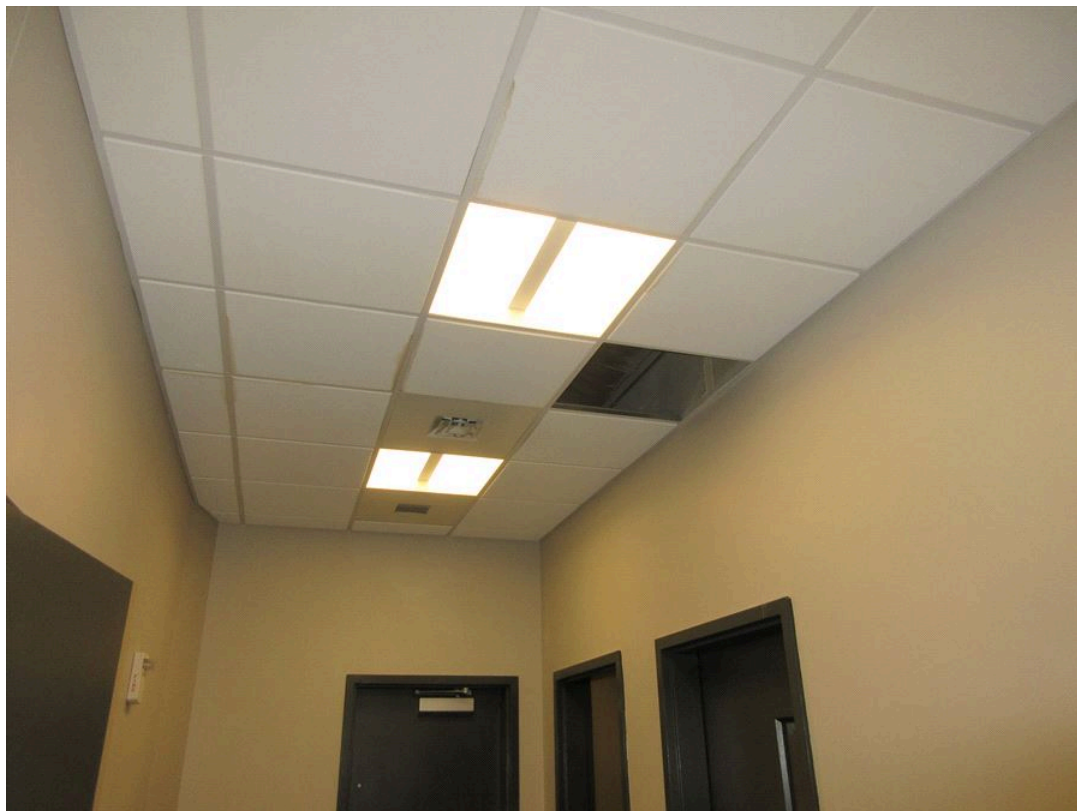
File Name: photo of missing ceiling tiles 3
Violation Code: 707.1
Inspected Date: 2026-03-27 18:13:59

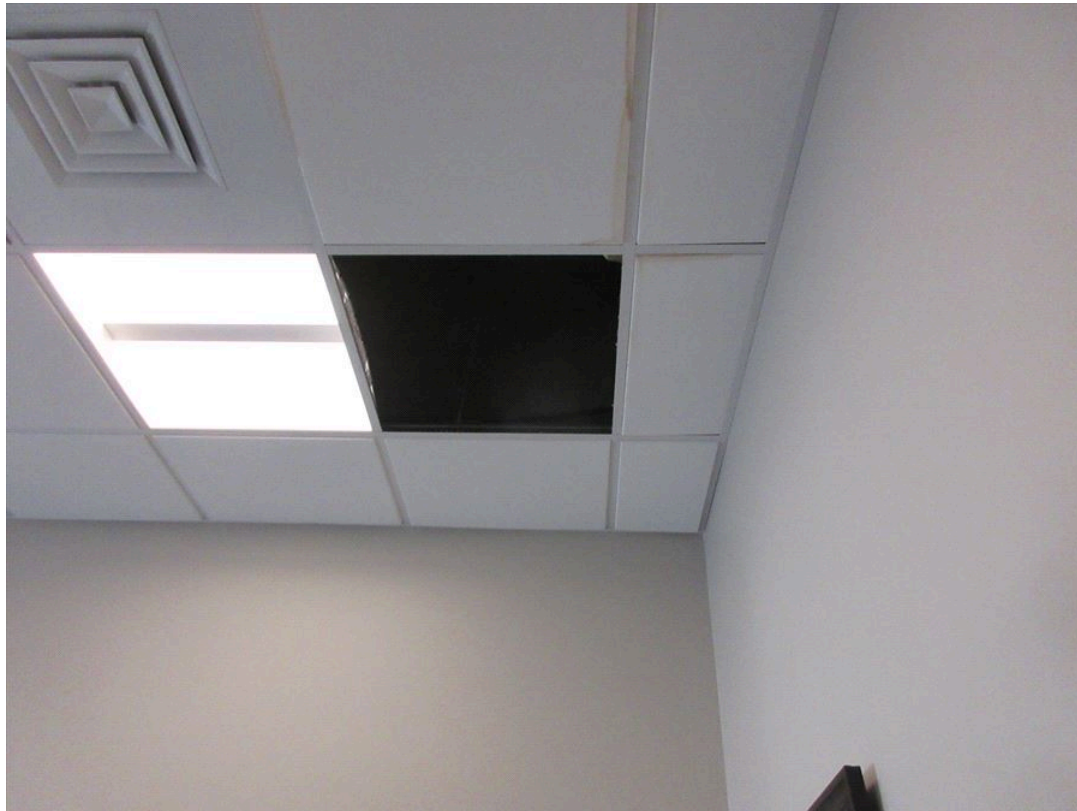
File Name: photo of missing ceiling tile 4
Violation Code: 707.1
Inspected Date: 2026-03-27 18:13:59

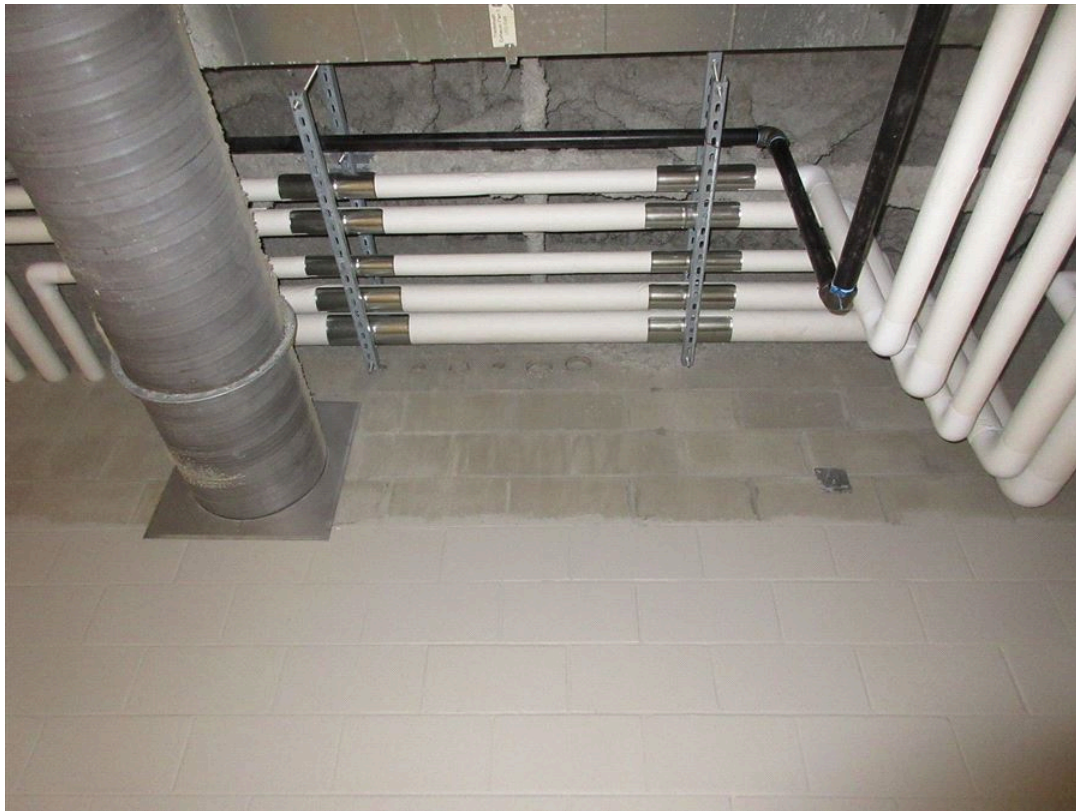
File Name: photo showing penetration in the wall

Violation Code: 707.1

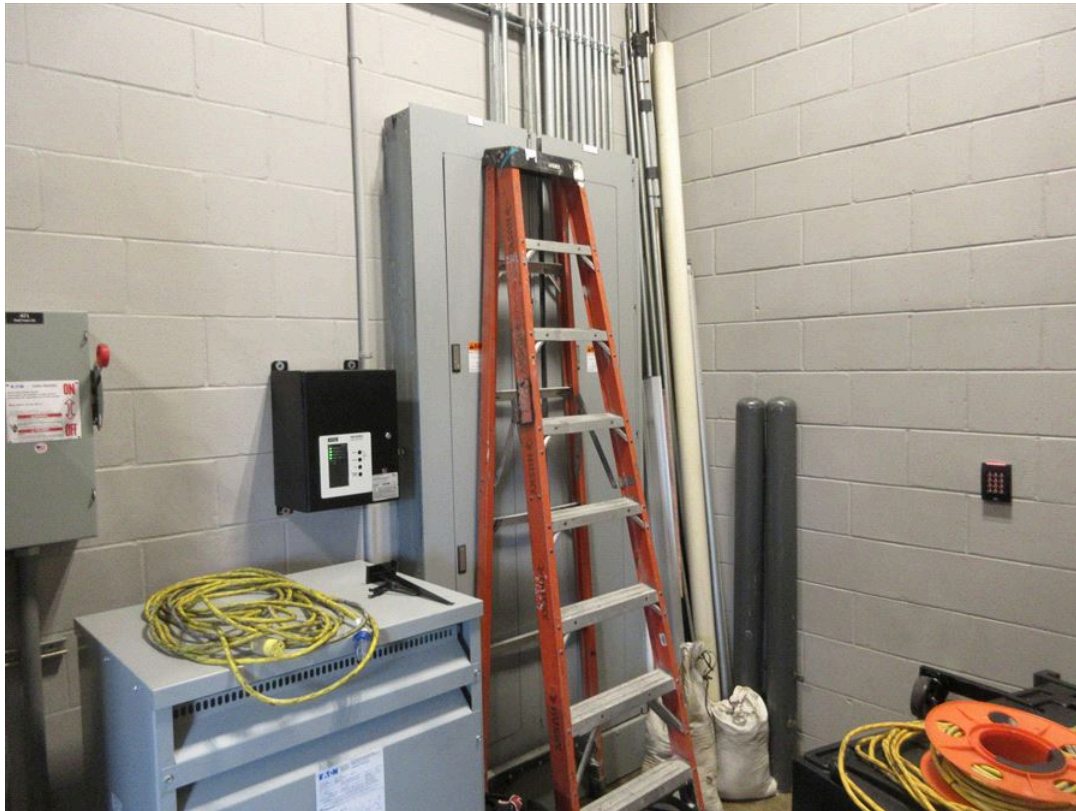
File Name: photo of storage blocking an electrical panel

Violation Code: 603.4

603.4	<p>Working space and clearances. Working space around electrical equipment shall be provided in accordance with Section 110.26 of NFPA 70 for electrical equipment rated 1,000 volts or less, and Section 110.32 of NFPA 70 for electrical equipment rated over 1,000 volts. The minimum required working space shall be not less than 30 inches (762 mm) in width, 36 inches (914 mm) in depth and 78 inches (1981 mm) in height in front of electrical service equipment. Where the electrical service equipment is wider than 30 inches (762 mm), the minimum working space shall be not less than the width of the equipment. Storage of materials shall not be located within the designated working space.</p>	There is storage blocking the electrical panel.

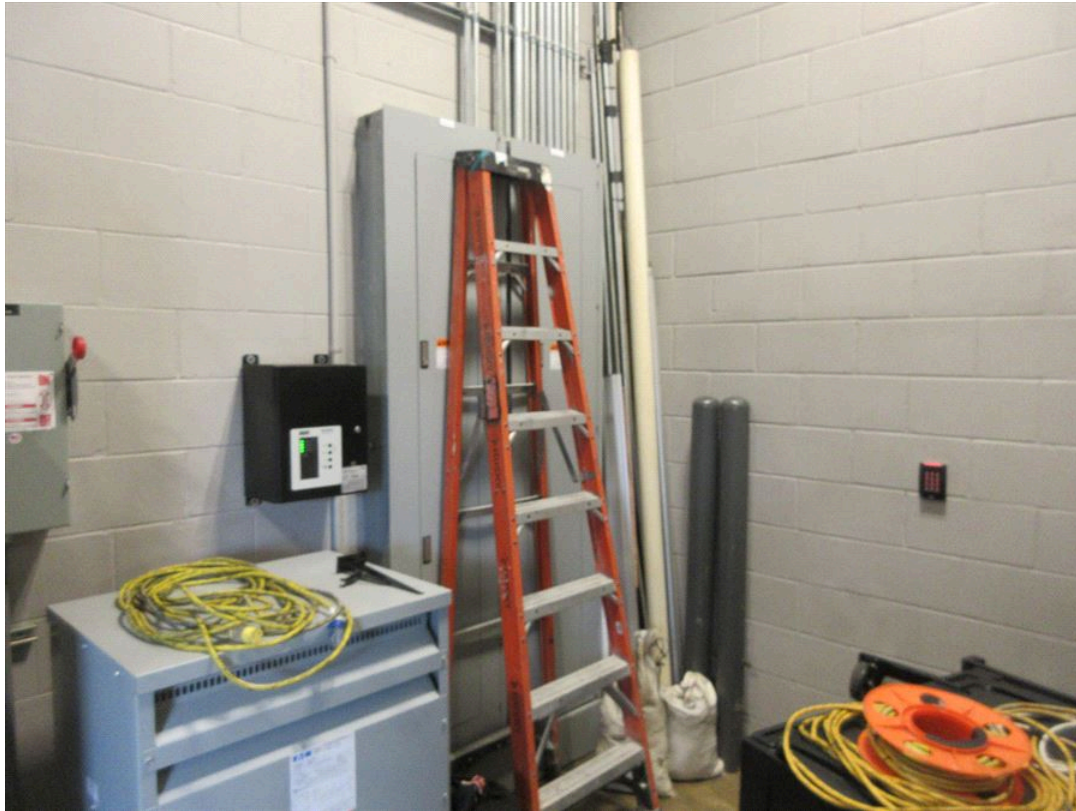
File Name: photo of storage blocking an electrical panel 2

Violation Code: 603.4

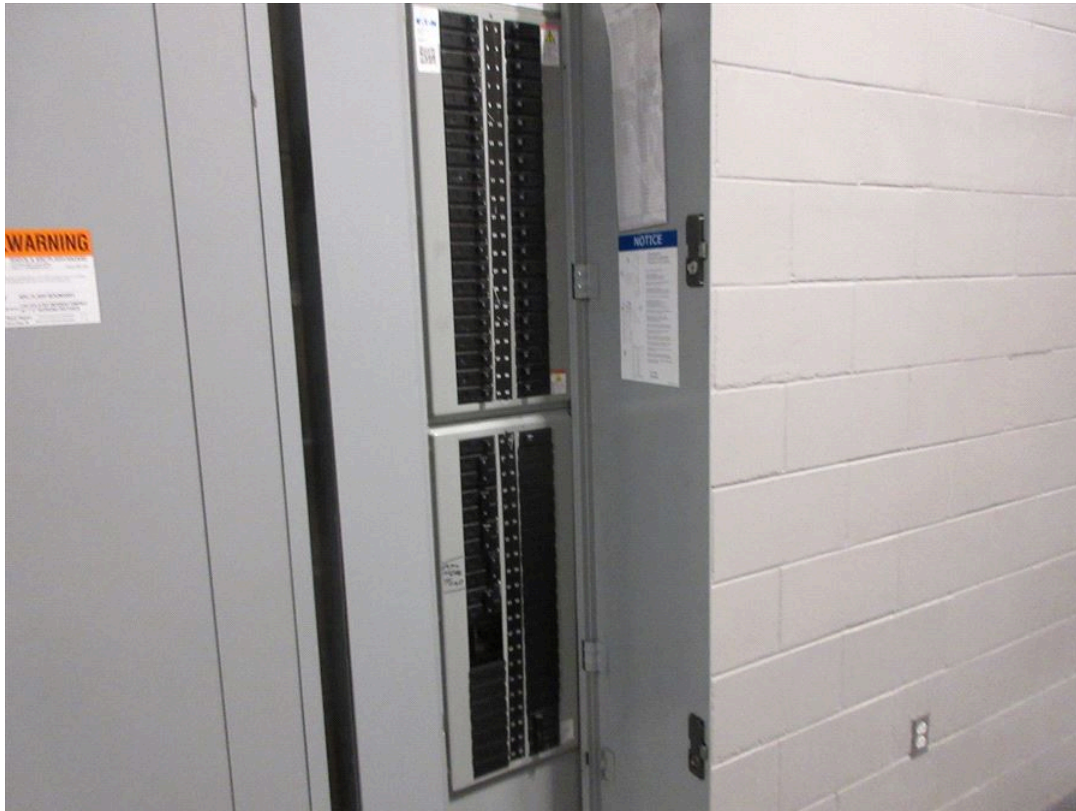
File Name: photo showing missing blanks in the electrical panel

Violation Code: 603.2

603.2	<p>Abatement of unsafe conditions and electrical hazards. Conditions that constitute an electrical shock or fire hazard shall be abated.</p>	There are blanks missing in electrical panels.
