Fire Inspection Report SFM Kayla Riggs

Name: Mississippi State Fairgrounds, Jackson, Hinds County **Location Street Number:** 1207 **Location Street Prefix:**
Location Street Name: Mississippi **Location Street Type:** Street **Location County:** Hinds
Phone Number: (601) 961-4000 **Zone:** 5
Code: CID

Name: Mississippi Trademart **Building Class Code:** All other assembly occupancies
Property Use: Convention center, exhibition hall
Occupant City: Jackson **Occupant Postal Code:** 39202 **Occupant State:** MS **Occupant County:** Hinds

Inspection Number: SFM20260008

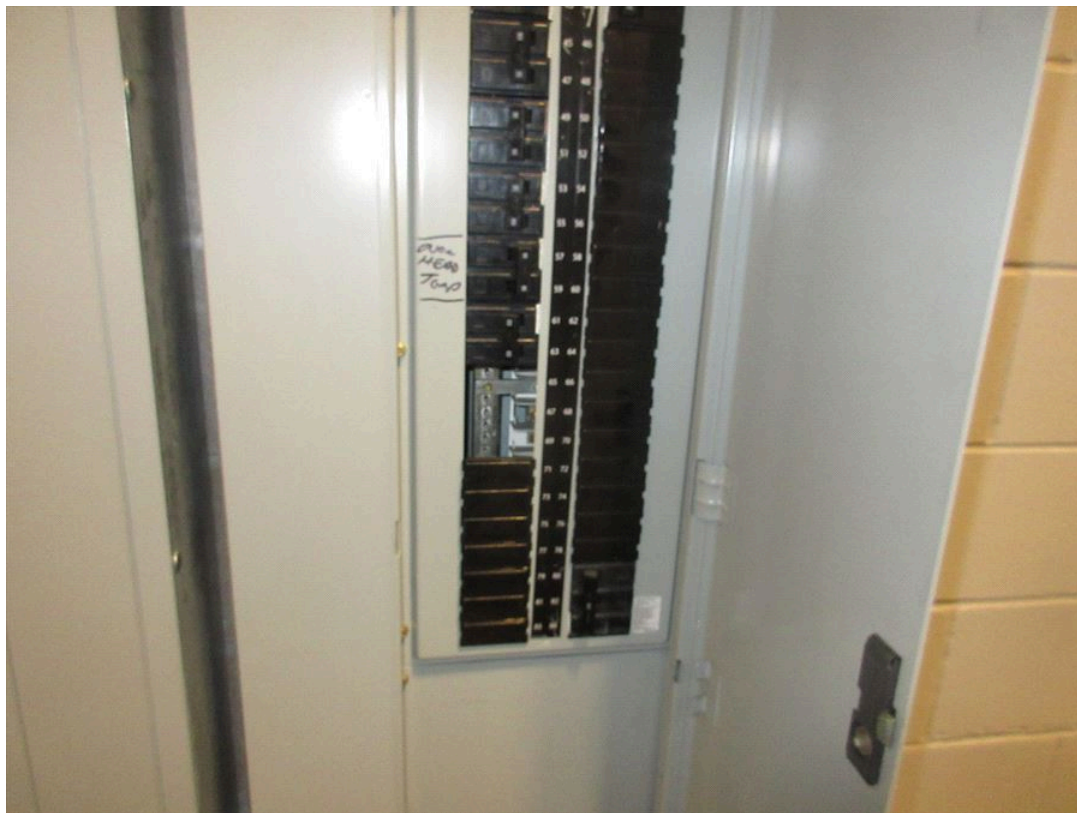
File Name: photo showing missing blanks in the electrical panel 2
Violation Code: 603.2
Inspected Date: 2026-03-27 18:19:20

603.2	<p>Abatement of unsafe conditions and electrical hazards. Conditions that constitute an electrical shock or fire hazard shall be abated.</p>	There are blanks missing in electrical panels.

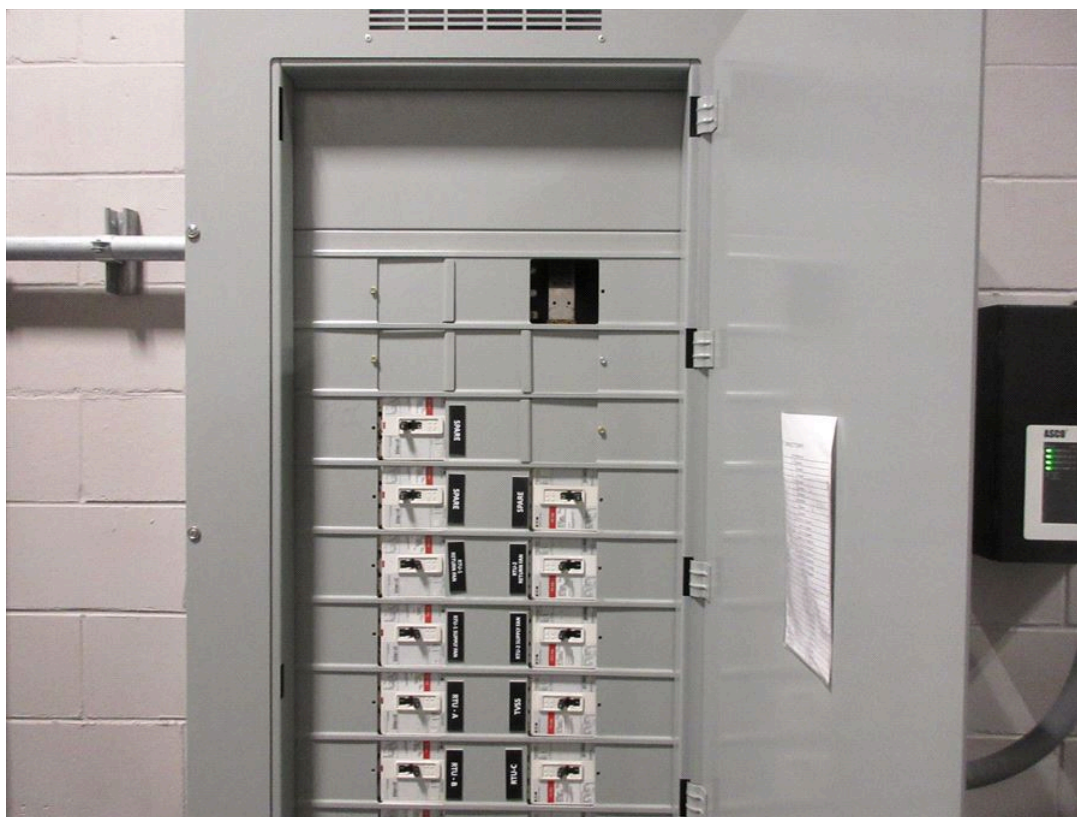
File Name: photo showing missing blanks in the electrical panel 3
Violation Code: 603.2
Inspected Date: 2026-03-27 18:19:20

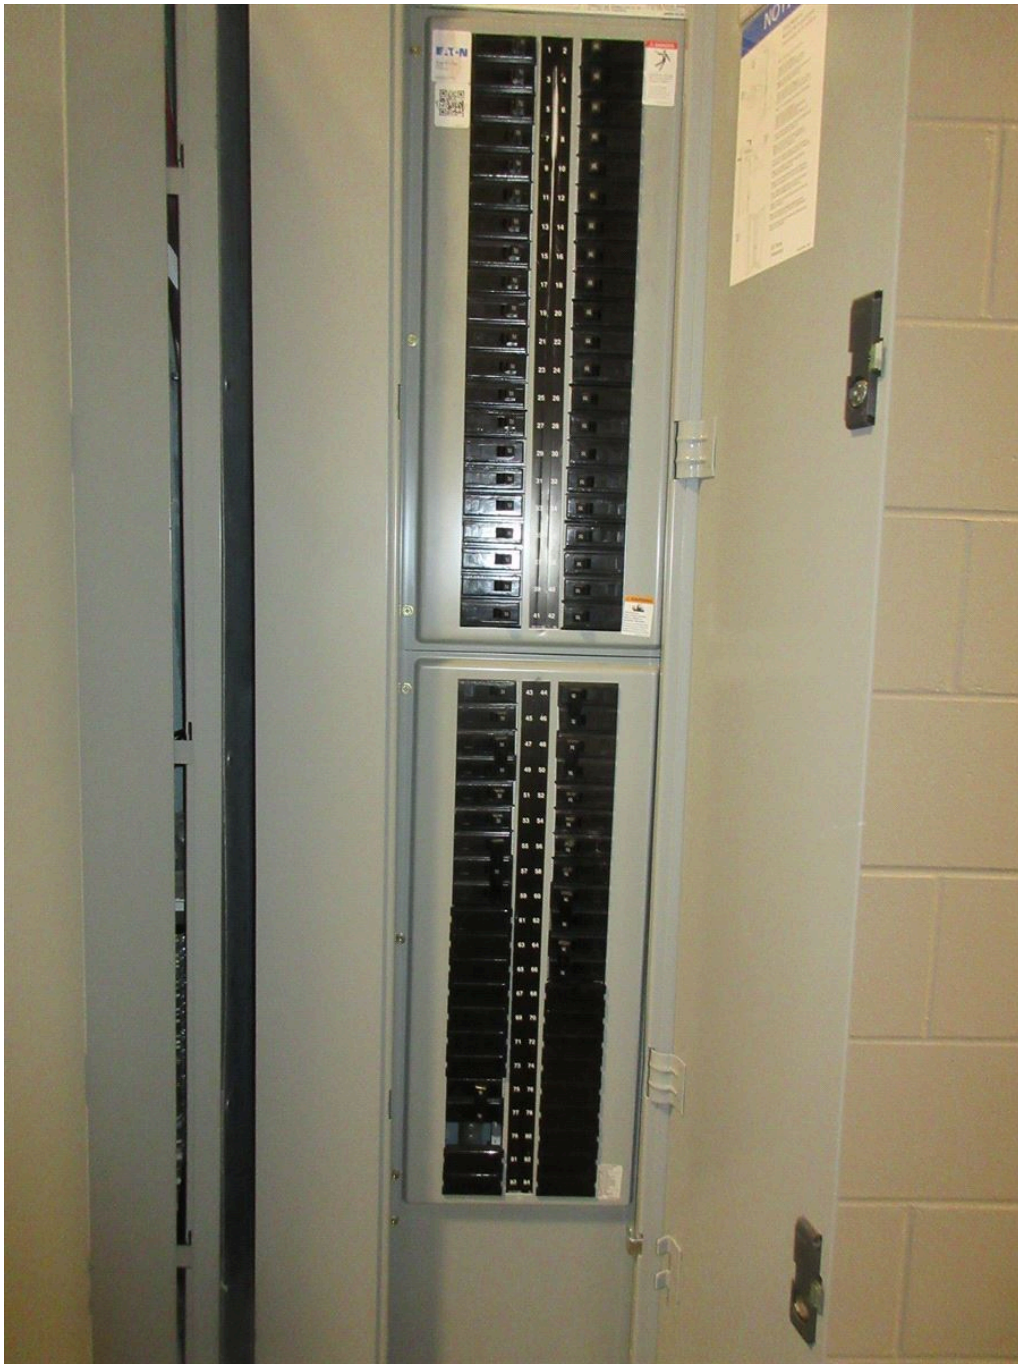
File Name: photo showing missing blanks in the electrical panel 4

Violation Code: 603.2

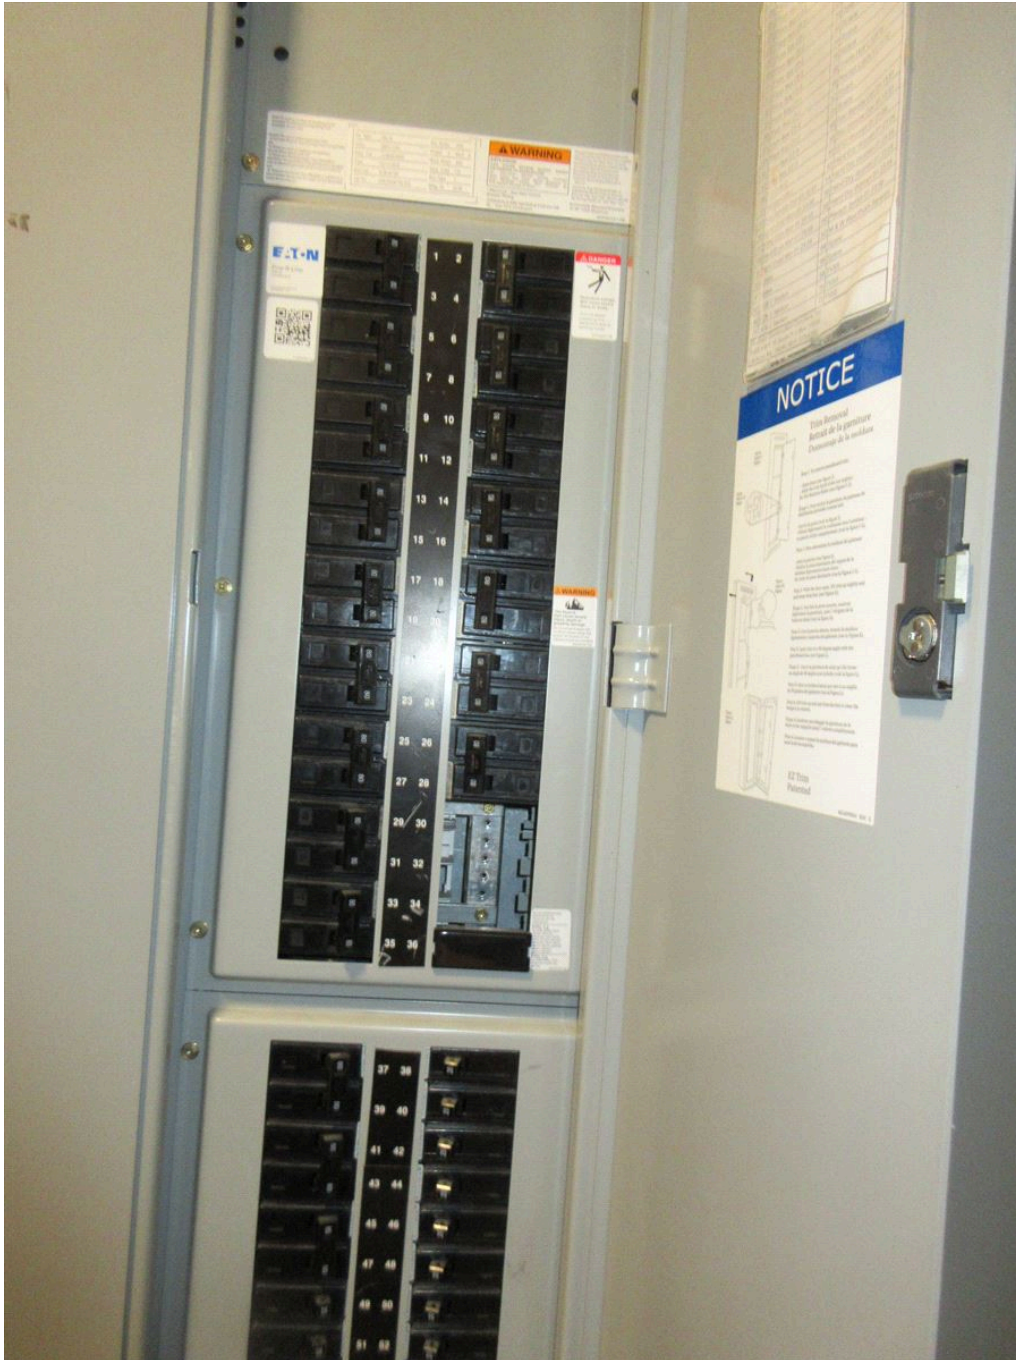
File Name: photo showing missing blanks in the electrical panel 5
Violation Code: 603.2
Inspected Date: 2026-03-27 18:19:20

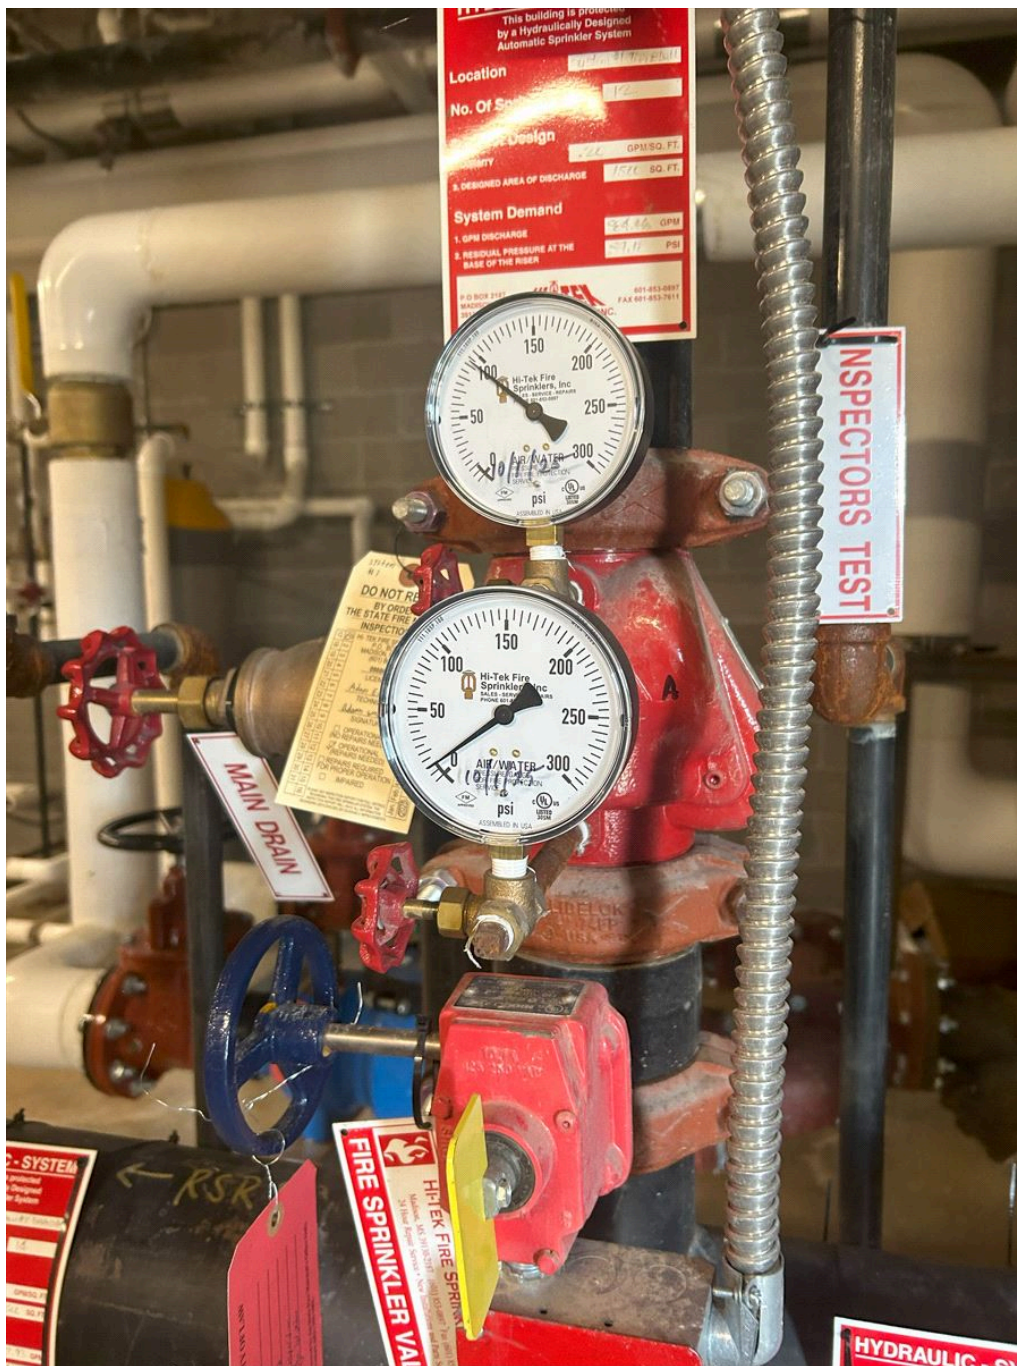
File Name: photo of close up of first riser in the trade mart
Violation Code: 903.5
Inspected Date: 2026-03-27 18:22:14

Violation Code	Description	Comments
903.5	Inspection, testing and maintenance. Automatic sprinkler systems shall be inspected, tested and maintained in accordance with Section 901.	The sprinkler system has low water pressure on the sprinkler system gauges that is not acceptable per NFPA 13. The system has been tagged as needing repairs by HiTek sprinkler company. The system was red tagged by the State Fire Marshal's Office in September of 2025. The water valve to the system was shut off at the time of inspection.

rated at 200 degrees. Deputies went to the riser room located at the Northeast Corner of the MS Trade Mart Building. Upon inspection of the sprinkler risers, it was observed that the middle riser, the second riser of three, had low water pressure in the supply and the demand gauges. The supply gauge, the gauge that measures pressure coming from the water main, was low on all three riser gauges and read approximately 10 psi. The system gauge, the gauge that measures pressure within the system piping, was at approximately 10 psi on the second riser. It was also observed that MS State Fire Marshal Inspector Lee Williams Red Tagged the sprinkler system on September 29, 2025. On October 1, 2025, HiTek Fire Sprinklers conducted a five-year (5) sprinkler system test in which they noted two (2) critical faults on the sprinkler system. Deputies then observed the fire alarm panel in the main office area of the building which showed multiple troubles. Upon speaking with Deputy Commissioner of Agriculture Hayes Patrick, the Department of Agriculture does not pay for the Fire Alarm to be monitored; therefore, the fire alarm system did not call out to the local fire department at the time of the fire.

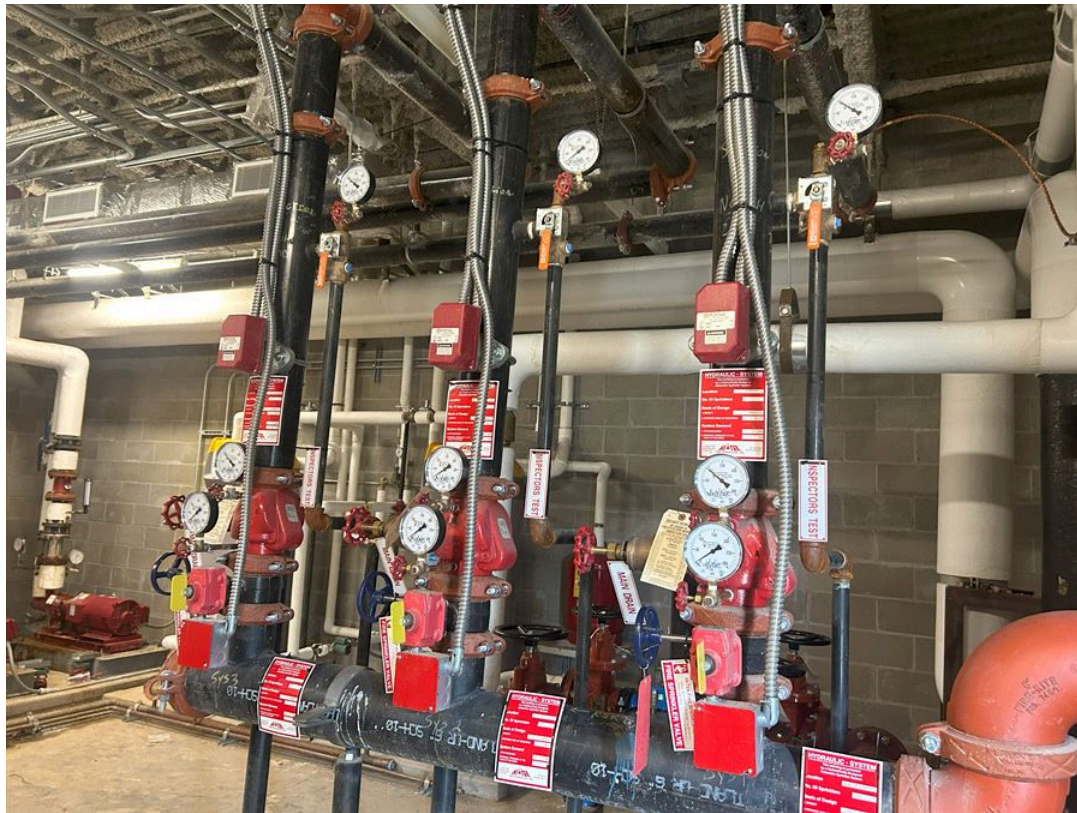
File Name: photo showing all three sprinkler risers in the trade mart
Violation Code: 903.5
Inspected Date: 2026-03-27 18:22:14

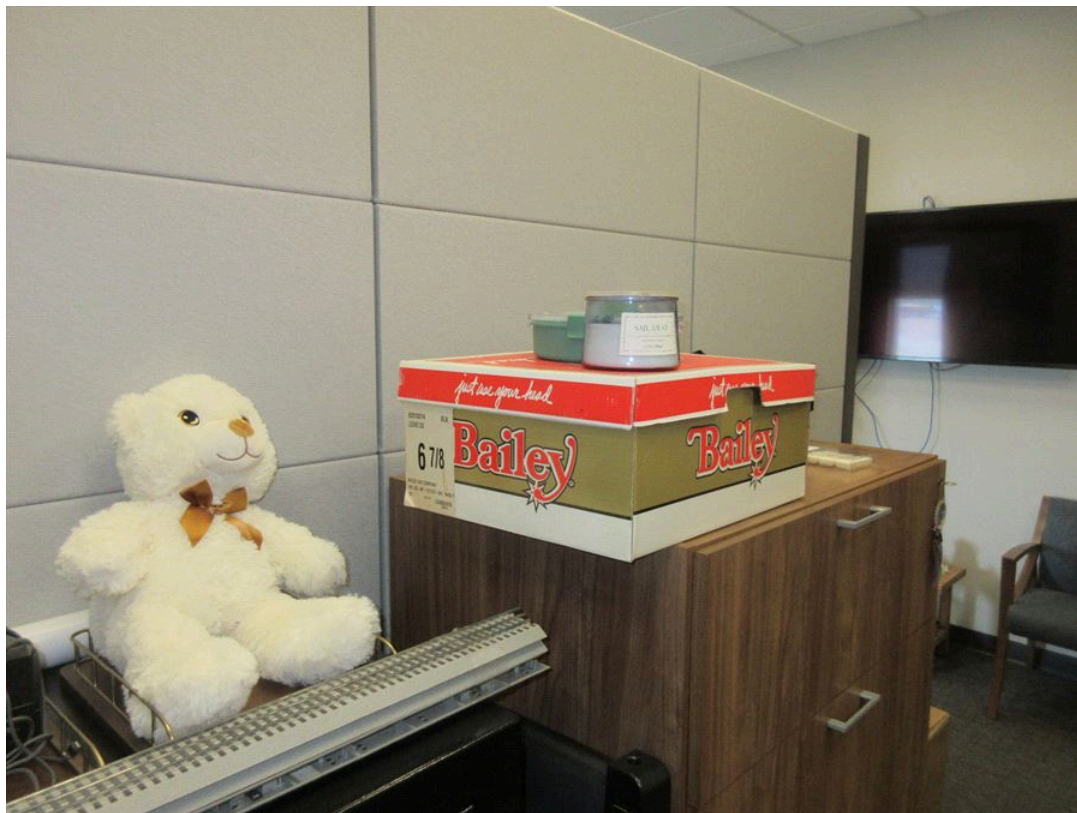
File Name: photo of candle in office
Violation Code: 308.1.1
Inspected Date: 2026-03-27 18:29:17

308.1.1	Where prohibited. A person shall not take or utilize an open flame or light in a structure, vessel, boat or other place where highly flammable, combustible or explosive material is utilized or stored. Lighting appliances shall be well-secured in a glass globe and wire mesh cage or a similar approved device.	There is a candle in an office.

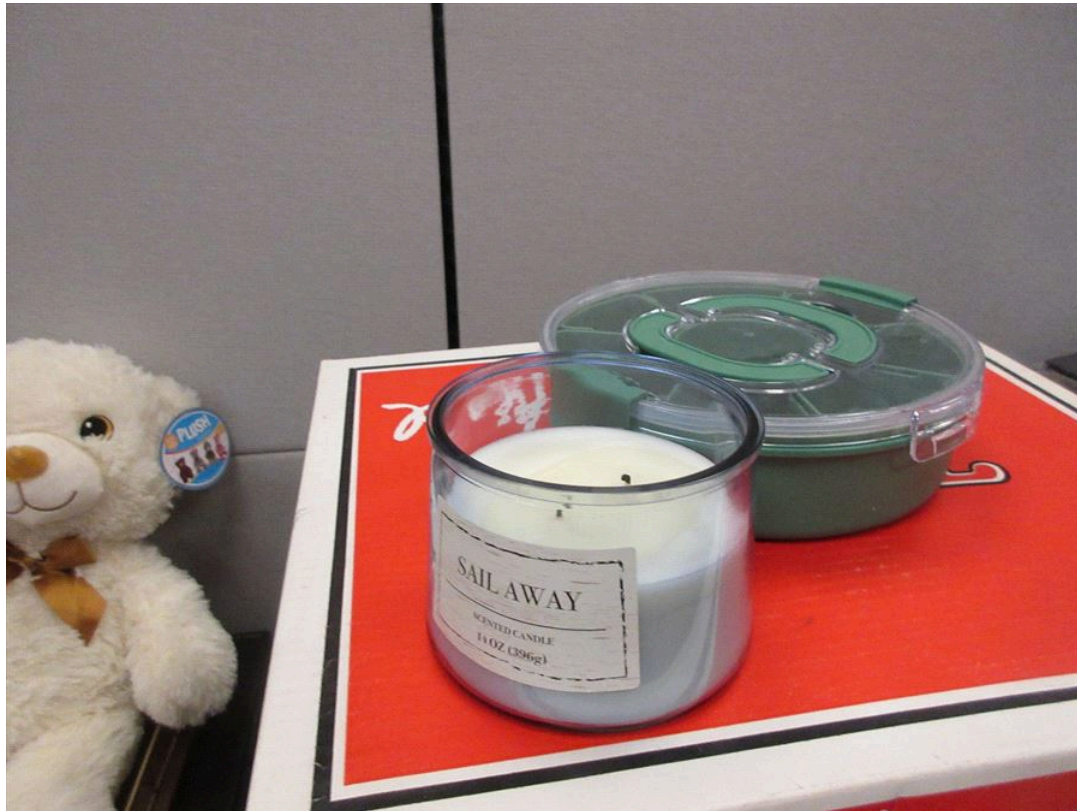
File Name: photo of close up of candle in office
Violation Code: 308.1.1
Inspected Date: 2026-03-27 18:29:17

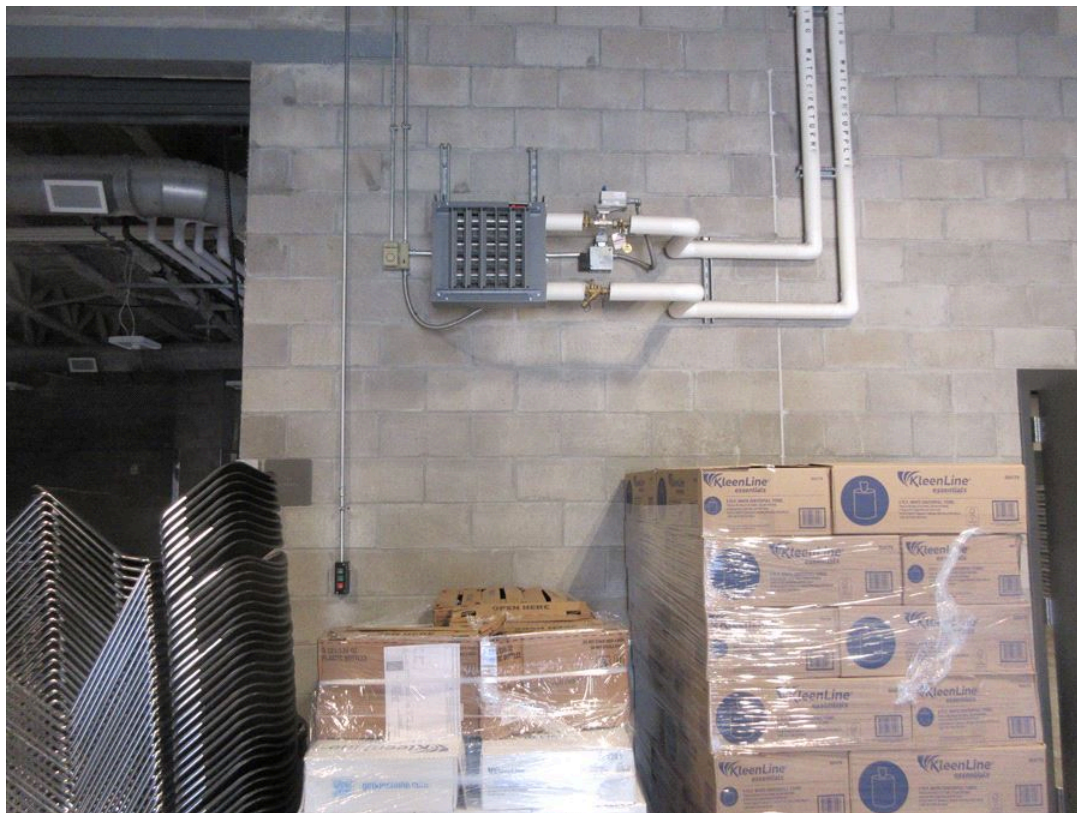
File Name: photo showing storage too close to heater
Violation Code: 315.3
Inspected Date: 2026-03-27 18:35:58

315.3	Storage in buildings. Storage of materials in buildings shall be orderly and stacks shall be stable. Storage of combustible materials shall be separated from heaters or heating devices by distance or shielding so that ignition cannot occur.	There is combustible storage in the path of heaters.

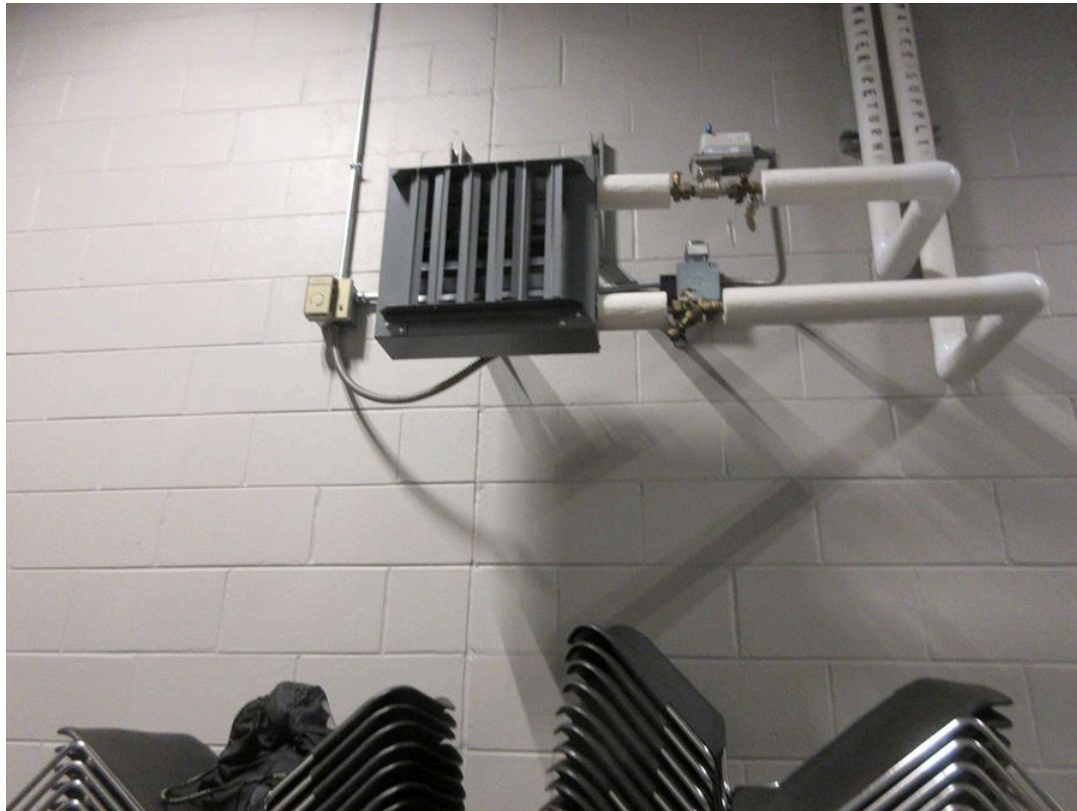
File Name: photo showing storage too close to a heater 2
Violation Code: 315.3
Inspected Date: 2026-03-27 18:35:58

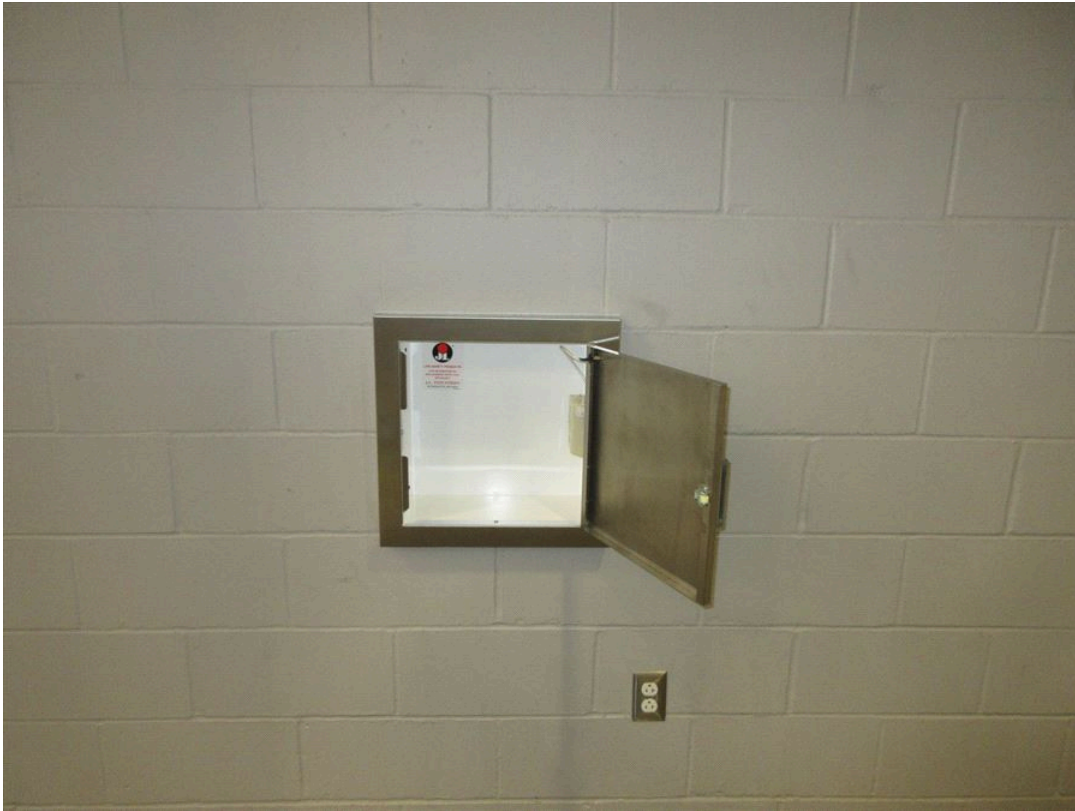
File Name: photo of missing AED equipment
Violation Code: 901.6
Inspected Date: 2026-03-27 18:38:18

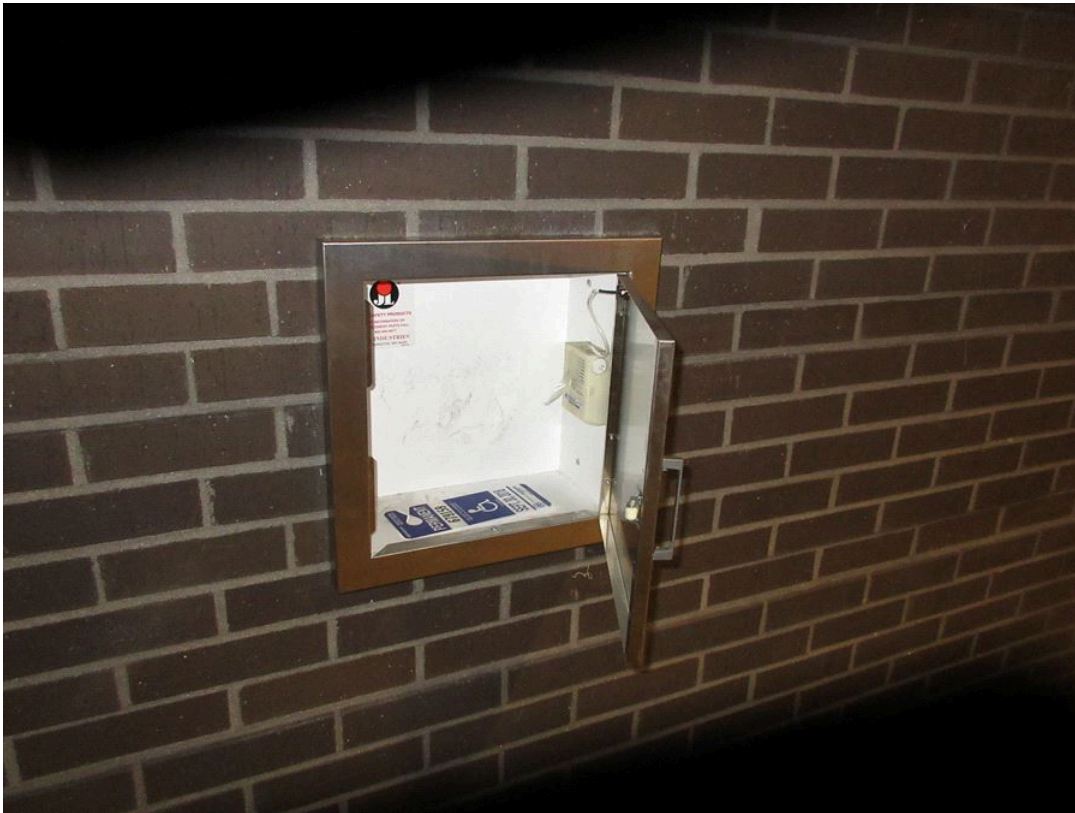
File Name: photo of missing AED equipment 2
Violation Code: 901.6
Inspected Date: 2026-03-27 18:38:18

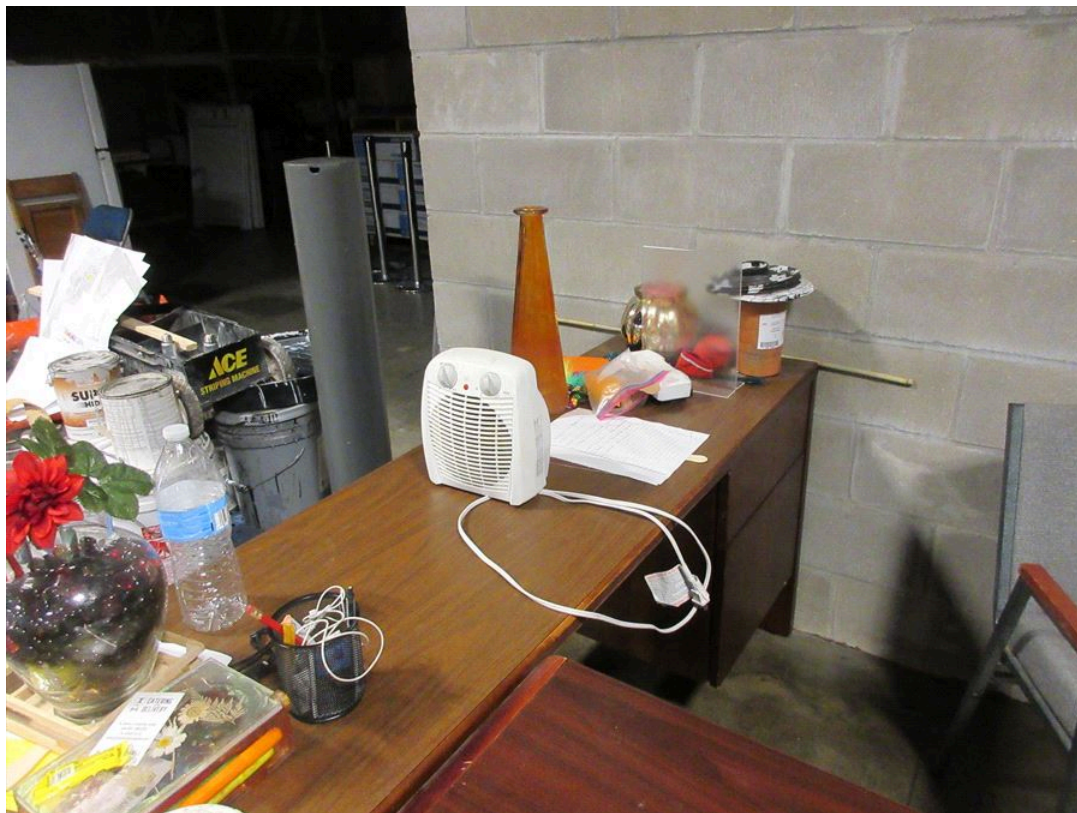
File Name: photo of space heater
Violation Code: 4102.1.4
Inspected Date: 2026-03-27 15:32:13

901.6	Inspection, testing and maintenance. Fire protection and life safety systems shall be maintained in an operative condition at all times, and shall be replaced or repaired where defective. Nonrequired fire protection and life safety systems and equipment shall be inspected, tested and maintained or removed in accordance with Section 901.8.	There are two (2) AED devices missing in the appropriate cabinets.
4102.1.4	Prohibited areas. Portable, electric space heaters shall not be operated within 3 feet (914 mm) of any combustible materials. Portable, electric space heaters shall be operated only in locations for which they are listed.	There are space heaters in prohibited areas.

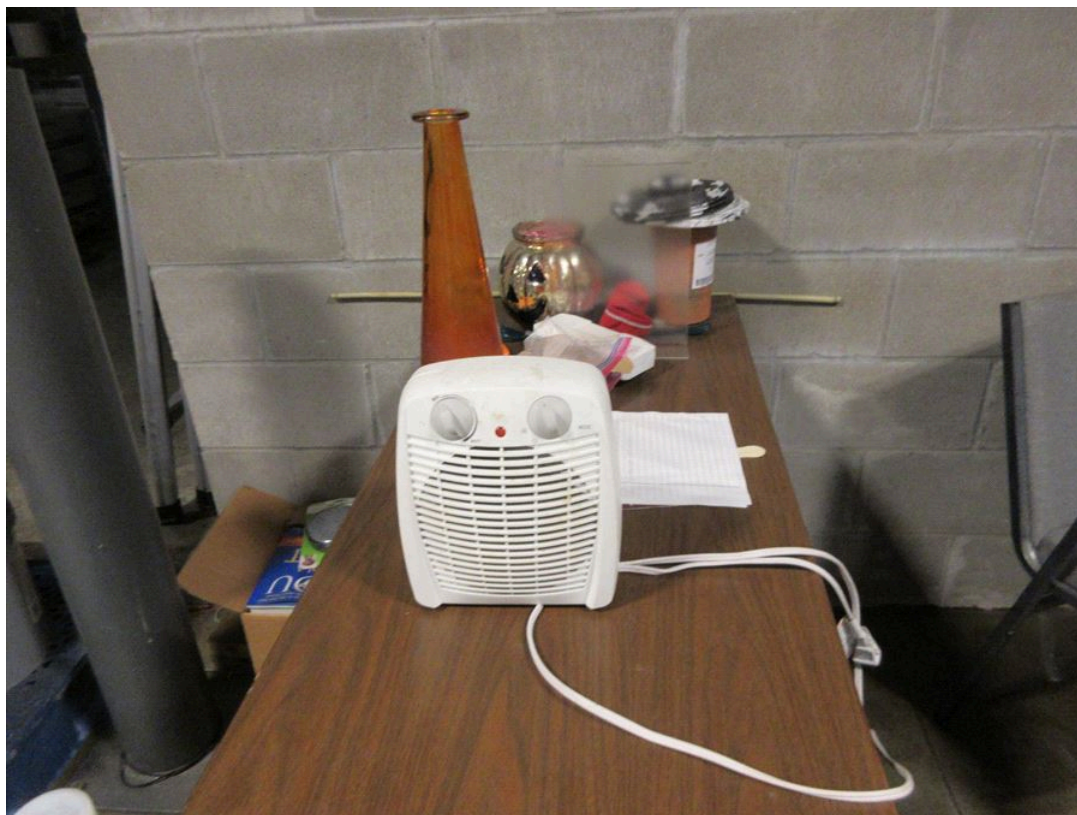
File Name: photo of close up of space heater
Violation Code: 4102.1.4
Inspected Date: 2026-03-27 15:32:13

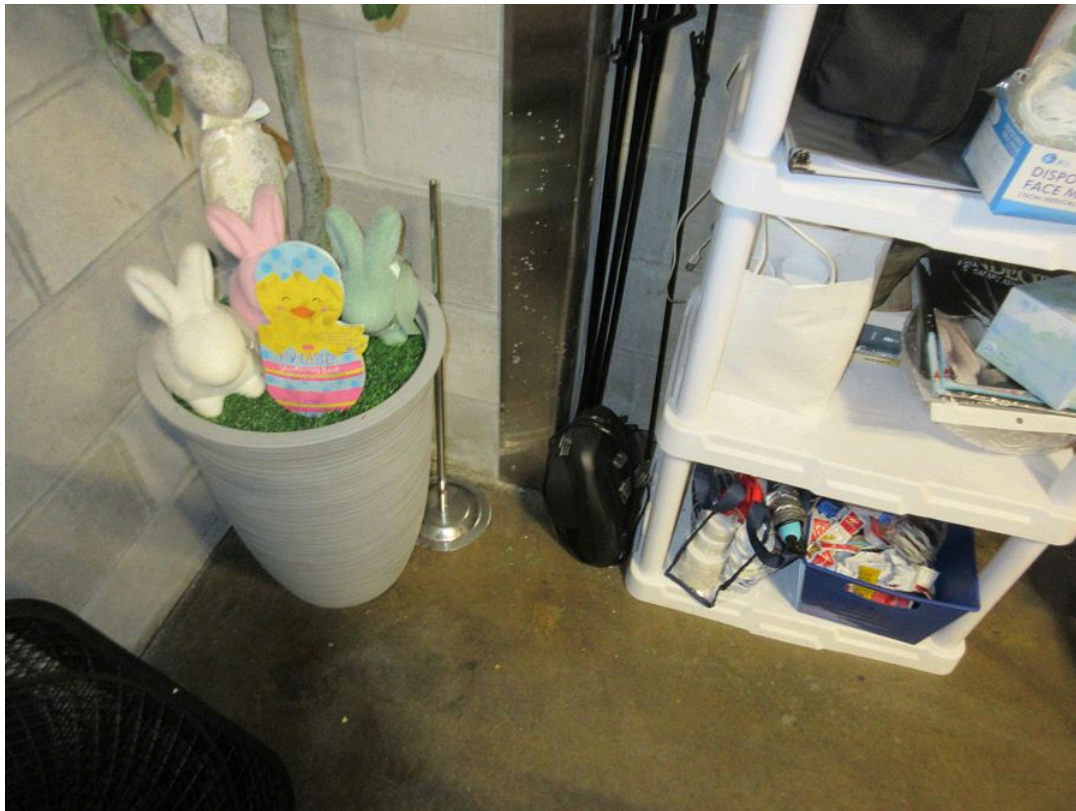
File Name: photo of space heater 2
Violation Code: 4102.1.4
Inspected Date: 2026-03-27 15:32:13

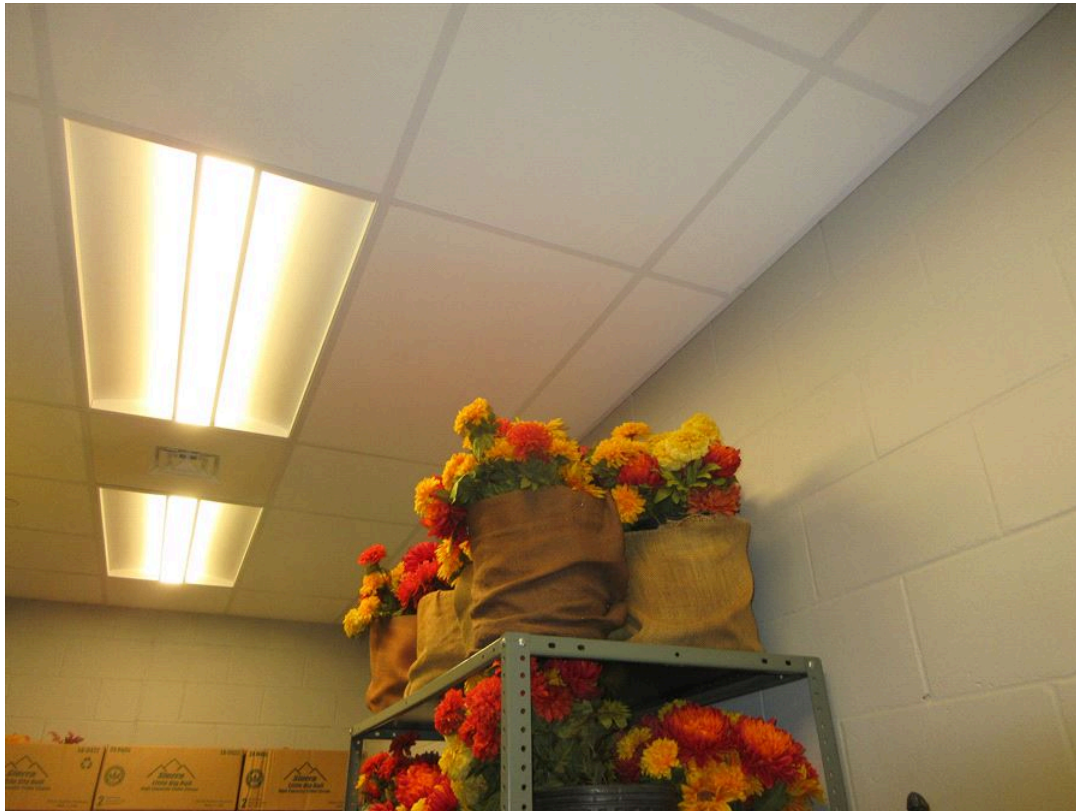
File Name: photo of storage being too high this was corrected on site
Violation Code: 315.3.1
Inspected Date: 2026-03-27 15:34:05

315.3.1	Ceiling clearance. Storage shall be maintained 2 feet (610 mm) or more below the ceiling in nonsprinklered areas of buildings or not less than 18 inches (457 mm) below sprinkler deflectors in sprinklered areas of buildings. Exceptions: 1.The 2-foot (610 mm) ceiling clearance is not required for storage along walls in nonsprinklered areas of buildings. 2.The 18-inch (457 mm) ceiling clearance is not required for storage along walls in areas of buildings equipped with an automatic sprinkler system in accordance with Section 903.3.1.1, 903.3.1.2 or 903.3.1.3.	There was storage placed too close to the ceiling. Note - this violation was corrected on site.
