Fire Inspection Report SFM Kayla Riggs

Name: Mississippi State Fairgrounds, Jackson, Hinds County **Location Street Number:** 1207 **Location Street Prefix:**
Location Street Name: Mississippi **Location Street Type:** Street **Location County:** Hinds
Phone Number: (601) 961-4000 **Zone:** 5
Code: CID

Name: Mississippi Trademart **Building Class Code:** All other assembly occupancies
Property Use: Convention center, exhibition hall
Occupant City: Jackson **Occupant Postal Code:** 39202 **Occupant State:** MS **Occupant County:** Hinds

Inspection Number: SFM20260008

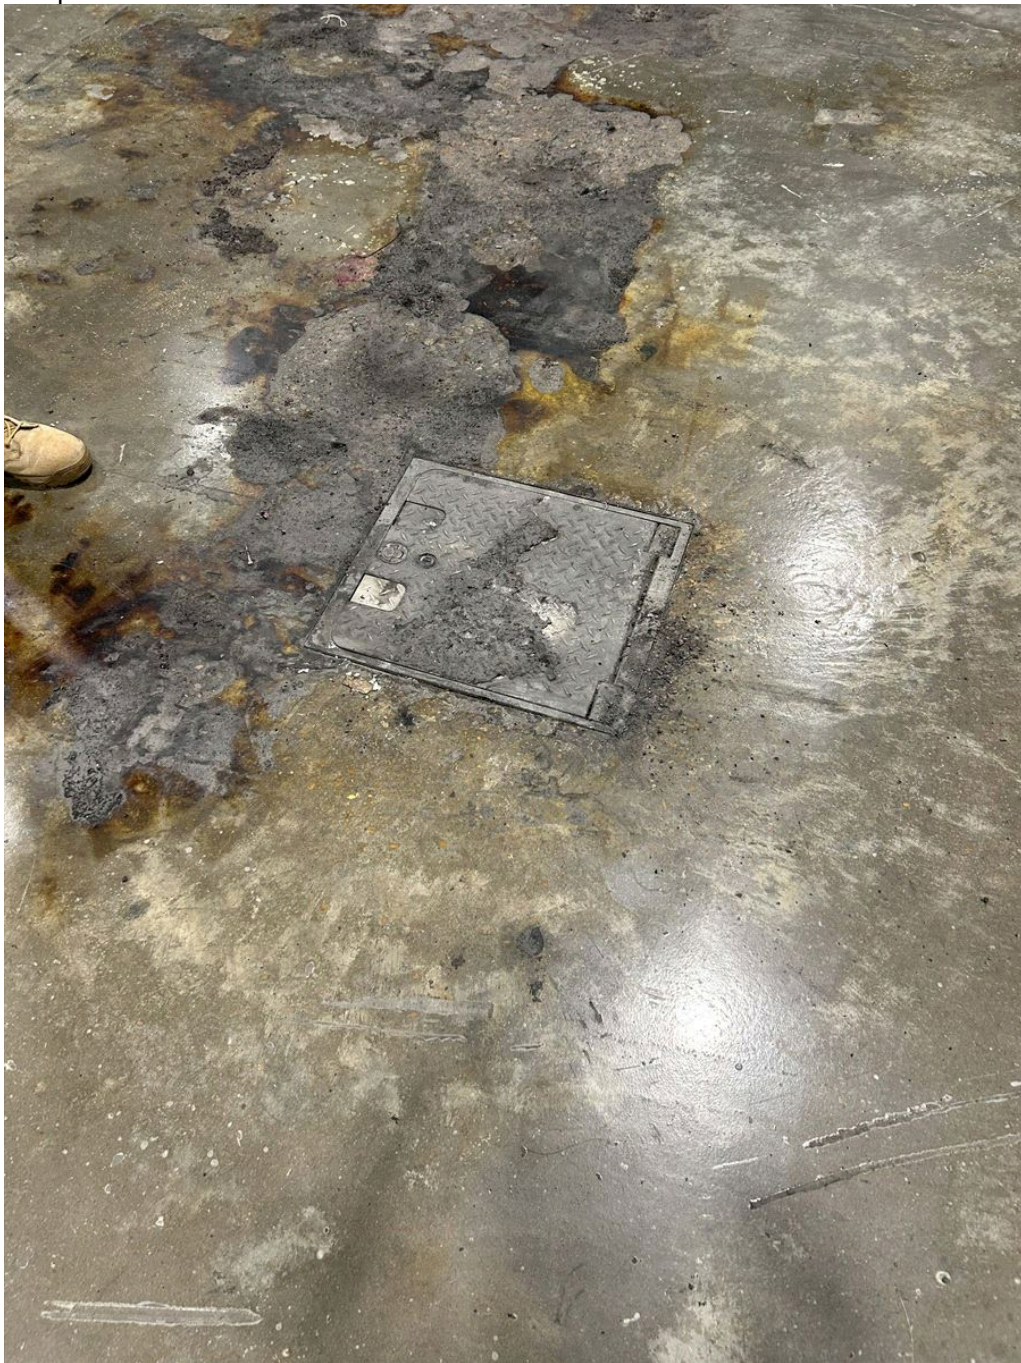
Title: photo of close up of where fire occurred in trademart

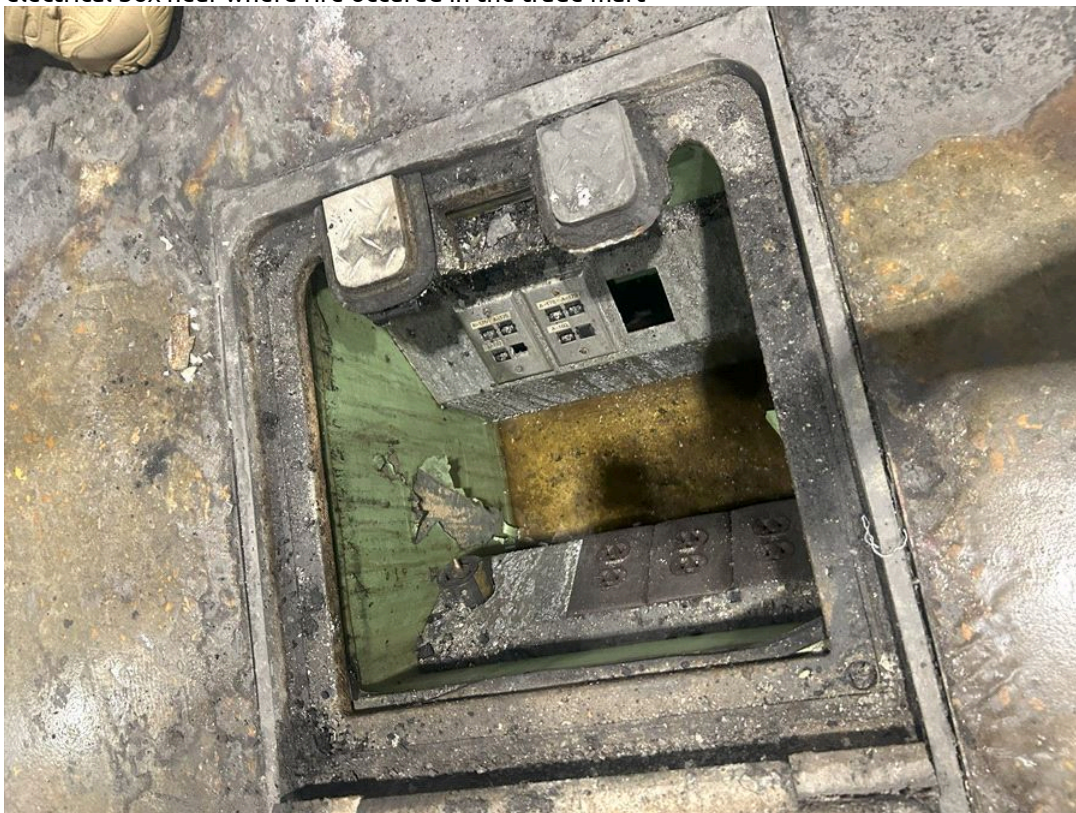
Title: photo of electrical box near where fire occurred in the trade mart

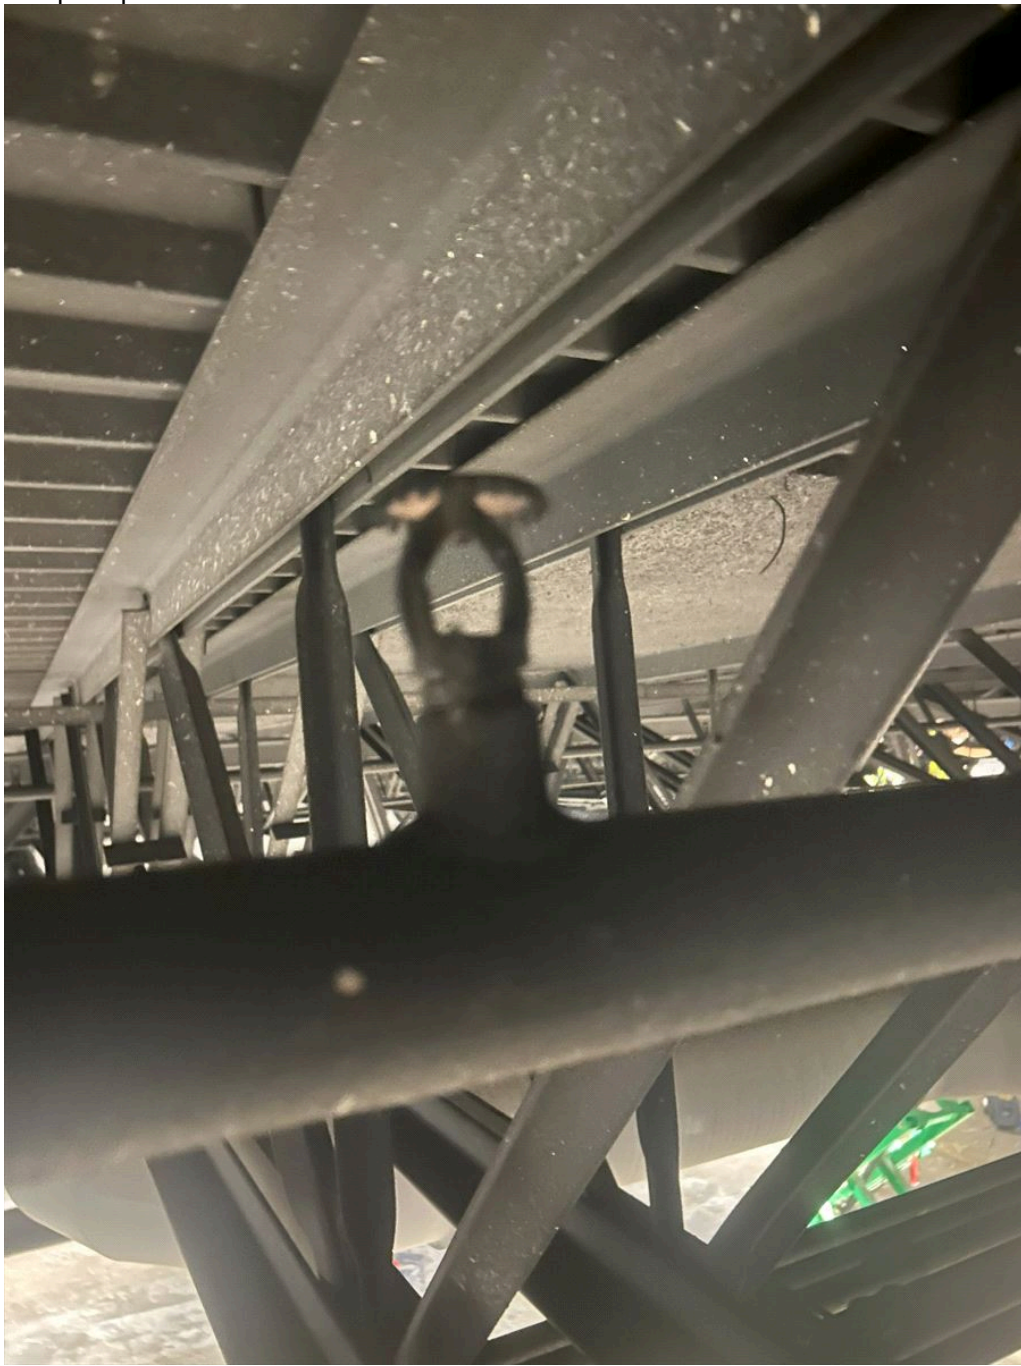
Title: photo of close up of sprinkler head above where trade mart fire occurred

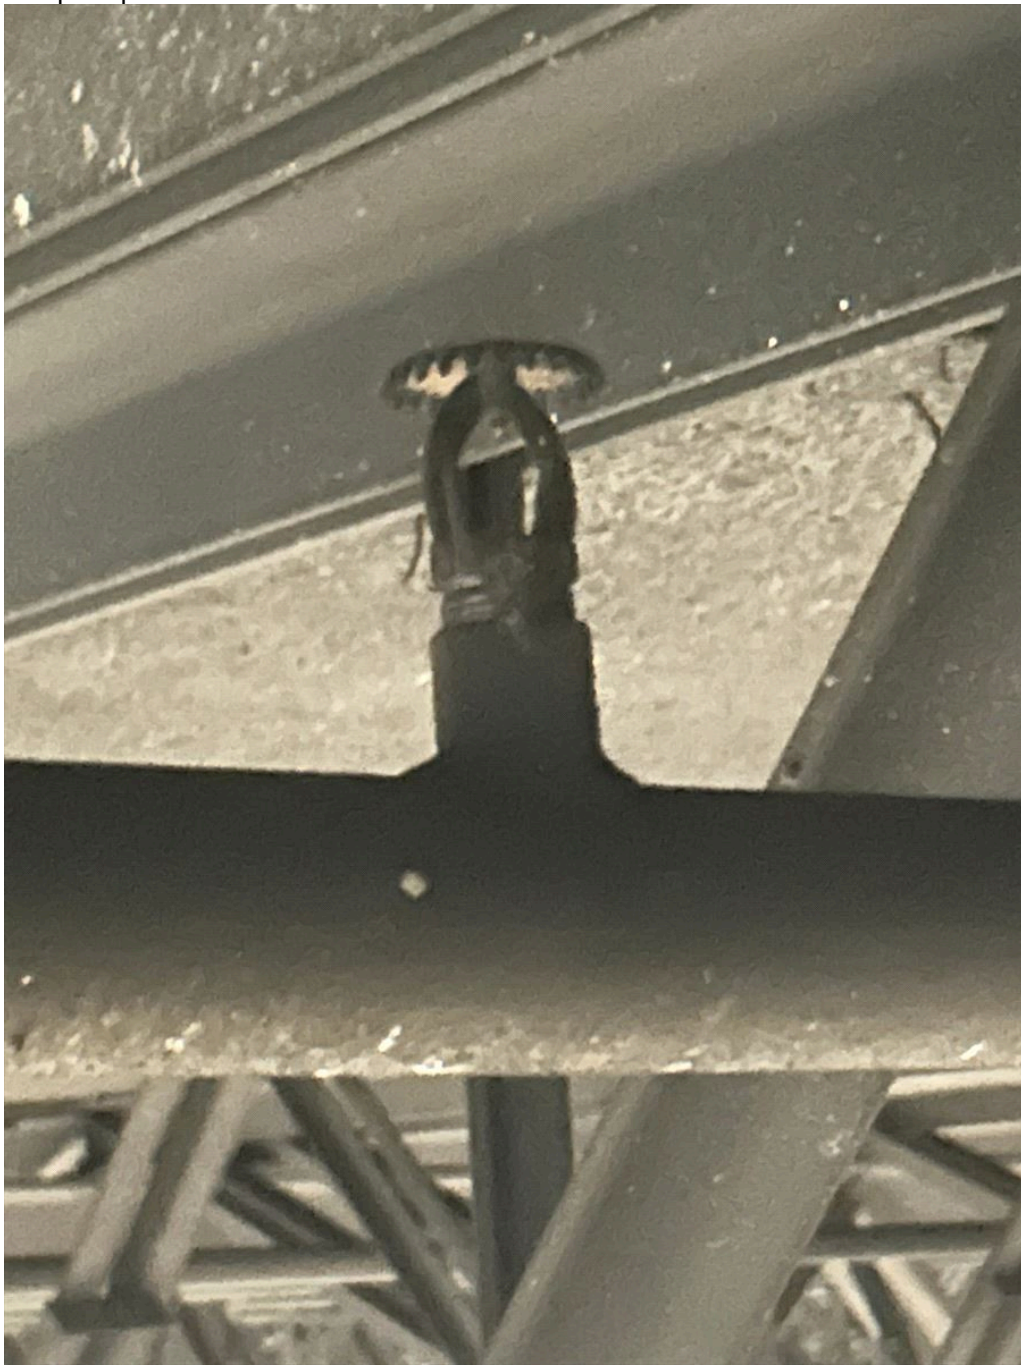
Title: photo of close up of sprinkler head above where fire occurred

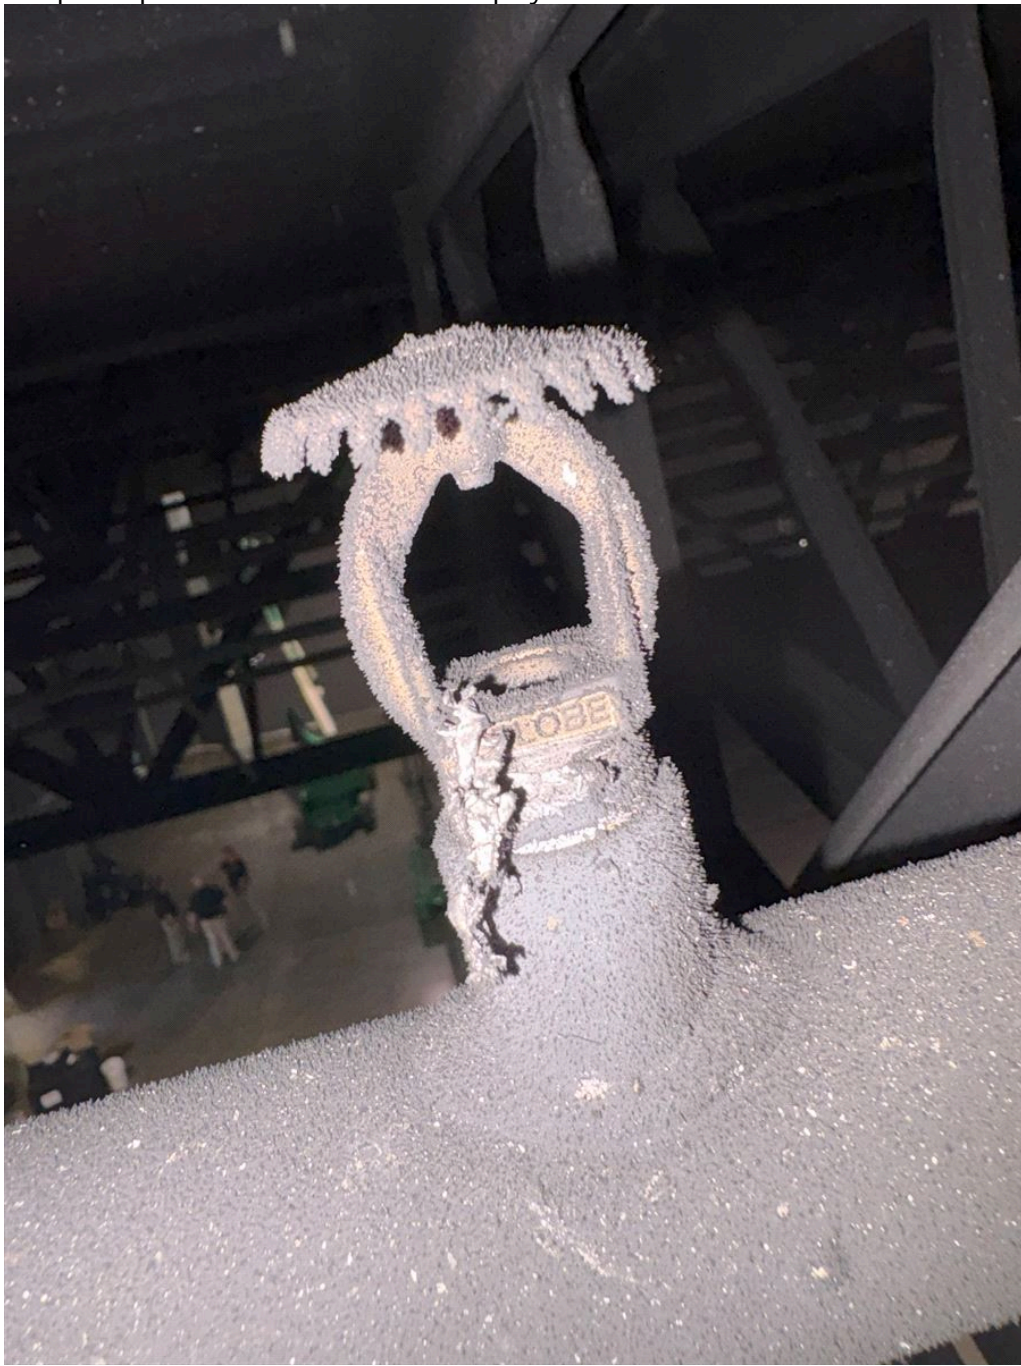
Title: photo of close up of a sprinkler head that has been deployed above where the fire occurred
