Fire Inspection Report SFM Kayla Riggs

Name: Mississippi State Fairgrounds, Jackson, Hinds County **Location Street Number:** 1207 **Location Street Prefix:**
Location Street Name: Mississippi **Location Street Type:** Street **Location County:** Hinds
Phone Number: (601) 961-4000 **Zone:** 5
Code: CID

Name: Mississippi Trademart **Building Class Code:** All other assembly occupancies
Property Use: Convention center, exhibition hall
Occupant City: Jackson **Occupant Postal Code:** 39202 **Occupant State:** MS **Occupant County:** Hinds

Inspection Number: SFM20260008

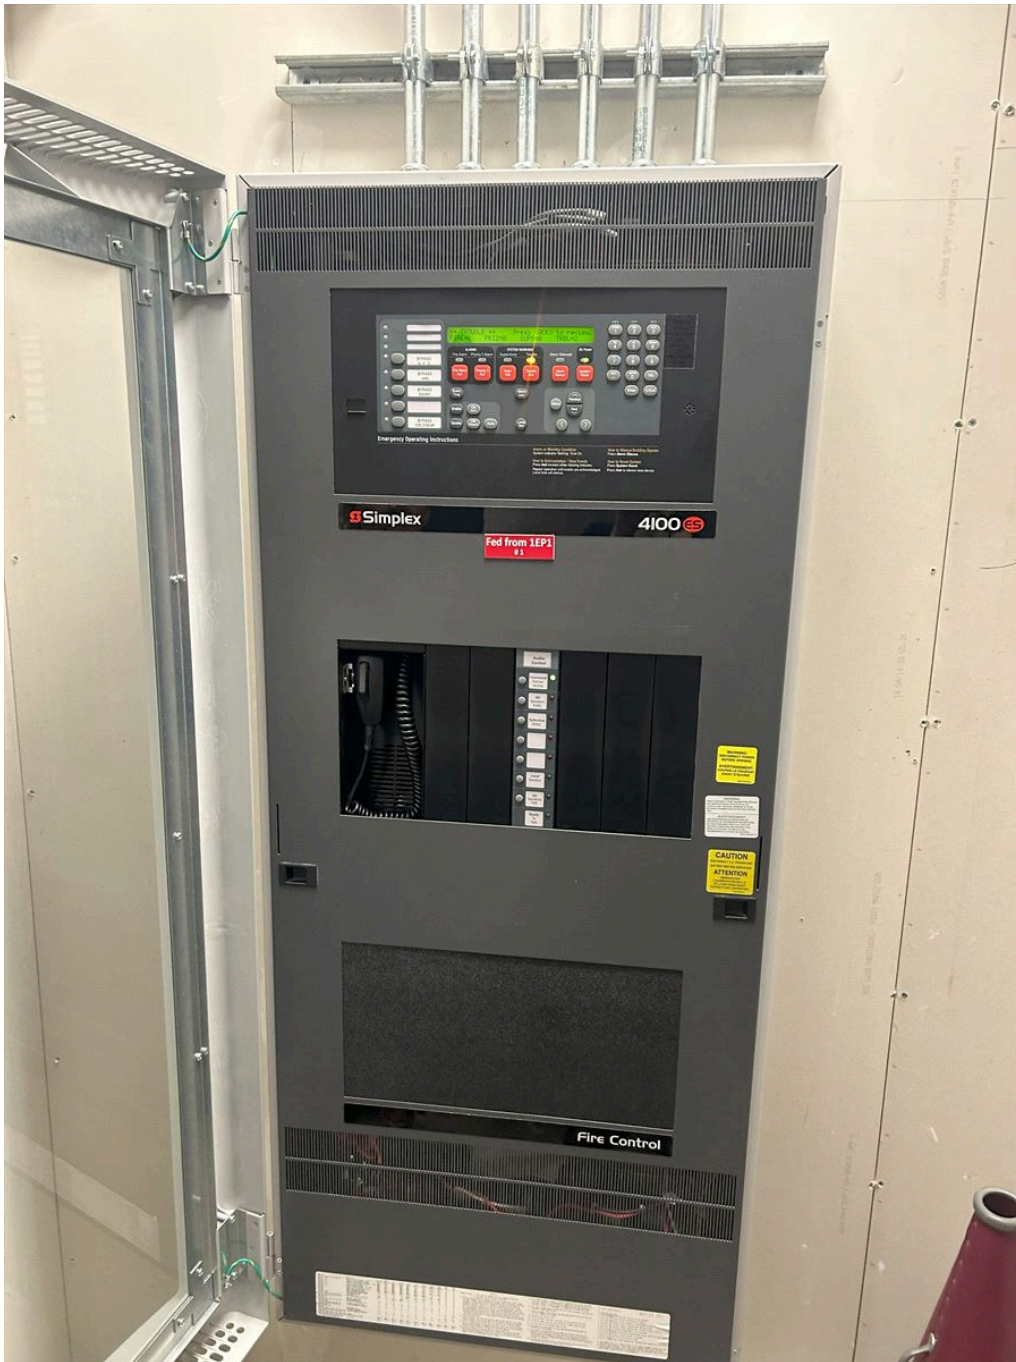
File Name: photo of close up of the troubles on the fire alarm panel

Violation Code: 907.8

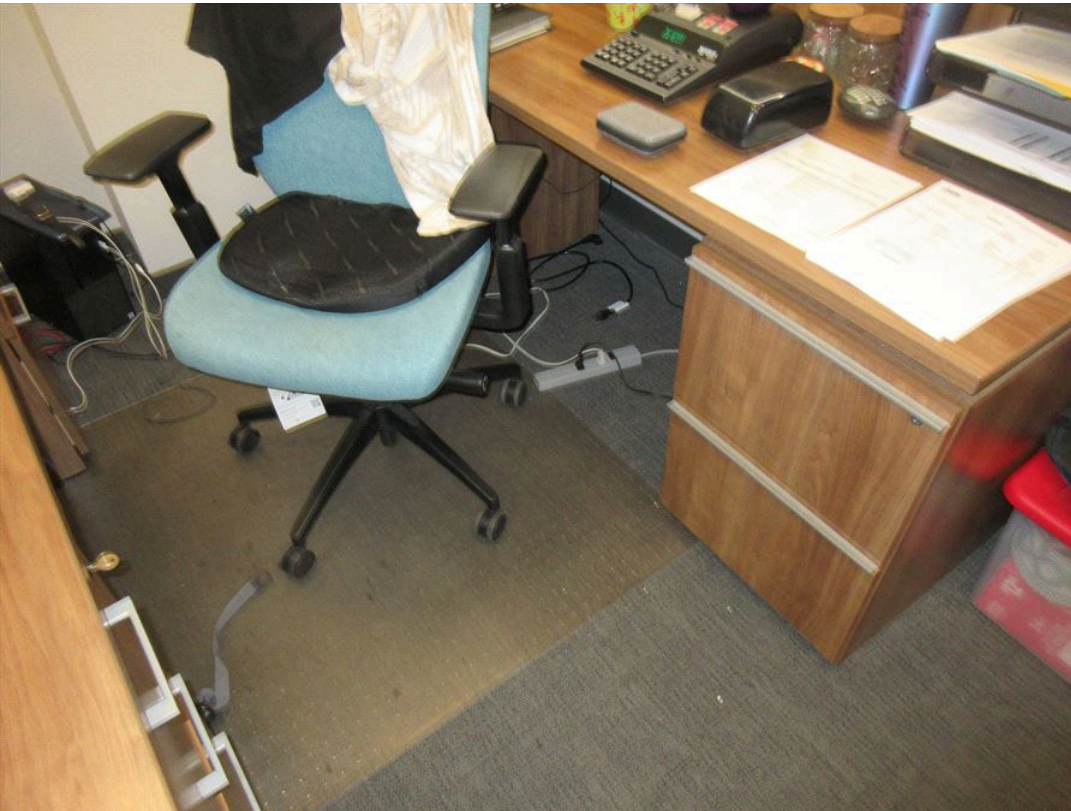
File Name: photo of close up of power strip under desk
Violation Code: 603.5.1
Inspected Date: 2026-03-27 17:49:53

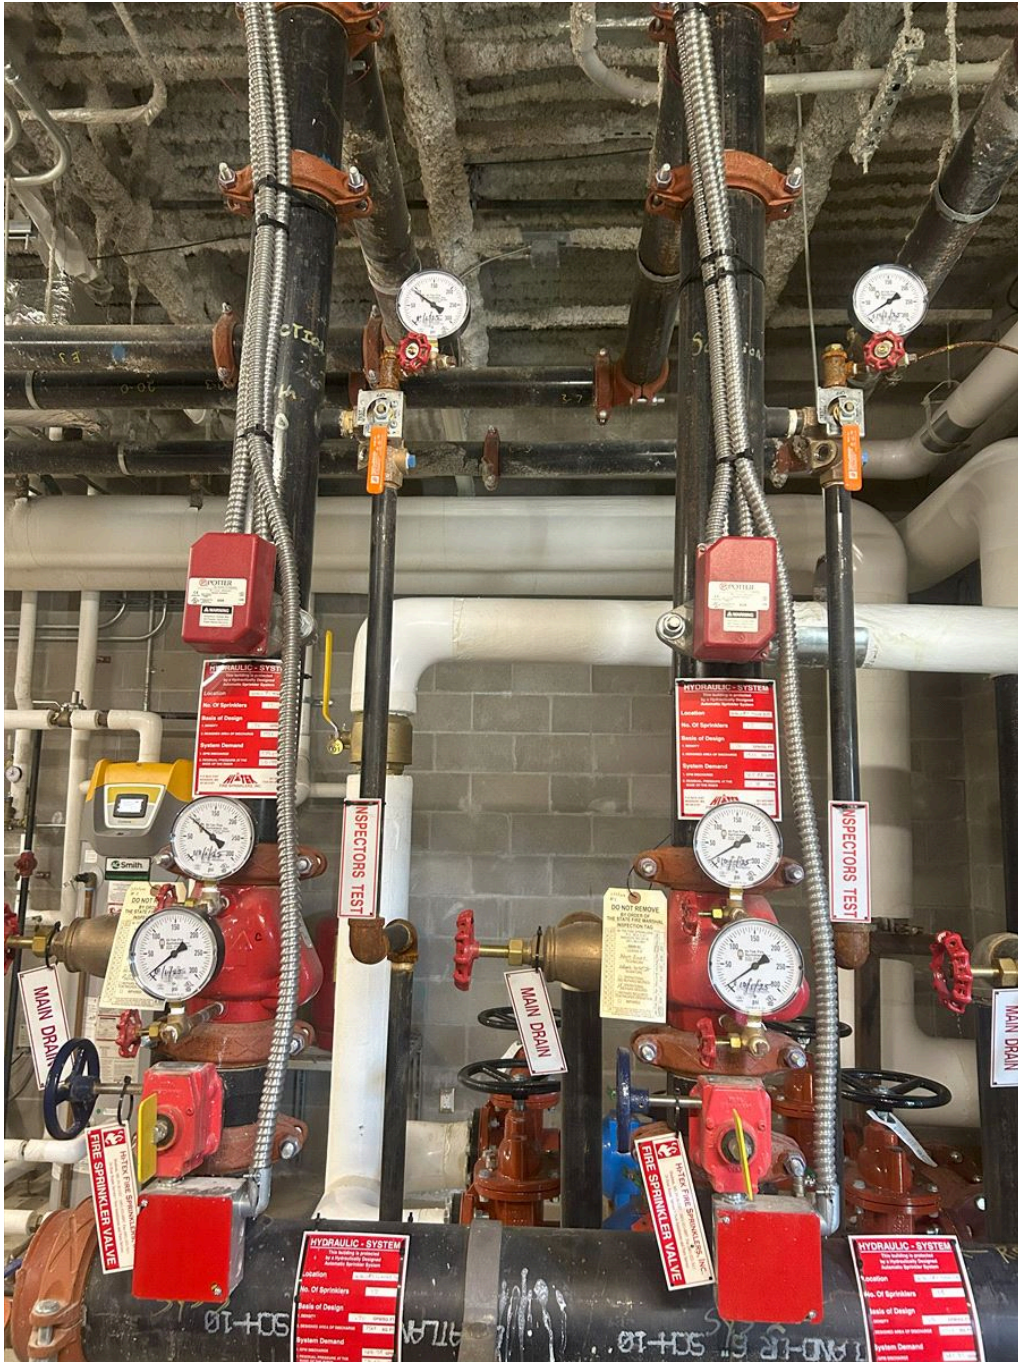
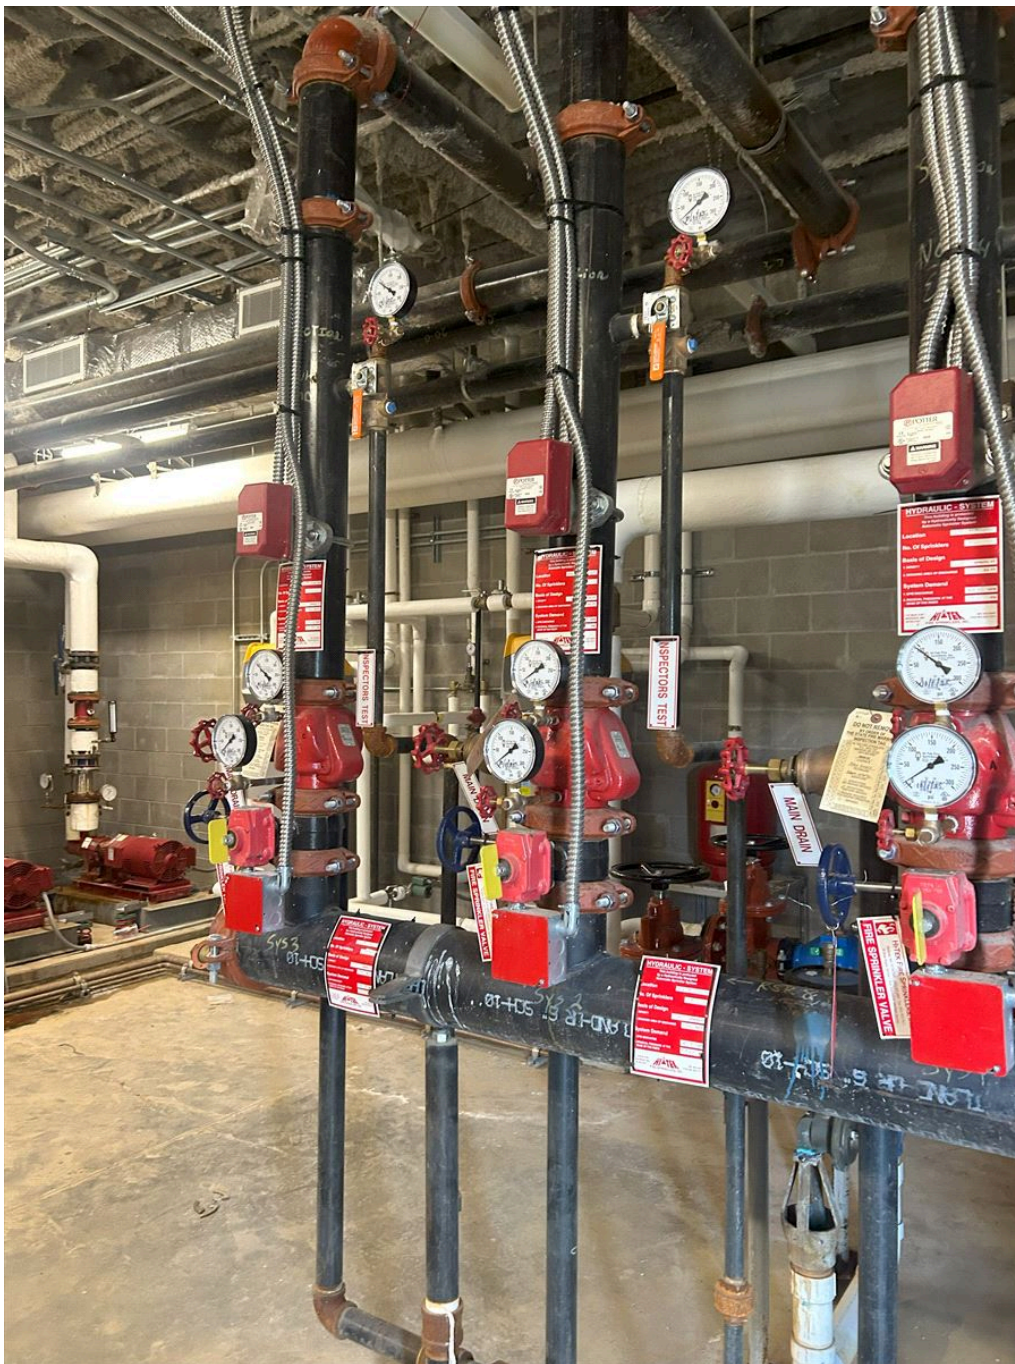
File Name: photo showing all three sprinkler risers in the trade mart
Violation Code: 903.5
Inspected Date: 2026-03-27 18:22:14

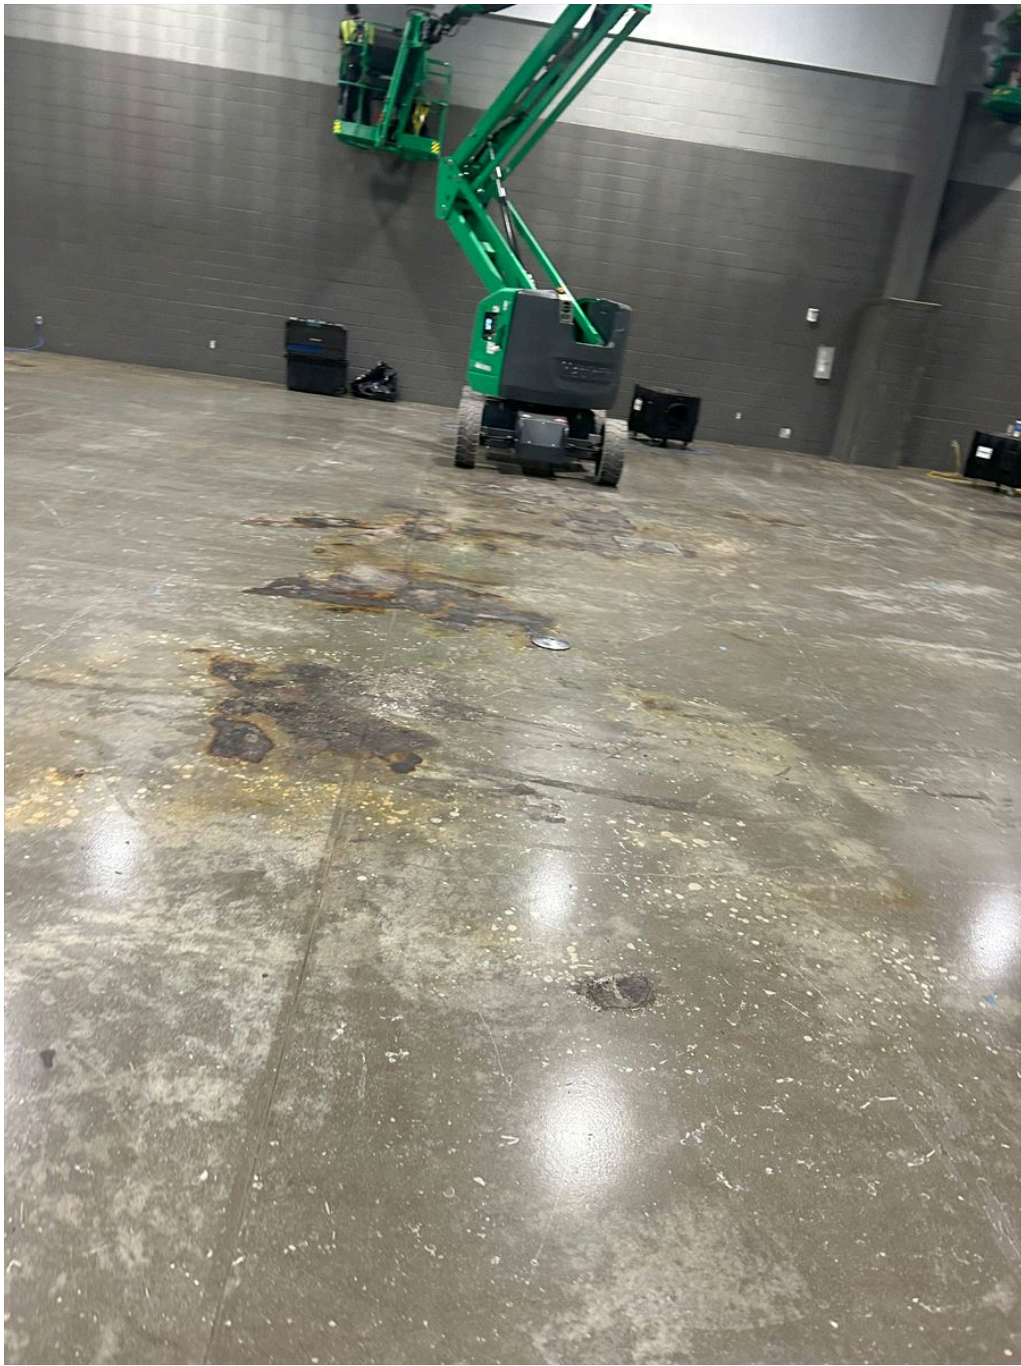
Title: photo of area in trade mart where fire occurred

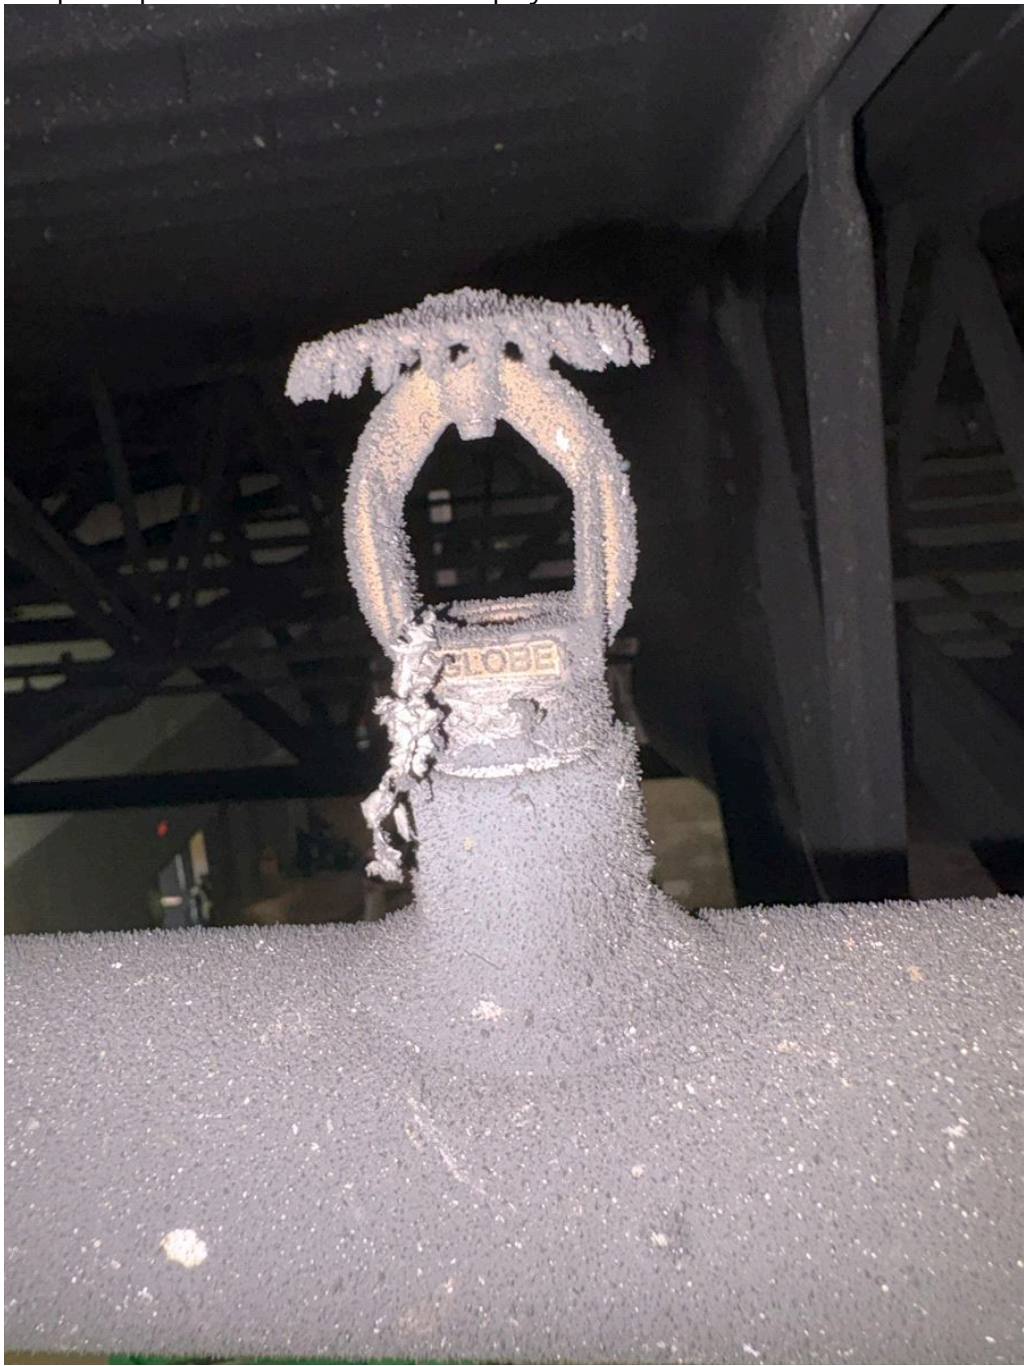
Title: photo of close up of a sprinkler head that has been deployed above where fire occurred
